Name of Dam: Cove No. 2

Location: Frederick County, State of Virginia

PHASE I INSPECTION REPORT NATIONAL DAM SAFETY PROGRAM

AUGUST 1978

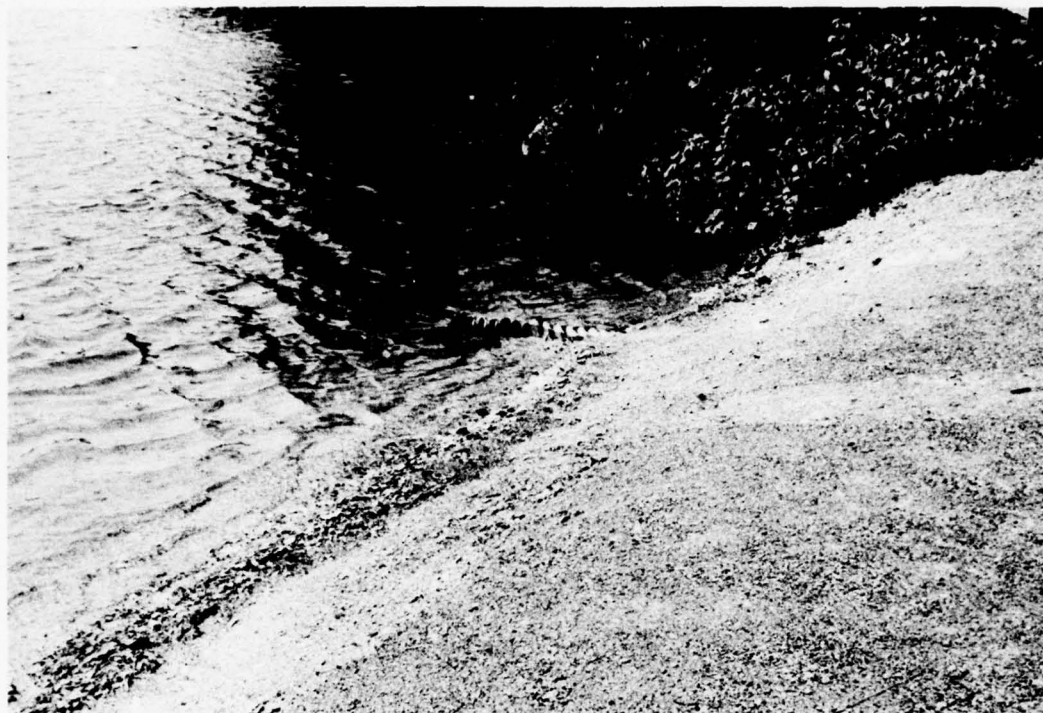
PHOTO 1

C. M. P. Intake of Principal Spillway at Left Abutment

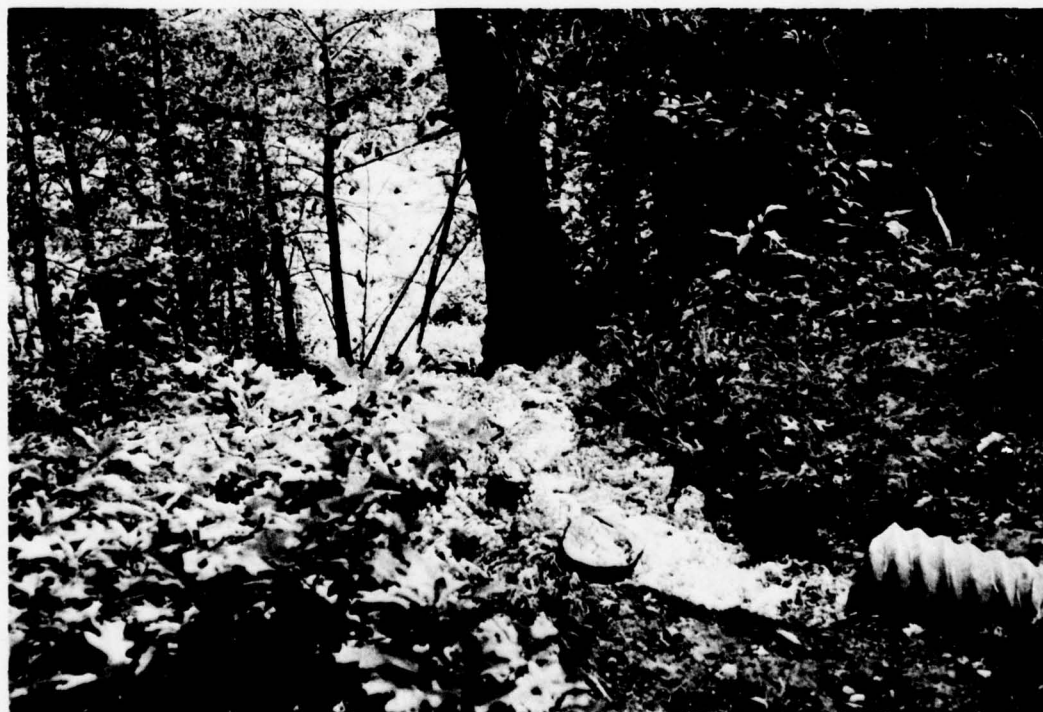
PHOTO 2

C. M. P. Outlet on Top of Ridge Near Left Abutment

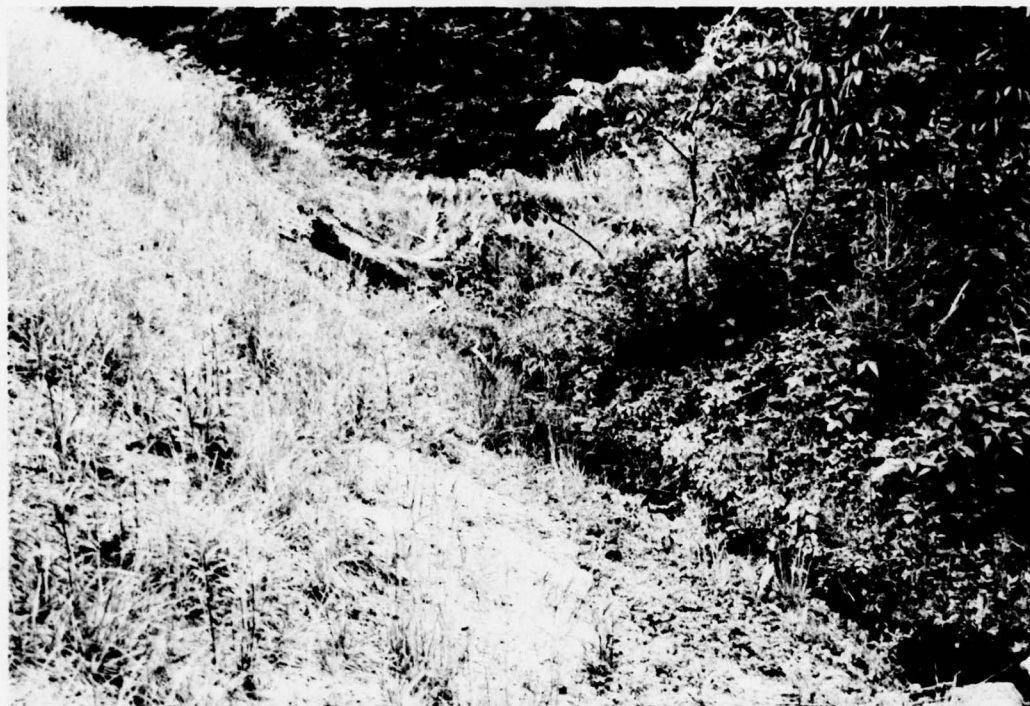
PHOTO 3

Clear seepage was found all along the toe of the embankment with flows ranging from 0.5 g.p.m. to 3.0 g.p.m. Some of the seepage water is reddish-brown colored due to an iron precipitate. These clear seeps should be checked regularly for evidence of piping.

Streamflow Along Downstream Toe of Embankment

ANY NOTICEABLE SEEPAGE	<p>There is considerable seepage along the downstream toe of the dam ranging from 0.5 g.p.m. to 3.0 g.p.m. as measured at four locations. Springs were reported by the owner from shale in the dam foundation during construction. There is stream flow collecting seepage along the toe. Some of the seepage is reddish-brown from iron precipitate.</p>	<p>Seepage profile through the dam needs to be defined.</p>
STAFF GAGE AND RECORDER	<p>There are none.</p>

There is no need for emergency measures, but the clear seepage at the toe needs to be studied further by the installation of piezometers.

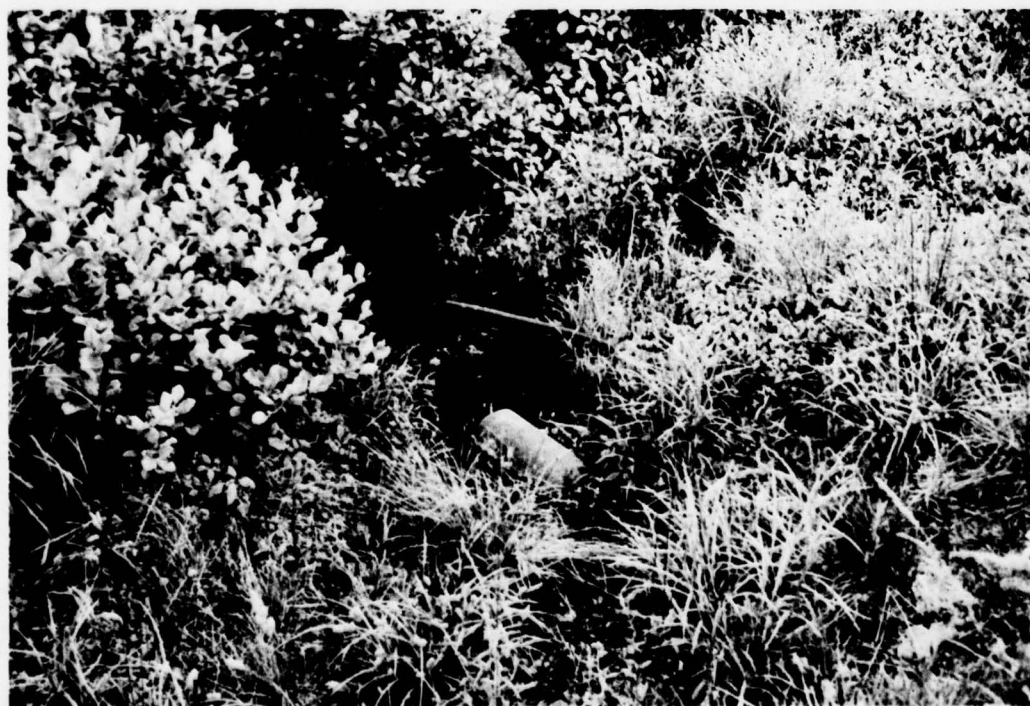
PHOTO 4

Outlet of 10 Inch Steel Pipe at Toe of Embankment

Coarse shale was placed in the downstream toe to act as a drain. Clear seepage (0.5 to 3.0 g.p.m.) flows from the shale. Two French drains were reportedly constructed in a spring area in the lower part of the downstream portion with a polyethylene pipe for an outlet. A two inch plastic pipe was observed beside the 10 inch steel pipe near the center of the dam at the toe with one inch of flow.

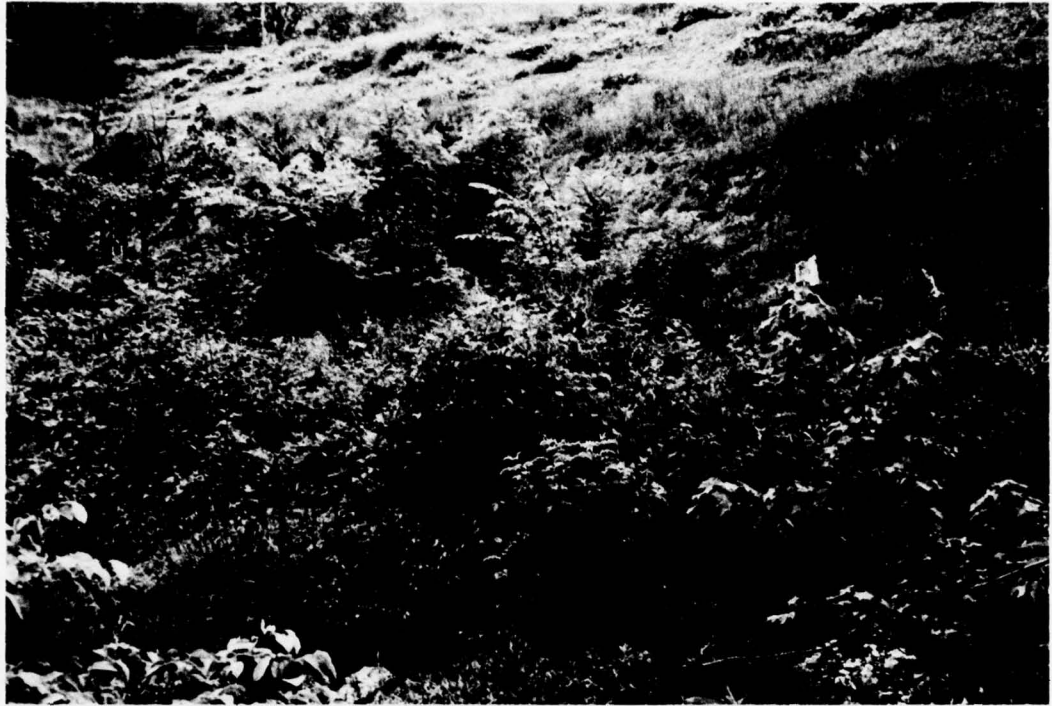
PHOTO 5

Downstream Slope of Dam Looking Toward Right Abutment

Sloughing of the embankment or abutment slope was not visible. The vegetative cover on the dam is variable with bare areas covered by shale fragments. Erosion is minor. The abutment slopes do not appear to be eroded.

- 3.2.1 Dam: The bare areas on the dam should receive topsoil and possibly be reseeded. The clear seepage should be further assessed to determine the elevation of the phreatic line through the embankment. The embankment crest and slopes should be accurately surveyed.
- 3.2.2 Appurtenant Structures: The smaller emergency spillway should be lined with riprap. The natural spillway area should be accurately surveyed.
- 3.2.3 Reservoir Area: A topographic survey around the lake should be done for accurate measurement of reservoir storage.
- 3.2.4 Downstream Channel: The campsites downstream of the natural spillway should be relocated.

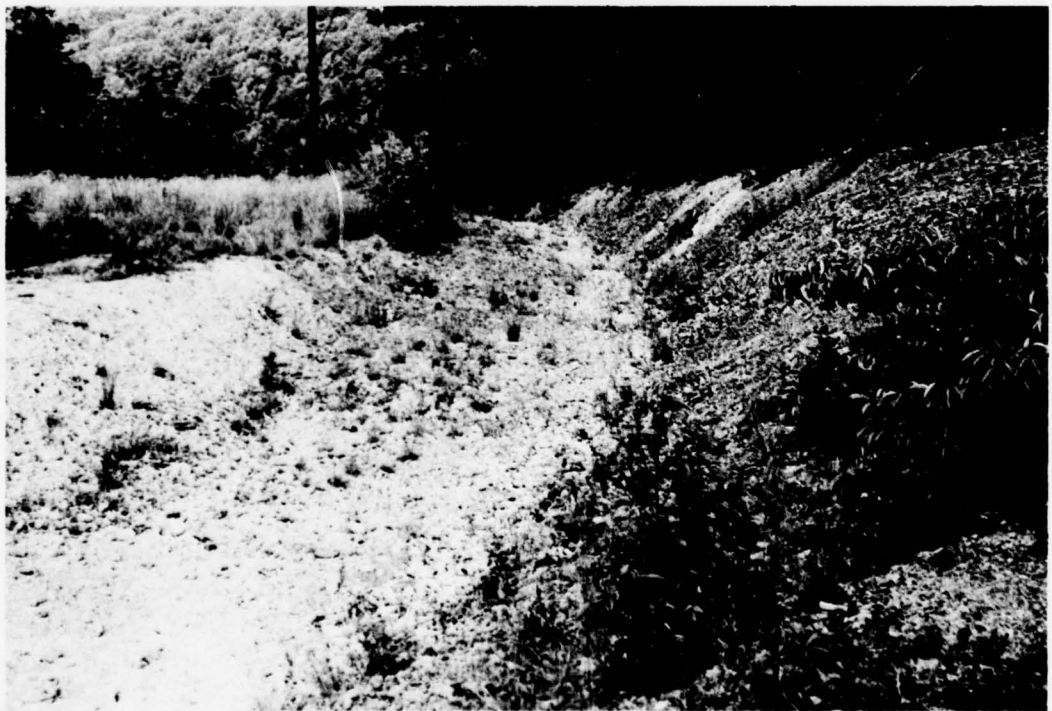
PHOTO 6

- 3.1.3 Appurtenant Structures: The small emergency spillway has no erosion protection. However, there is a twelve feet wide by two to three feet high fill at the southwest edge of the reservoir which serves as a small dike. The elevation at the top of this dike, which also serves as a roadway, is about the same as the spillway. Non-measurable clear seepage is also present at the toe of this fill.

Emergency Spillway Looking Downstream
