Name Of Dam: LAKE JACKSON DAM

Inventory Number: VA. 15306

PHASE I INSPECTION REPORT NATIONAL DAM SAFETY PROGRAM

JUNE 1978

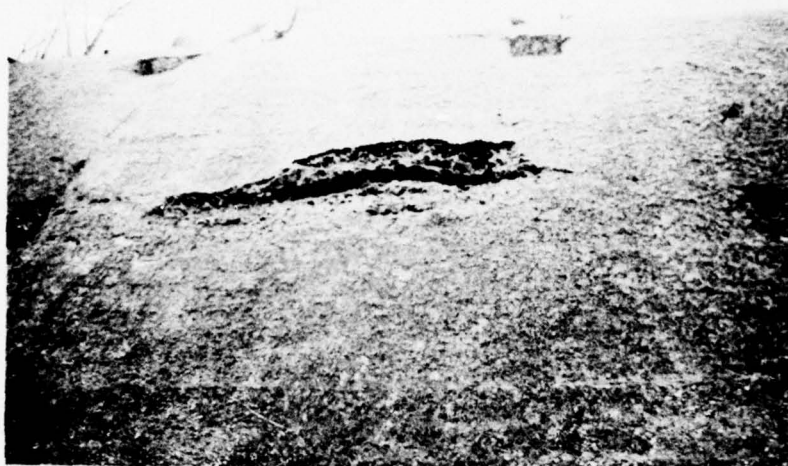
LAKE JACKSON DAM - SPALL ON
SURFACE OF SPILLWAY

The tainter gate was opened to lower the lake level below the crest of the dam. This action was requested by the Corps of Engineers to expose the face of the spillway for inspection. A few cracks, severe weathering and deterioration of concrete were visible on the exposed spillway. However, the face was covered by a green algae-type growth which made thorough observations difficult.

7.2.3 Repair weathered concrete all along the catwalk and powerhouse by applying a topping or grout finish.

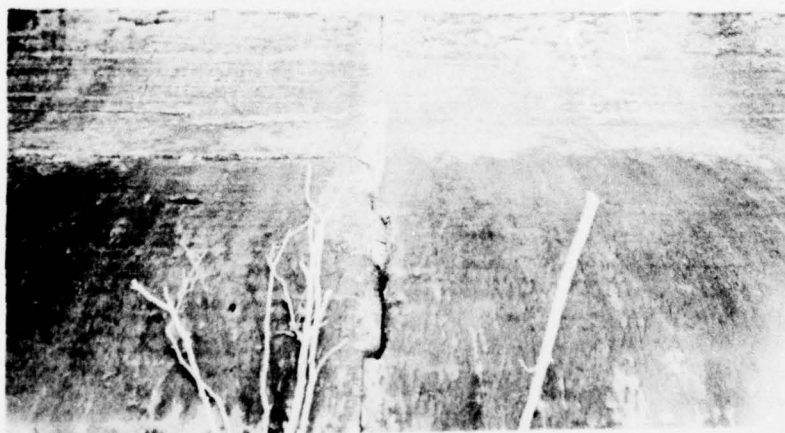
LAKE JACKSON DAM - SPALLING
AT CONSTRUCTION JOINT

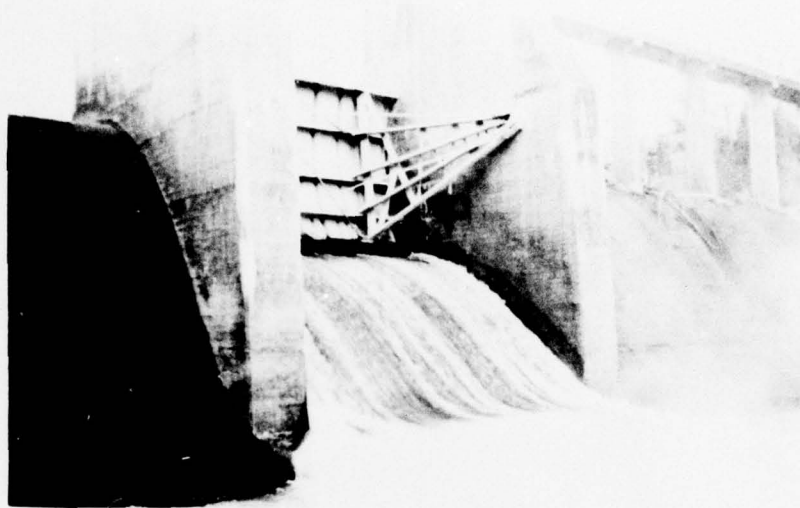
3.1 Findings: Information observed in the field is outlined in Appendix D. Overall, the concrete dam had severe signs of weathering and deterioration. Evidence of seepage along the right abutment contact did not appear to be critical, but determination could not be made on a visual inspection. Upon closure, the tainter gate did not seat firmly against the bottom sill to stop the flow of water.

LAKE JACKSON DAM - TAINTER GATE

Over the top of the tainter gate is a machinery room. An electrical winch opens the gate. The opening height is graduated in revolutions. The tainter gate appeared to be in good condition. However, when it was closed at the end of the inspection, a large flow of water passed under the gate. A county representative remarked that the gate did not seal right away.

7.2.2 Install a new bottom sill and seal for the tainter gate.
