National Dam Safety Program. Cove Dam
Number 1 (VA 06905), Frederick County,
Virginia. Phase I Inspection Report.

PHASE I INSPECTION REPORT
NATIONAL DAM SAFETY PROGRAM

Name of Dam: Cove No. 1
State: Virginia
County: Frederick
Stream: Tributary to Laurel Run
Date of Inspection: 16 June 1978

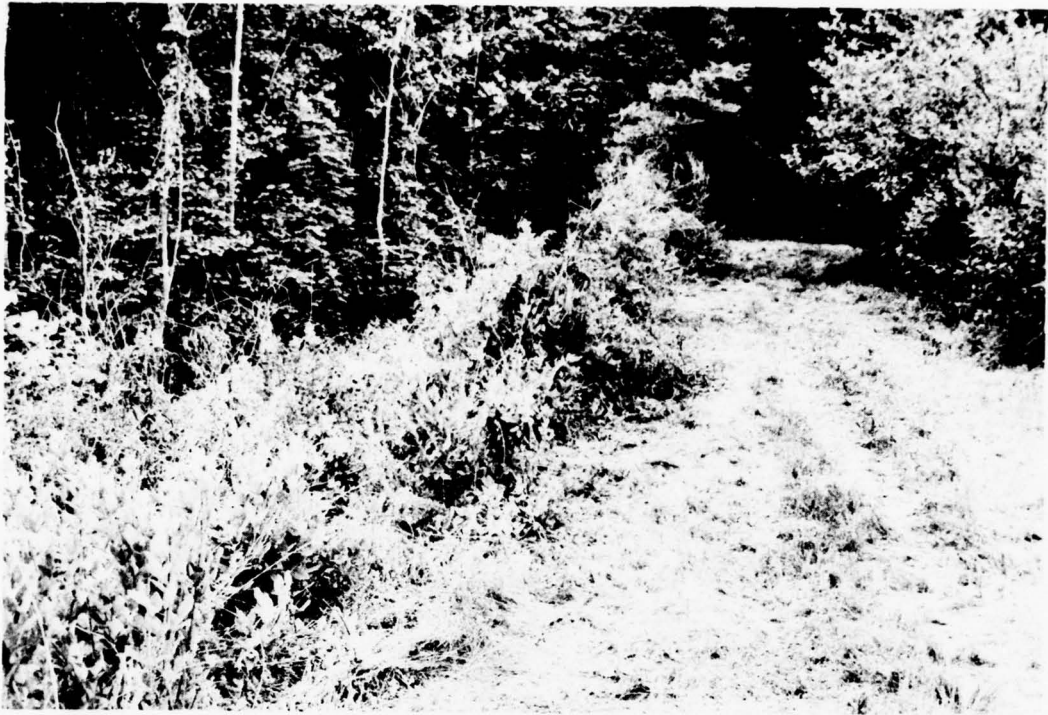
PHOTO 1

- 3.1.2 Dam: Silty sand and gravel with cobbles were observed on portions of the dam surface. Silty clay with rock fragments were observed on other portions. The dam has many trees and brush growing on the downstream face and a few trees growing on the upstream face (see Photo 1). These trees and brush should be removed to prevent the root system from damaging the embankment. Ground cover should be planted to keep the erosion to a minimum. The top of the dam has vehicle ruts which are dry. The crest of the embankment varies irregularly in elevation between the abutments from a low elevation at the right abutment of 1155.1 to a high elevation of 1157.3 above the spillway. This is an unfavorable condition, particularly when the embankment is overtopped causing a concentration of flow in one area of the dam and increased velocities. Presently, the crest is not seriously eroded indicating that the embankment has probably not been overtopped to date.

Top of Dam at Right Abutment Showing Dense Vegetation

- 3.2 Evaluation: The repair of the emergency spillway, repair of the outlet pipe, raising and leveling the crest, and the removal of trees should be done as soon as possible to prevent damage to the embankment and the emergency spillway. The other repairs can be done as routine maintenance items since they do not threaten the integrity of the dam.

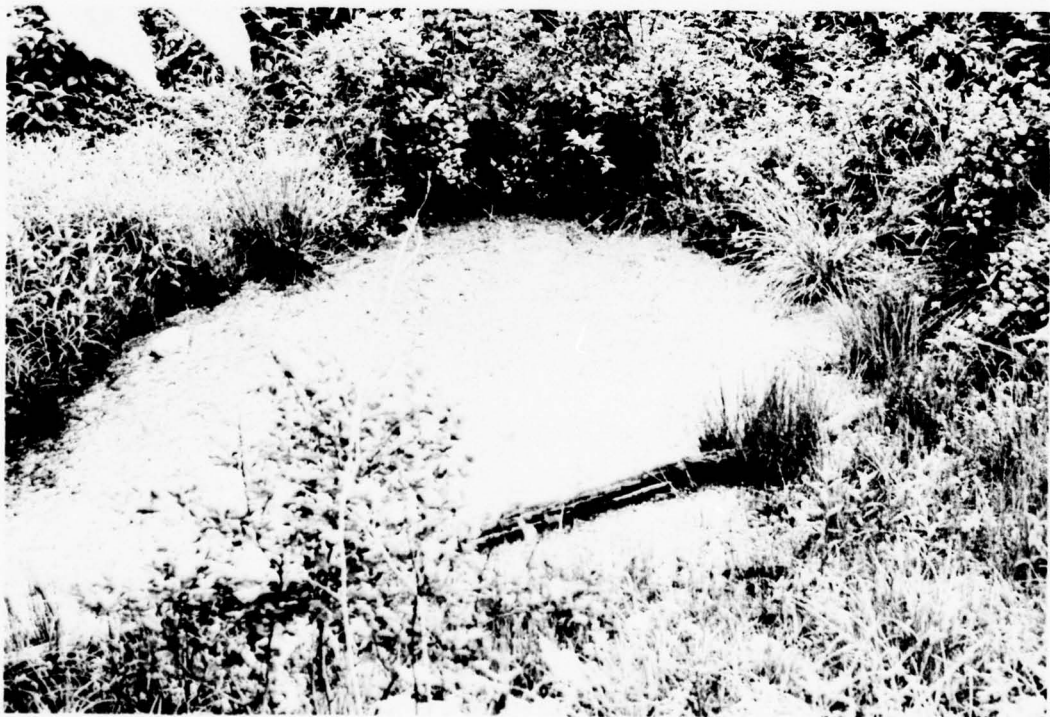
PHOTO 2

6.2.1 Visual Observations: No evidence of sloughing or sliding in the embankment, cut slopes or drainage structures was observed. Clear seepage occurs in three areas at the downstream toe of the dam. The seepage from a grouted outlet pipe has formed a small pond with a measured flow of 0.75 g.p.m. (see Photo 2).

Small Red Pond at Covered Outlet of Sealed 10 Inch Pipe at Downstream Toe Near Middle of Dam

ANY NOTICEABLE SEEPAGE	Seepage at the downstream toe 100 feet from the right abutment in a 50 feet wide area was not measurable. A 20 feet wide pond of red water (from iron precipitate) (see Photo 2) near the downstream center at the outlet of a 10 inch pipe which was reportedly grouted after it had been damaged. The pipe was not visible--covered with earth. A flow of 0.75 g.p.m. was measured. There is a wet area (100 feet long) from seepage on the left abutment of the embankment toe.	The seepage is of sufficient quantity to warrant close regular inspection and/or piezometers. A siphon drain is scheduled to be installed in the fall of 1978 to replace the 10 inch pipe, according to the owner.
STAFF GAGE AND RECORDER	None	
DRAINS	The owner reported that the downstream toe drain had been constructed by bulldozing scattered sandstone rocks into a pyramid section. There is a cover of soil and topsoil with a vegetative growth which obscures inspection of the rocks. Previously reported seepage occurs at the toe. The engineer's plans called for an embedded four inch tile drainpipe with porous backfill.	The toe drain presently seems to be adequate but the materials appear to be mixed.

- 4.4 Evaluation: The maintenance of the dam is poor with respect to the removal of trees and brush. However, the primary spillway pipe was free of debris and siltation (see Photo 4). The owner should immediately provide a means of draining the lake by repair of the existing, plugged, 10 inch drain or by new construction.

A detailed assessment of increasing spillway capacity and assessment of seepage conditions, including the clear seepage from the outlet pipe is needed immediately.

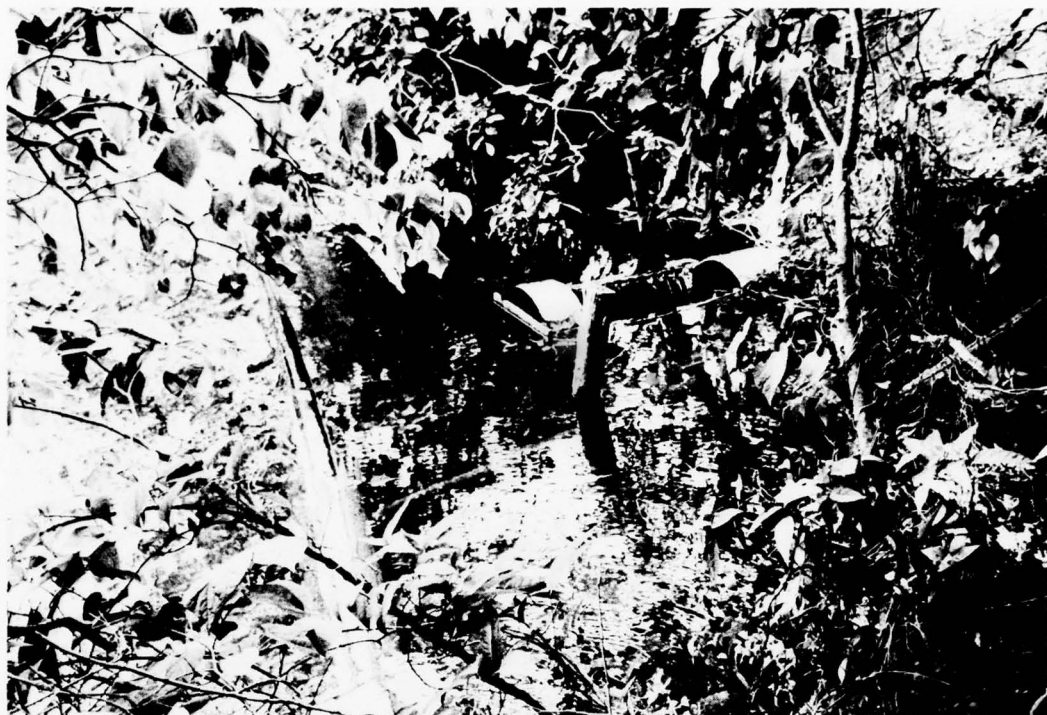
PHOTO 3

Inlet of 24 Inch C. M. P. Principal Spillway Near Right Abutment

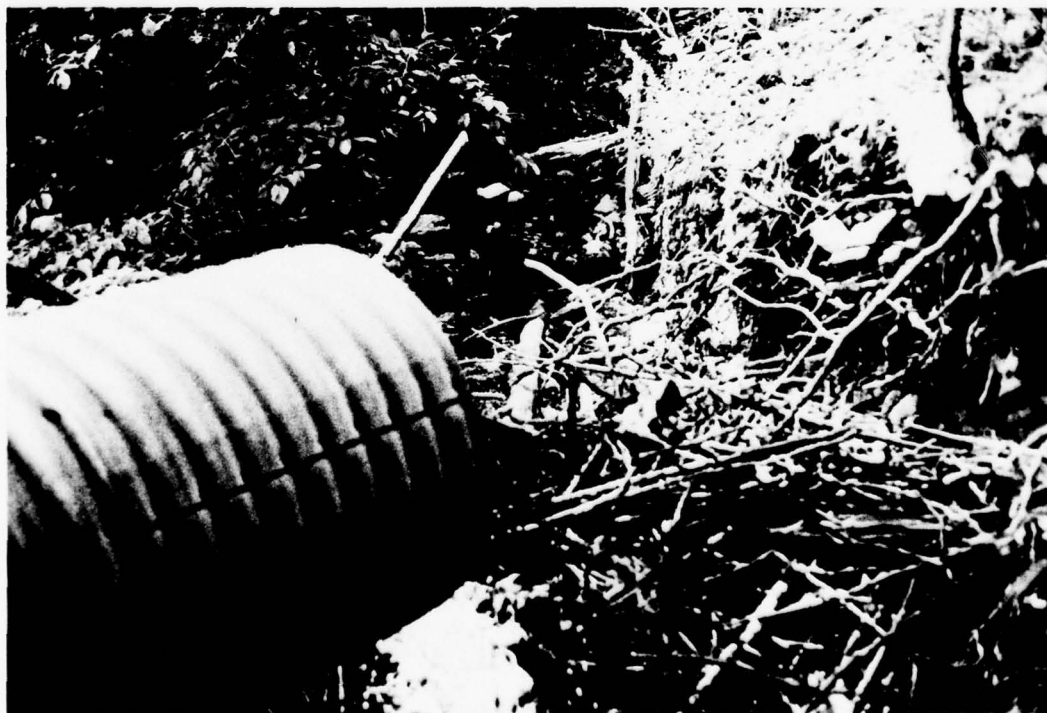
PHOTO 4

Outlet of 24 Inch C. M. P. Principal Spillway Showing Stilling Basin With Trash and Downstream Channel

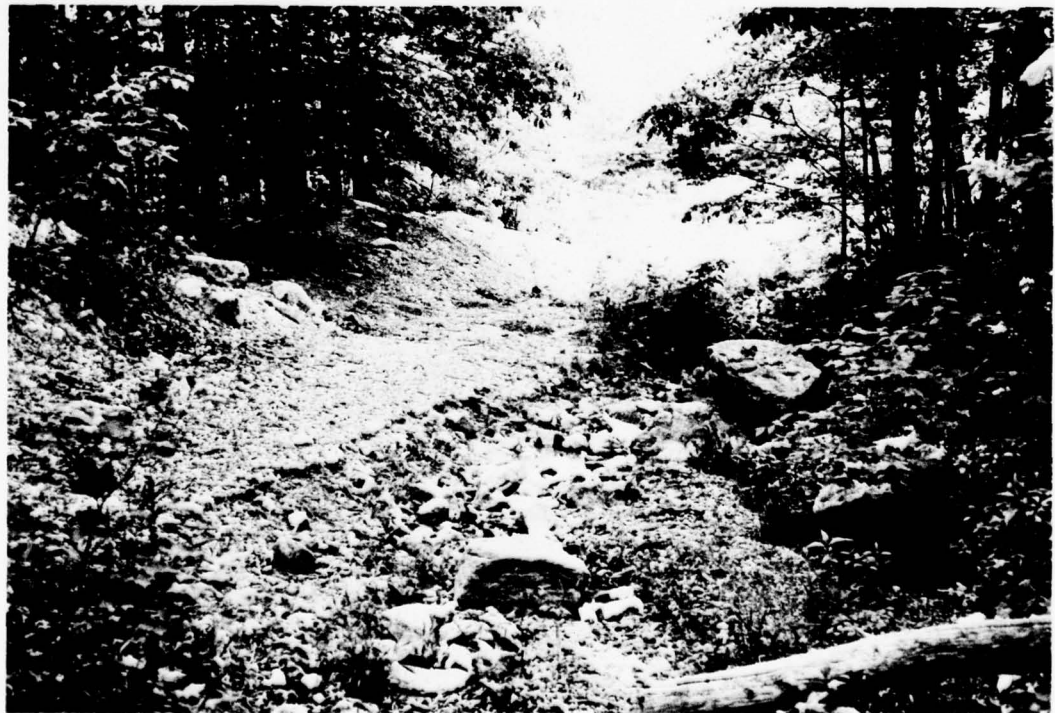
PHOTO 6

Discharge Channel of Emergency Spillway Looking Upstream
