Name Of Dam: CLIFTON FORGE Dam

Location: ALLEGHANY COUNTY, VIRGINIA

Inventory Number: VA 00503

# PHASE I INSPECTION REPORT

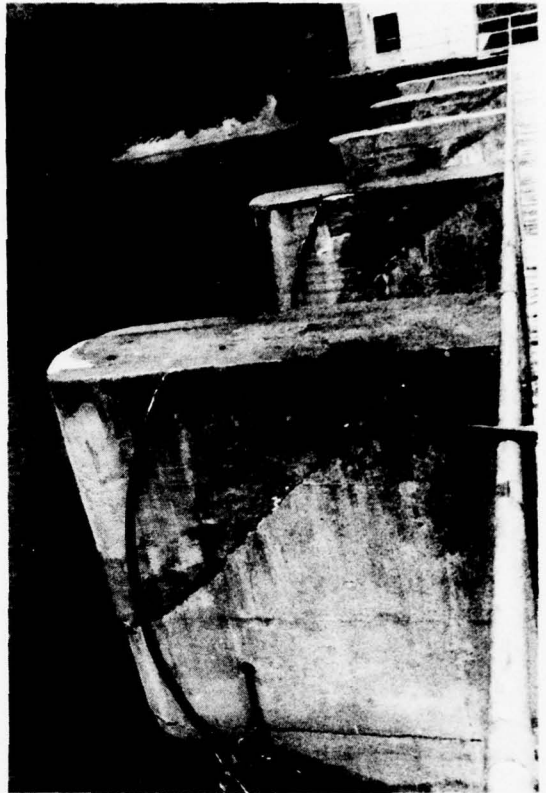
SPILLWAY GATE PIERS

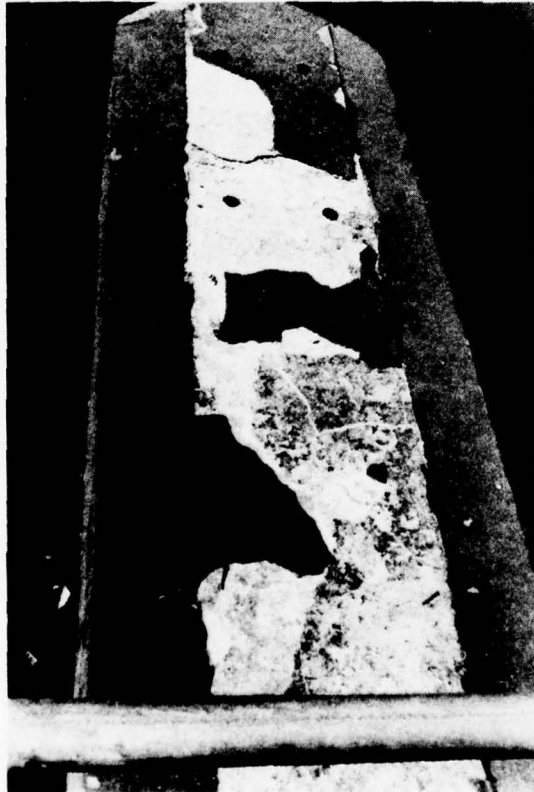
There were no conditions observed which indicated that the dam needed immediate repair. The concrete was scaling in some areas, particularly at the top of the spillway gate piers. For the most part, this scaling appeared to be a mortar-cemented surface which was beginning to separate from the mass concrete beneath. More severe scaling is occurring on the face of the dam near the left abutment. The scaling is occurring at a horizontal joint at the top surface of a lift of concrete.

The cause of the scaling is unknown but it could be due to "freeze-thaw" action on the surface, brought about by seepage through the construction joint. The scaling concrete is several inches deep and runs along the entire length of the bulkhead section of the dam, 23 feet below the top. The scaling does not appear to represent a condition which would affect the safety of the dam, but the owner should consider repairing it as part of a general maintenance procedure.

SCALING CONCRETE ON THE TOP  
OF THE SPILLWAY PIERS

concrete debris from the old 12-inch downstream pipeline and repair of the scaling concrete, should be done. It is also suggested that future consideration be given to increasing the spillway capacity.

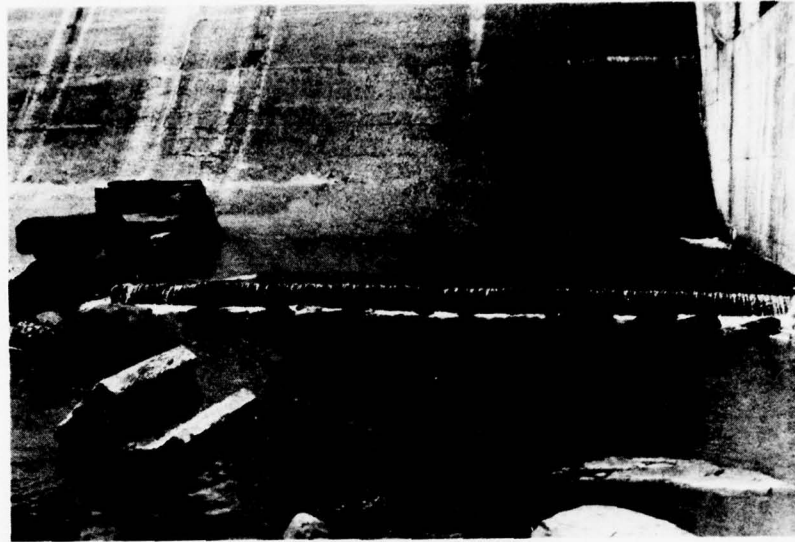
A large discharge over the dam in 1950 caused the existing scour at the end of the spillway. The old 12-inch pipeline, in existence prior to the construction of the dam, was washed out and the streambed was heavily scoured. However, there was no evidence of a deep scour pool at the end of the spillway. Another large flood was produced by Hurricane Camille in 1969. A damage survey of Smith Creek was performed by the Corps of Engineers in 1971 after the flood and no serious damage to the dam was noted in their report. A portion of the report is included in Appendix IV.

BASE OF SPILLWAY CHUTE - RESERVOIR OUTLET IS ON  
RIGHT, SOME DAMAGE RESULTING FROM HURRICANE CAMILLE ON LEFT?

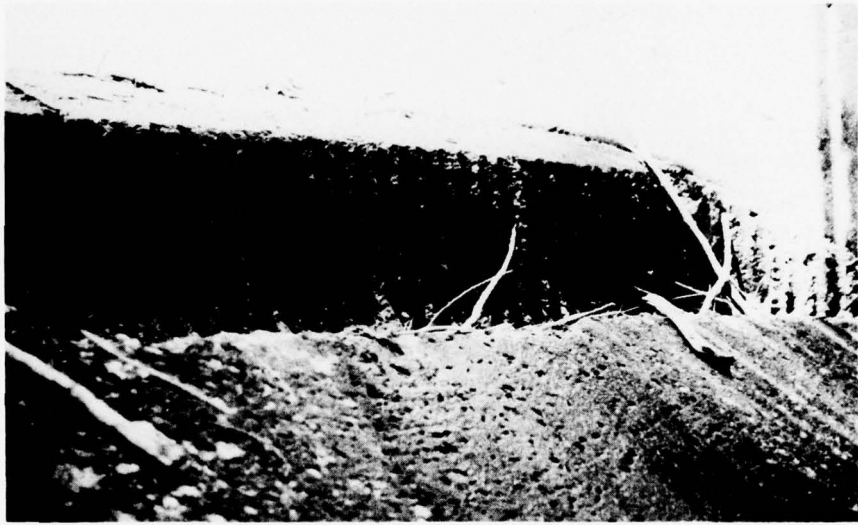
What effect these notches have had on the spillway hydraulics is difficult to evaluate. There did not appear to be any spalled concrete near the broken concrete giving evidence of cavitation damage, and there did not appear to be any excessive erosion on the abutment below the spillway. The notches have little effect on the structural integrity of the dam.

NOTCH CUT INTO SPILLWAY FLOOR VIEWED  
FROM RIGHT ABUTMENT BELOW SPILLWAY

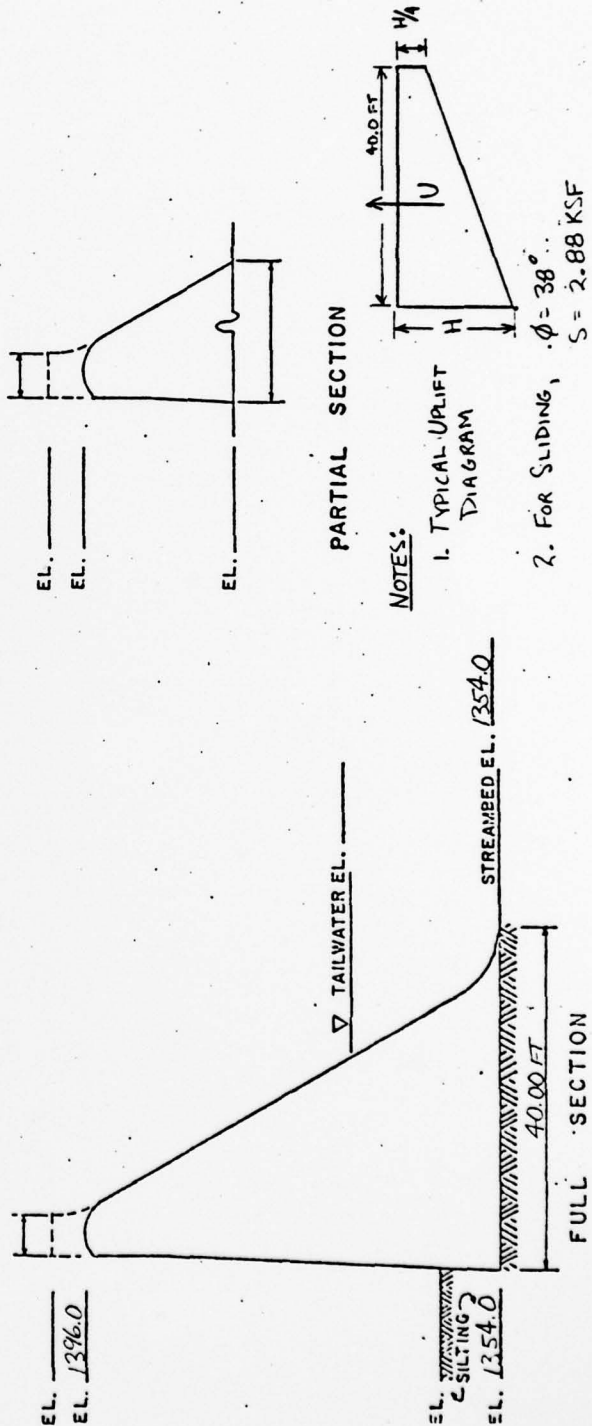
The Clifton Forge Dam has two main sections: the spillway section which makes up the right end of the structure, and a bulkhead section which forms the left end. A separate analysis was provided for each. The spillway section was found to be slightly better with respect to stability than the bulkhead section under all loading conditions, but neither section meets the required factors of safety as set out in Reference 1 of Appendix VI. Basically, the factor of safety against sliding should be greater than 3 and the resultant foundation pressure force should fall within the middle third of the base of the structure.

These conditions were only satisfied for the spillway section for the loading conditions with the reservoir at the level of the spillway crest. The bulkhead section had a factor of safety of 2.8 for this condition, only slightly below the criteria. For the loading conditions presented by the PMF and one-half PMF, the factors of safety were generally between 1 and 2 for sliding, with the resultant foundation pressure force outside the middle one-third section of the base. A summary of the results of the stability calculations are presented in Appendix V.

ANALYSIS DONE ON X FULL SECTION PARTIAL SECTION  
 LOCATION OF SECTION CLIFTON FORGE SPILLWAY  
 ANALYSIS PREPARED BY D.C. RECHWARD

LOADING CASE	ELEV. HEAD WATER	ELEV. TAIL WATER	ΣV	ΣH	ΣH / ΣV	LOCATION RESULTANT FROM TOE	% BASE COMPRESSION IN	FACTOR SAFETY SLIDING	FOUNDATION PRESSURE	
									TOE	HEEL
PMF	1412.8		68.9 K/FT	99.1 K/FT	1.44	3.53 FT	26%	1.71	13.01 KSF	0. KSF
1/2 PMF	1408.0		76.5	86.5	1.13	9.01	68%	2.02	5.66	0.
NORMAL WATER LEVEL + ICE	1396.0		95.1	60.0	0.63	16.73	100%	3.16	3.54	1.21

7.2.1 Structural Stability: The owner should obtain the services of a qualified consultant to evaluate the structural stability of the dam and make recommendations for remedial action to be carried out by the owner. The analysis should follow the guidelines recommended in Reference 1 of Appendix VI and should be completed within 120 days of receipt of this Report.

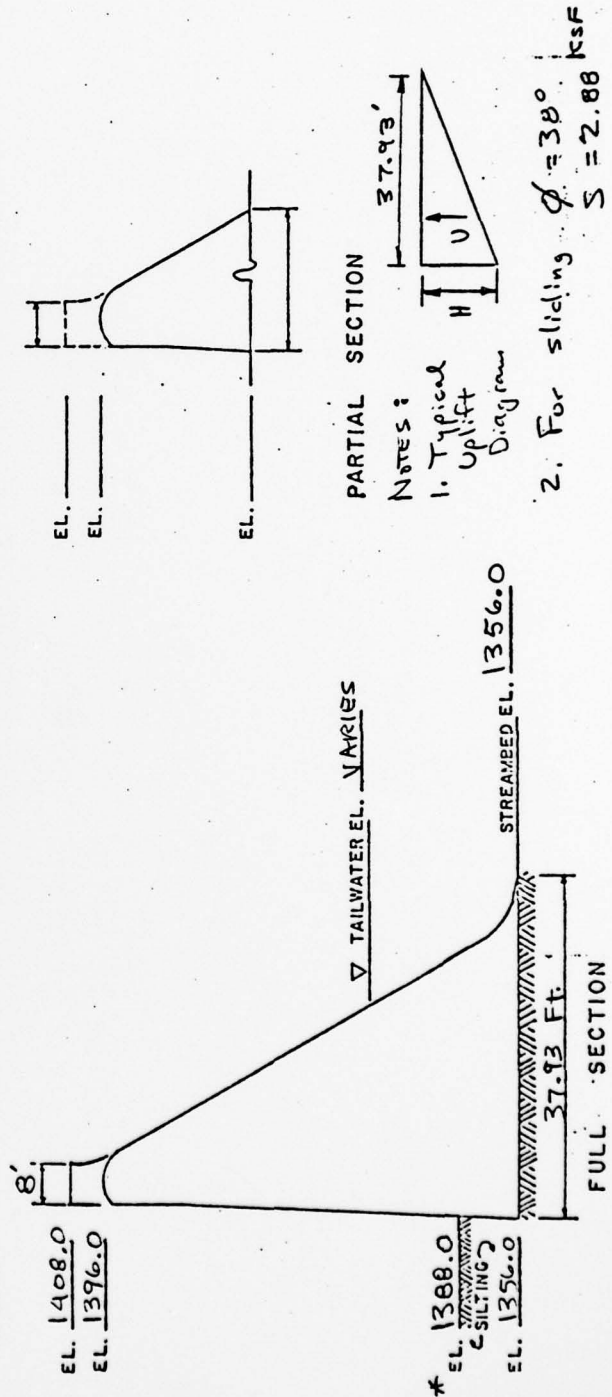
ANALYSIS DONE ON  $\sqrt{\text{FULL SECTION}} - \text{PARTIAL SECTION}$   
 LOCATION OF SECTION CLIFTON FORGE BULKHEAD  
 ANALYSIS PREPARED BY T. SCHNEFFELT

LOADING CASE	ELEV. (FT)		$\Sigma V$ (K/FT.)	$\Sigma H$ (K/FT.)	$\frac{\Sigma H}{\Sigma V}$	LOCATION RESULTANT FROM TOE (FT)	% BASE COMPRESSION IN	FACTOR SAFETY SLIDING	FOUNDATION PRESSURE	
	HEAD WATER	TAIL WATER							TOE (KSF)	HEEL (KSF)
PMF	1412.8	1368.0	84.3	117.3	1.39	2.99	24%	1.49	18.8	0
1/2 PMF	1408.0	0	104.2	101.0	0.97	9.78	77%	1.89	7.10	0
Normal Water Level + ICE	1396.0	0	118.3	71.64	.61	16.69	100%	2.82	4.24	2.00
