Name Of Dam: DOUTHAT DAM

Location: BATH COUNTY, VIRGINIA.

(Inventory Number: VA-01701).

PHASE I INSPECTION REPORT

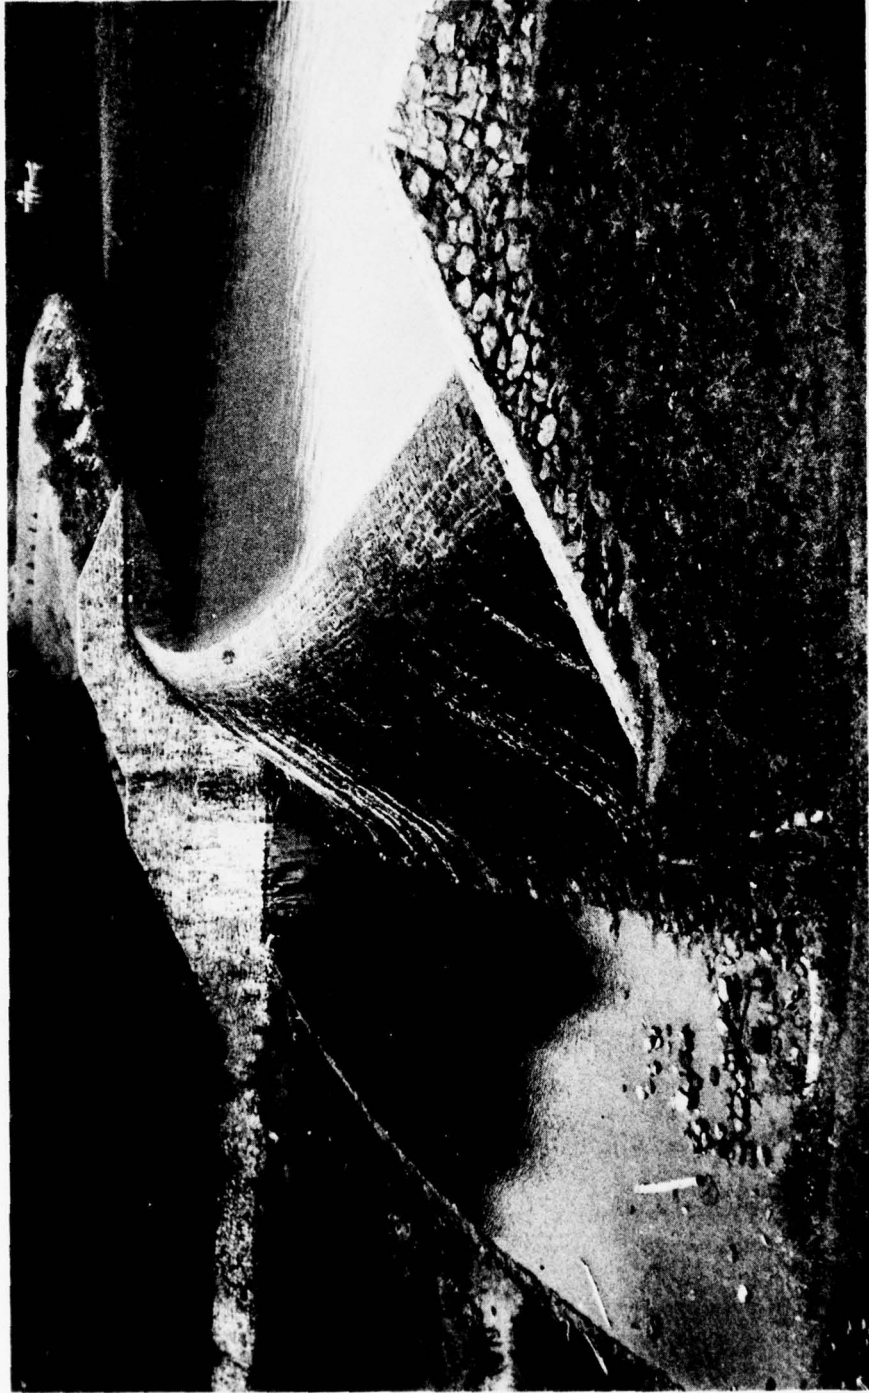
OVERVIEW PHOTO OF DOUTHAT DAM AND SPILLWAY

The crest and uppermost portion of the spillway surface appear to have been recently repaired. There are several missing stones in the masonry paving at the mid-height on the lower weir surface (see Overview Photo on the front page). A seepage condition exists in two areas of the spillway. One area is located on the lower mid-portion of the weir surface where concentrated red stains are shown. The other area lies at the base of the downstream endwall on the left end of the spillway with an estimated flow of 1 g.p.m. to 2 g.p.m.

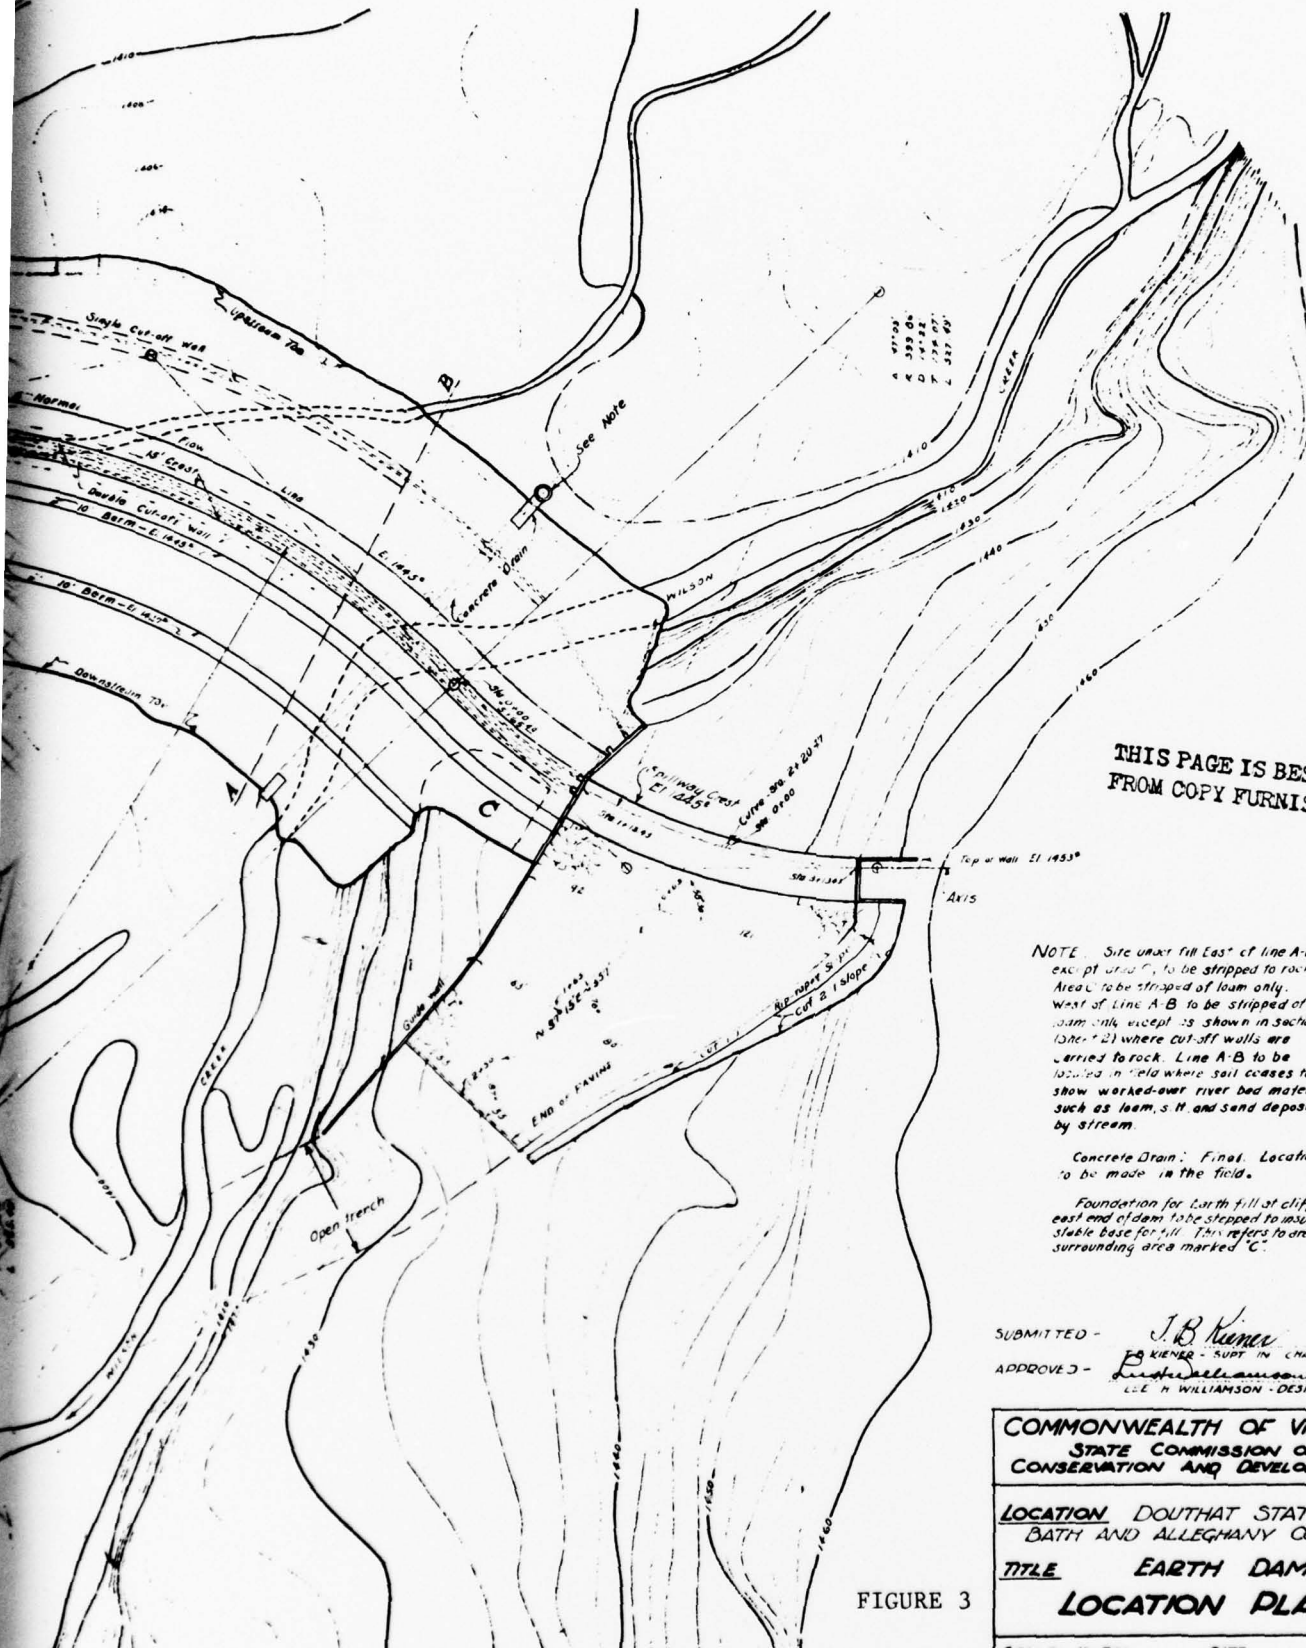
FIGURE 3

The drawings show that the impervious earth core and the concrete cutoff walls were designed to be founded on bedrock. The site under fill east of line A-B (see Figure 3, Appendix I) was to be stripped to rock. West of line A-B the site was to be stripped of loam only. Line A-B was to be located in the field where soil ceases to show reworked alluvial deposits, such as loam, silt, and sand deposits. The foundation for earthfill at the cliff near the east end of the dam was to be stepped to provide a more stable base for the fill.

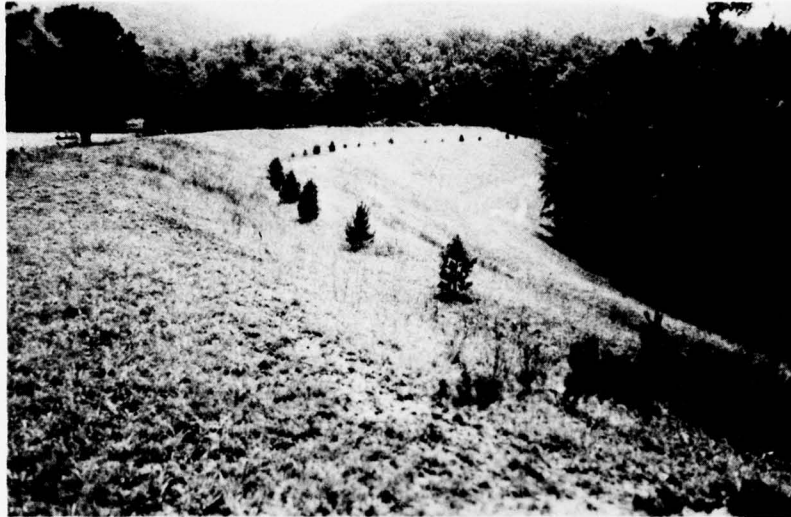
DOUTHAT DAM EMBANKMENT FROM RIGHT ABUTMENT

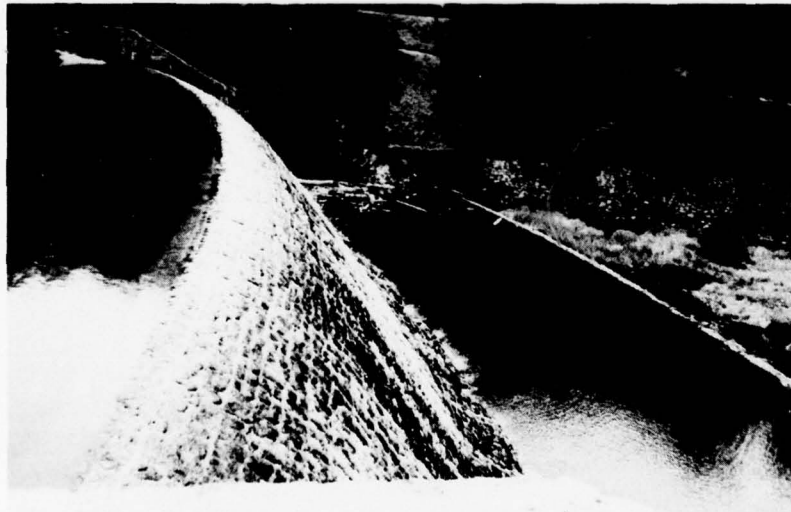
DOUTHAT DAM - VIEW OF SPILLWAY CREST

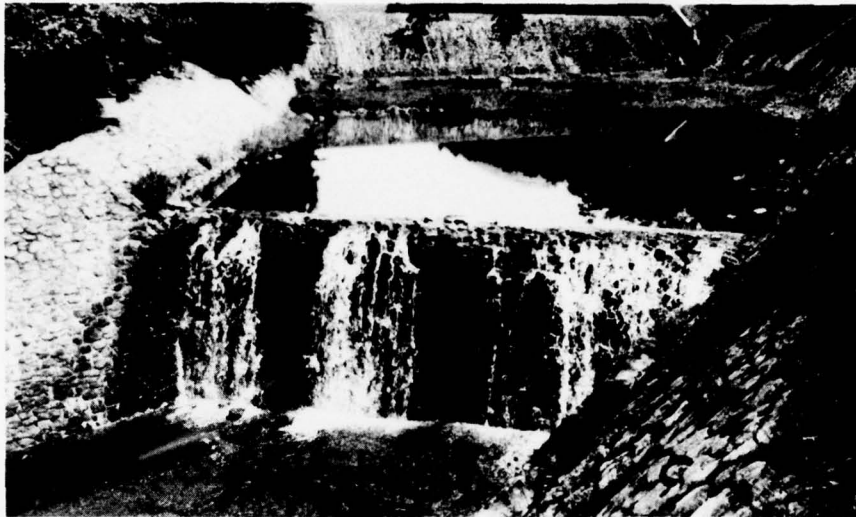
SPILLWAY DISCHARGE CHANNEL AND DOWNSTREAM PLUNGE POOL

The channel was trenched in the original gravelly streambed. There is a small bridge (2 to 3 feet high) across the channel at the distance of about 800 feet below the dam, which consists of several drainage pipes cast in a concrete mass. No significant obstructions to the flow were observed within a length of 1,000 feet of the channel. Dense trees are growing on the both banks of the channel. Masonry wall of plunge pool at lower end of spillway channel was washed out.

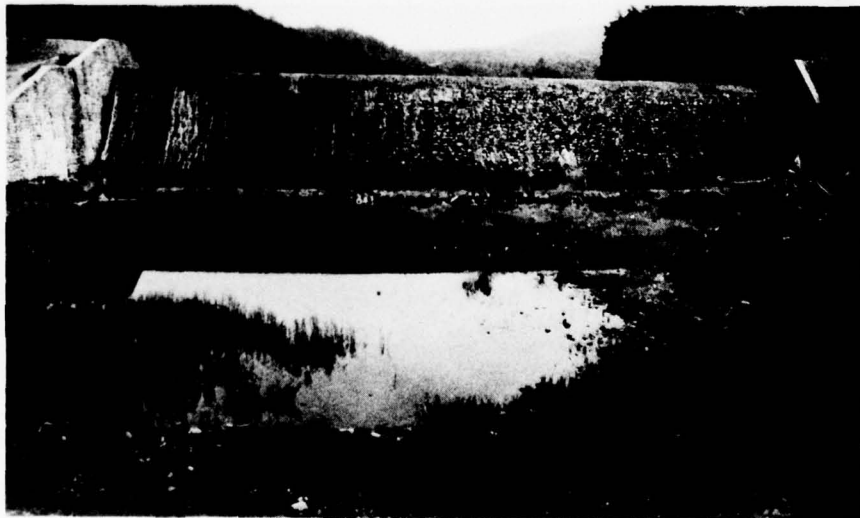
DOUTHAT DAM SPILLWAY

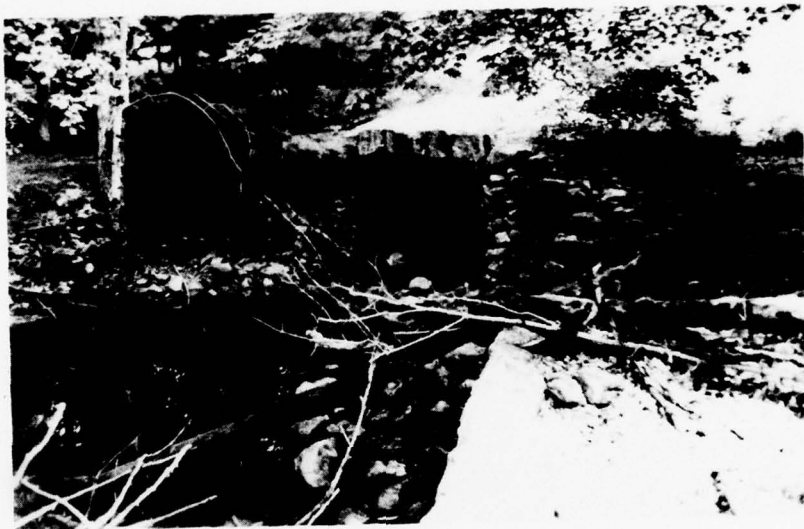
OUTLET END OF CONCRETE DISCHARGE TUNNEL
