Carvin Cove Dam (~~Inventory Number~~ VA 02301). Roanoke River Basin.  
Botetourt County, Virginia. Phase I Inspection Report.

REPORT DOCUMENTATION PAGE		READ INSTRUCTIONS BEFORE COMPLETING FORM
1. REPORT NUMBER VA 02301	2. GOVT ACCESSION NO.	3. RECIPIENT'S CATALOG NUMBER
4. TITLE (and Subtitle) Phase I Inspection Report National Dam Safety Program Carvin Cove Dam Botetourt County		5. TYPE OF REPORT & PERIOD COVERED Final

REVISION NO. 1 TO PHASE I INSPECTION REPORT  
NATIONAL DAM SAFETY PROGRAM

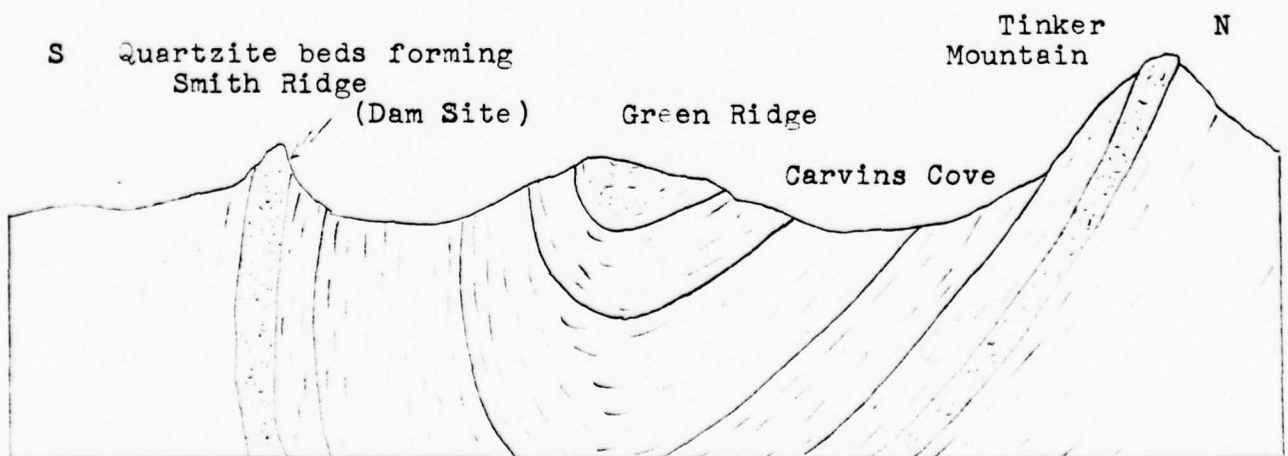
Figure 1. A generalized cross-section illustrating the ridge development and general structure at Carvins Cove. (Berkey 1924)

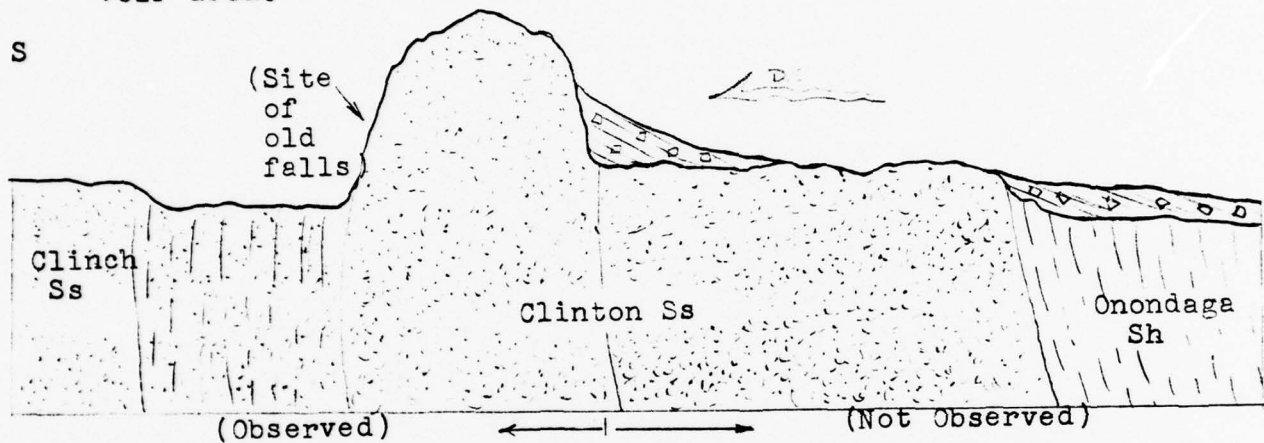
Figure 2. A generalized section taken normal to the dam alignment to illustrate the lithology of the dam site. (after Berkey, 1924)

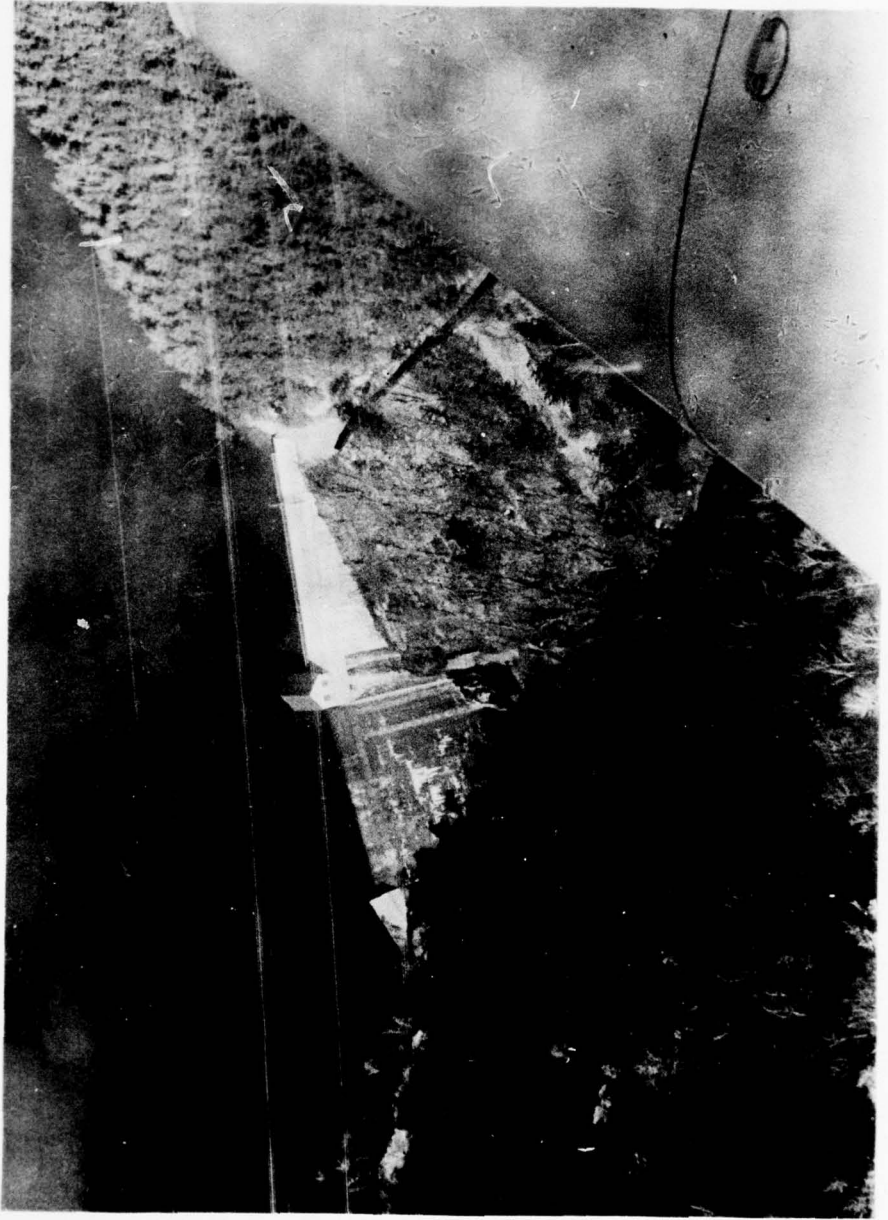
CARVIN COVE DAM - OVERVIEW SHOT

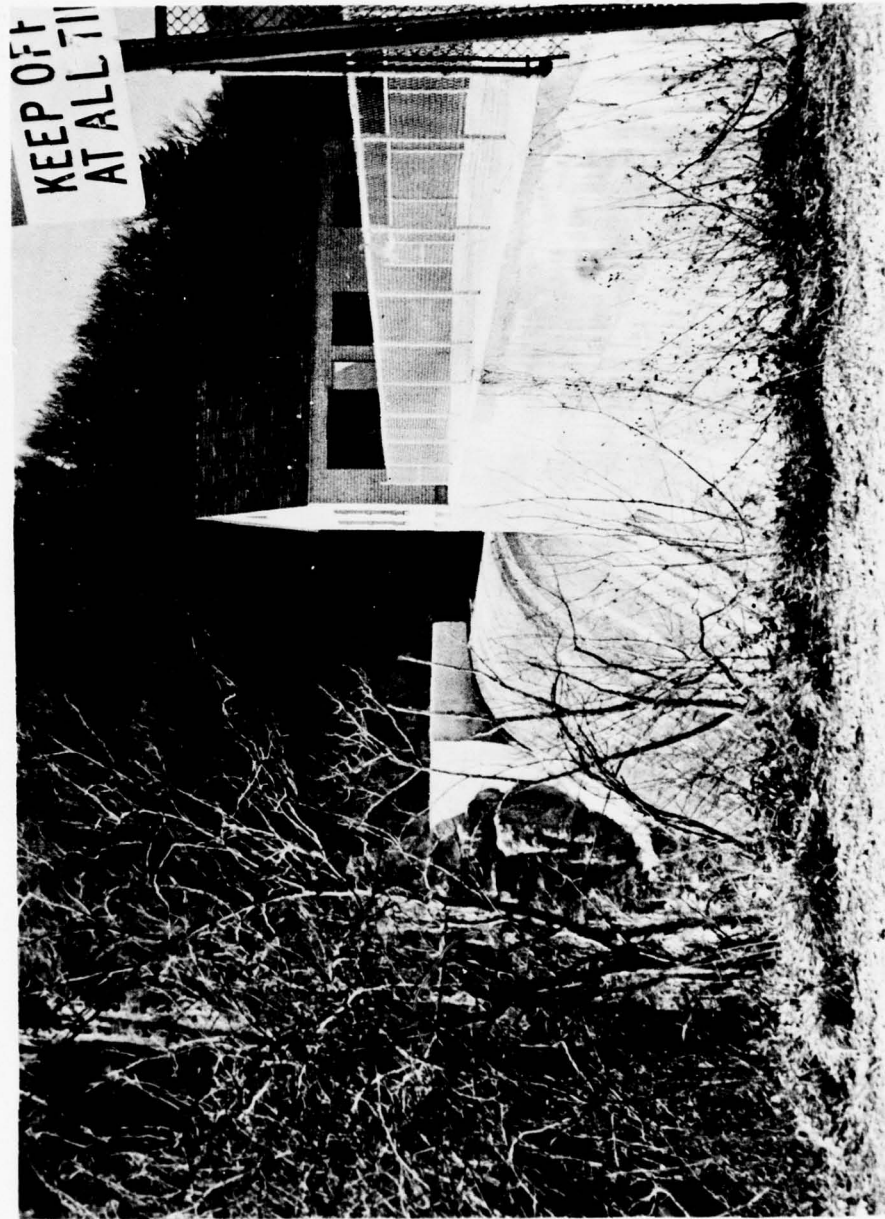
CARVIN COVE DAM - VIEW FROM LEFT  
ABUTMENT SHOWING VALVE PIT HOUSE  
AND SPILLWAY

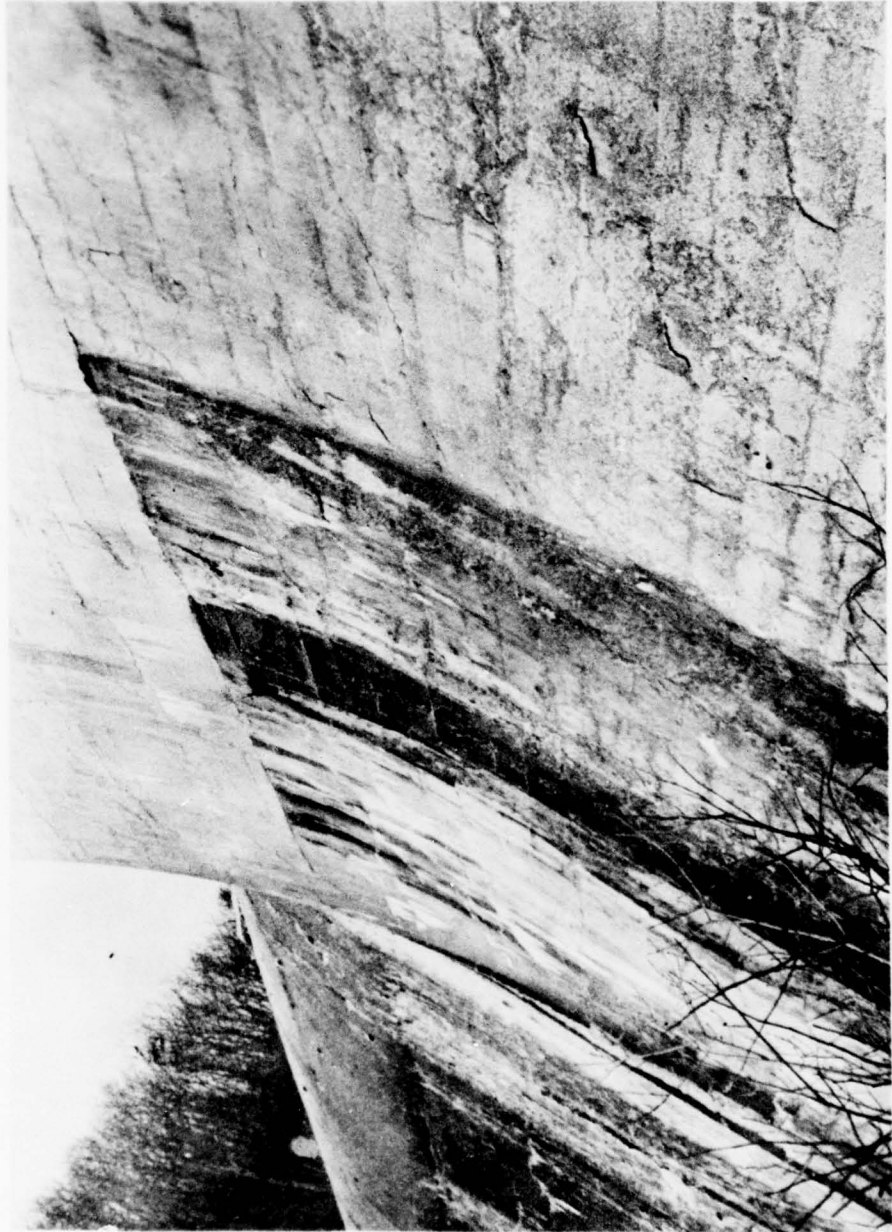
3.2 Evaluation: The visual inspection revealed 5 or 6 through seepage points which occur through the face of the dam approximately 17 feet below elevation 1175. These are located directly in front of the valve pit house, on the downstream face. A rather large seep also occurs in the valve pit nearest the spillway at approximately the same elevation as the seeps on the face of the dam. This is a good indication a plane of seepage exists about 17 feet below the top of the dam underneath the valve pit house. Nothing was observed in the field that required immediate remedial action. Later hydraulic and stability calculations indicated that overtopping was critical. The relatively small amount of surface flaking which has occurred on the face of the dam over the last 50 years indicates the dam has good weathering capabilities. The only remedial surface treatment done to the dam is a grout coat applied to the top and extending 5 feet down either face of the dam. The horizontal cracking on the face of the dam appears to occur along the concrete lift lines. Over a 50 year life cycle, this is not an uncommon occurrence. There is no evidence to indicate the cracks are other than facial. These cracks will promote accelerated weathering of the dam. In addition to the ground seeps observed on the right abutment a wet spot was noted at the dam's left abutment interface at approximately elevation 1167+. No material was observed piping from the wet spot, and in fact flowing water was not observed. All presently observed seeps in the abutments are considered minor in nature, however, they should be observed during weekly inspections to prevent a worsening condition going unobserved.

CARVIN COVE DAM - SEEPS IN DAM  
UNDER VALVE PIT HOUSE

7.2.1.2 Ground Seeps: Immediately set up and maintain a regular observation schedule of inspecting the ground seeps to prevent a worsening condition going unobserved.

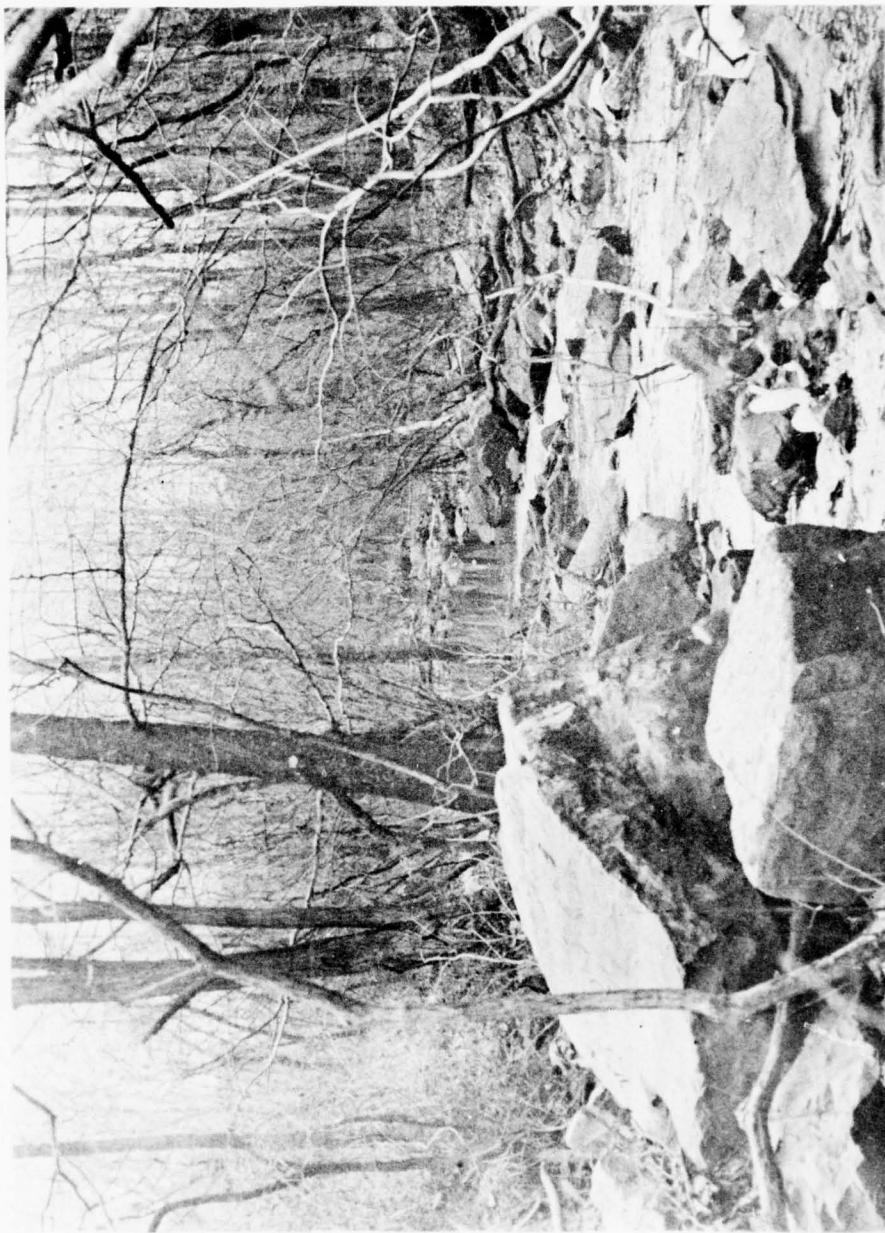
CARVIN COVE DAM - CARVIN CREEK  
IMMEDIATELY DOWNSTREAM FROM DAM

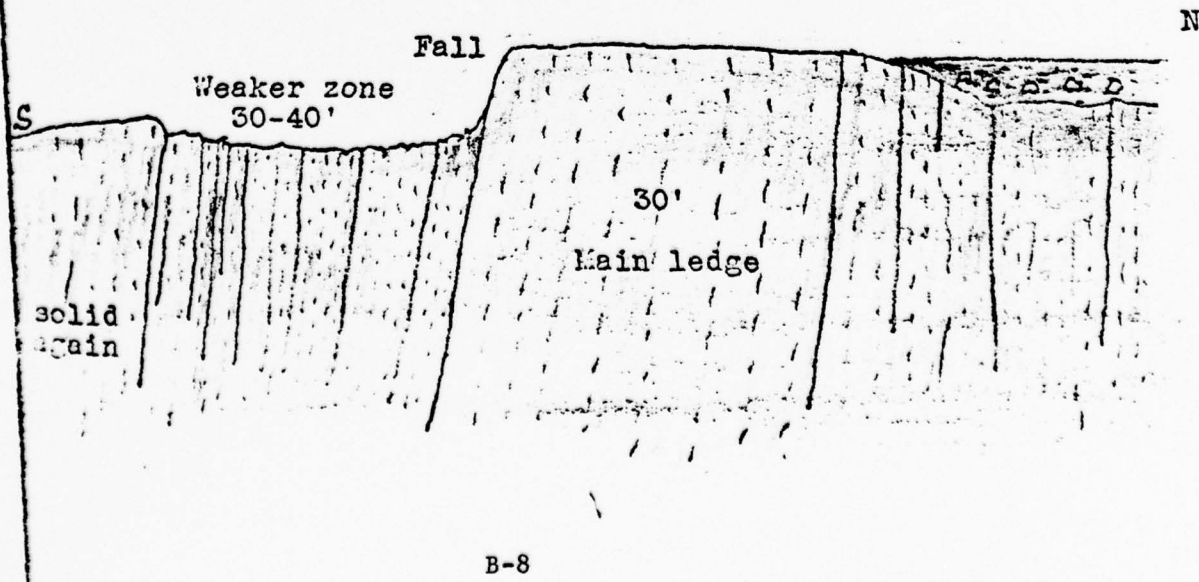
Cross section designed especially to show the position of the zone of somewhat weaker rock below the main ledge.

This zone, however, is one that should not be disturbed unnecessarily. It should not be subjected to extraordinary demands such as might be placed on it if the spillway were allowed to discharge directly into this zone. Whatever is done in the matter of spillway arrangements should take this into account and the spillway should lead across this zone before discharging the waters. No other precaution is necessary.
