Name Of Dam: GEORGE F. BRASFIELD

Inventory Number: VA 04101

# PHASE I INSPECTION REPORT

## NATIONAL DAM SAFETY PROGRAM

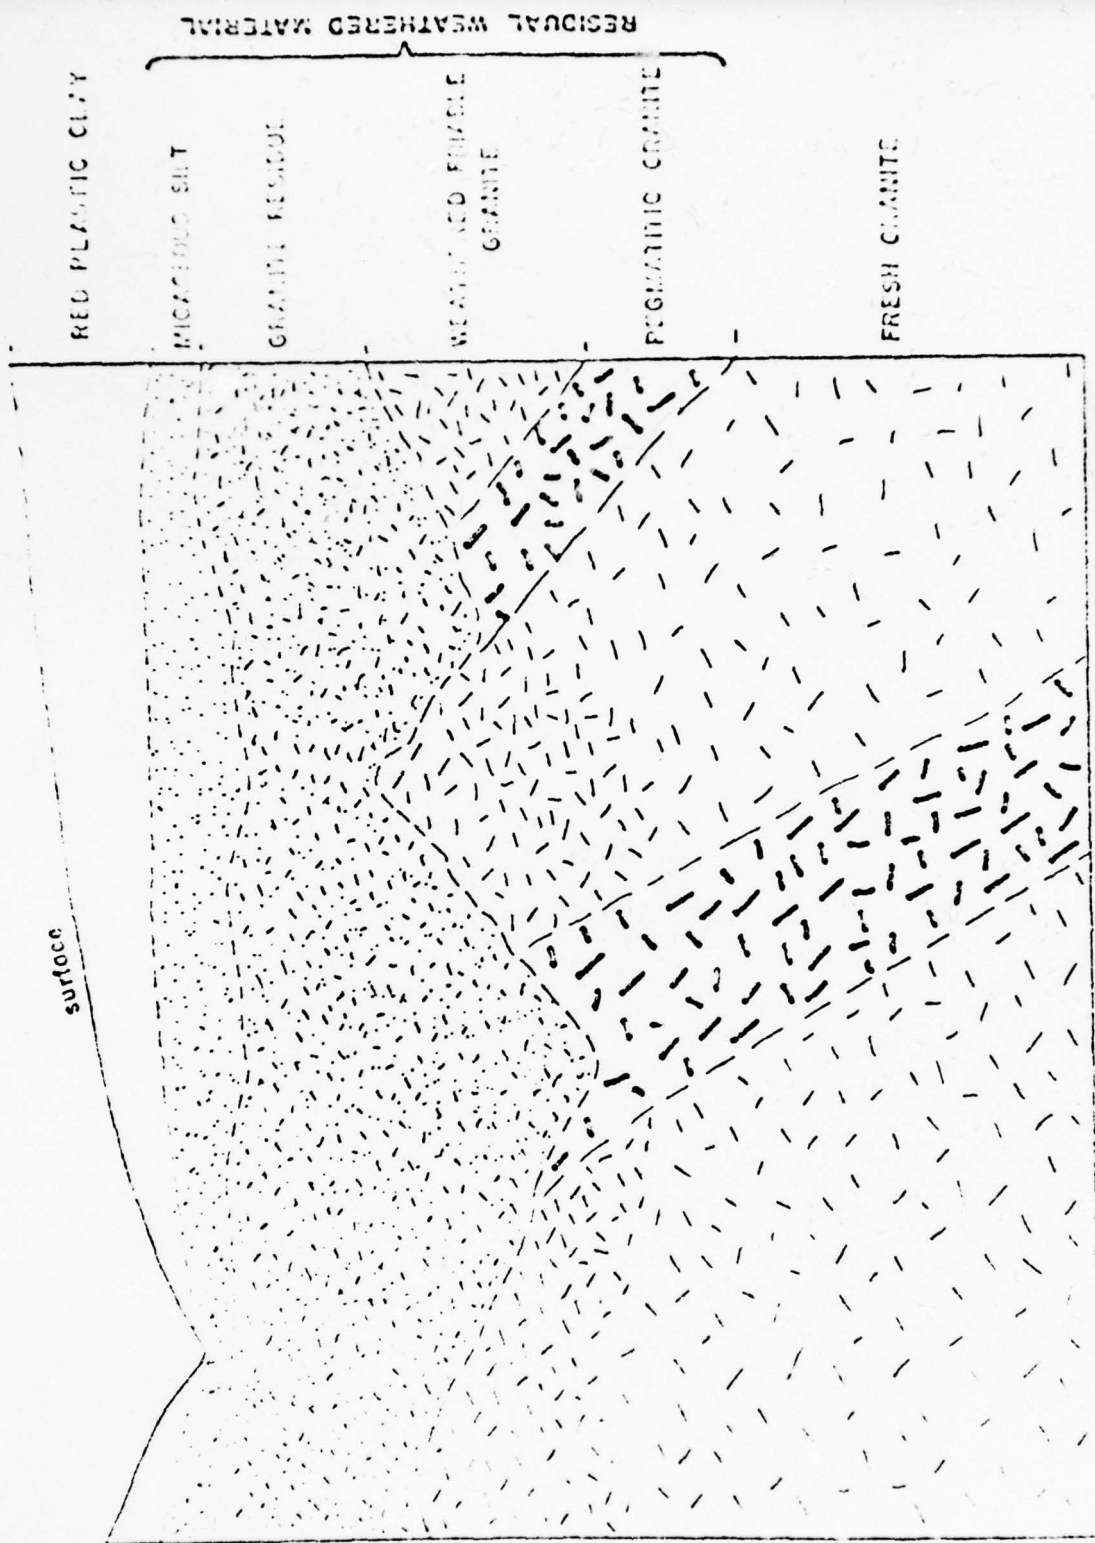
As shown in Figure 1, the normal soil profile is divisible into several zones. The topsoil which is humus-bearing is sandy and in most places is not over 2 feet thick. Immediately underneath it is a zone of plastic red clay which is breached generally in the bottoms of the short tributary gullies in either valley wall. The red clay layer is 1 to 15 feet thick. Directly under this zone is a body of gray disintegrated granite which has the general texture and consistency of sawdust when disturbed but which in the undisturbed condition is reasonably tight and coherent. The upper contact of this zone is sharp, but the lower one is gradational down into weathered friable granite bedrock--some of which is soft enough to be broken by hand in the core samples.

Figure 1.- Diagrammatic profile of weathered zone on the Petersburg Granite in cross of BL-2 base line across Appomattox River.

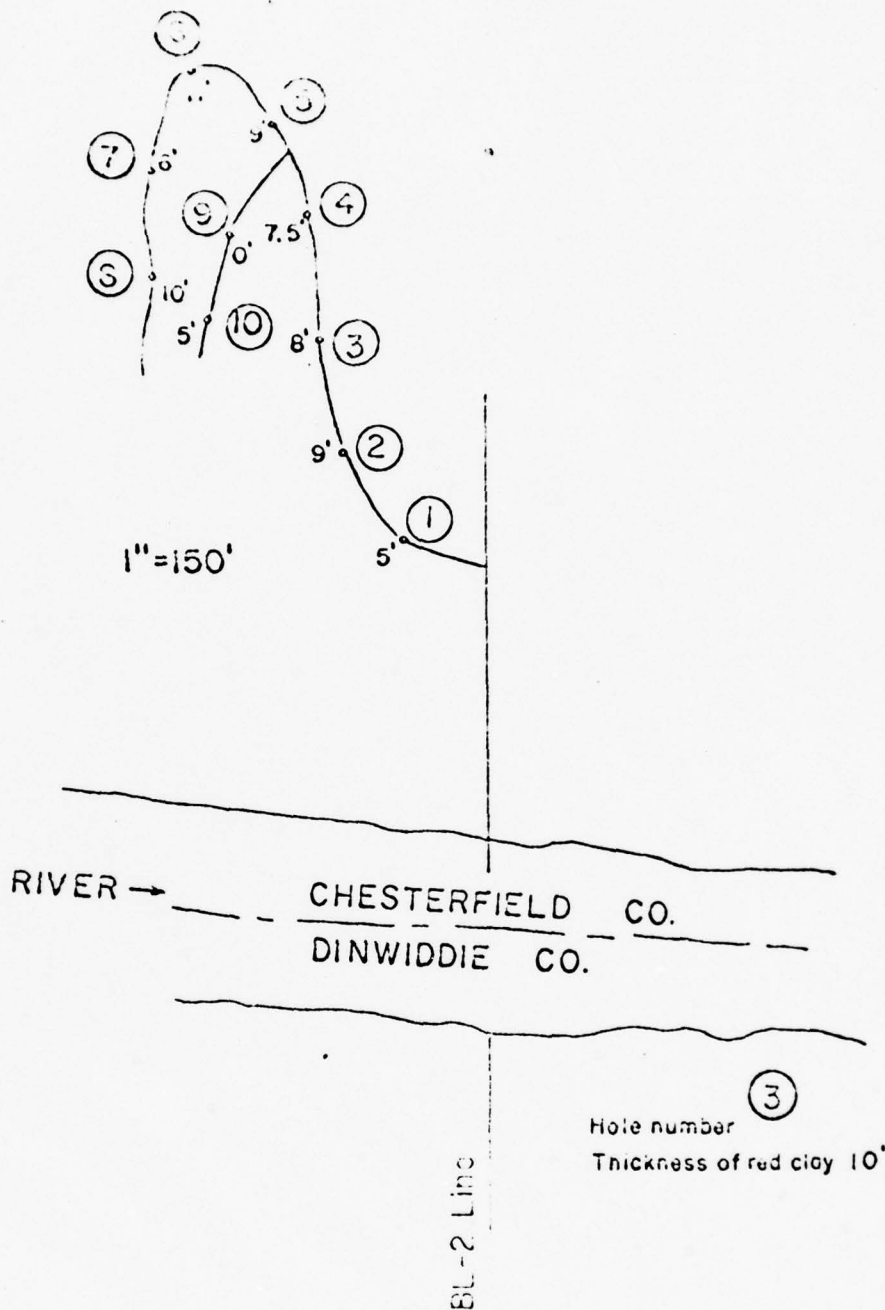
Figure 2.—Sketch of eager holes with thickness of red clay encountered—

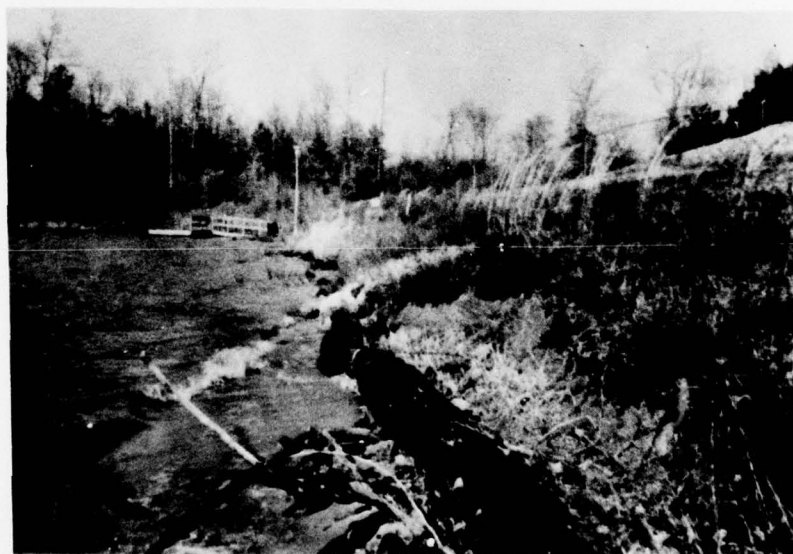
GEORGE F. BRASFIELD - VIEW OF BANK EROSION ON U/S SLOPE  
OF LEFT ABUTMENT

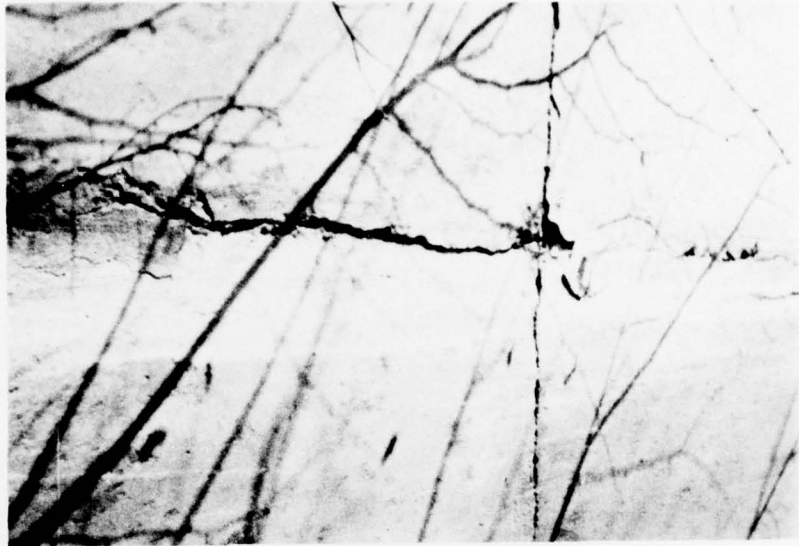
1.7.1 Observations: The concrete monoliths were placed in 6' lifts. Some spalling was noted on the visible portion of the non-overflow sections. The spalling is more pronounced at the intersection with the vertical construction joints.

1.8.1 Observations: Spalling and efflorescence are prevalent along the construction joints especially at the intersection with the horizontal monolith joints. According to the design documents, a copper waterstop has been installed between the vertical construction joints to prevent leakage during temperature changes.

1.8.2 Remarks: The spalling along the vertical construction joints is not considered critical. It appears that the spall zones are areas in which lean grout was used to patch voids during construction..

GEORGE F. BRASFIELD - VIEW OF SPALLING ON D/S FACE  
ALONG JOINTS

1.7.2 Recommendations: The observed spalling is not considered detrimental to the structural integrity of the dam. However, the spalling should be periodically inspected as a part of an annual maintenance program. The downstream face of the overflow sections should be inspected when the flows permit access.

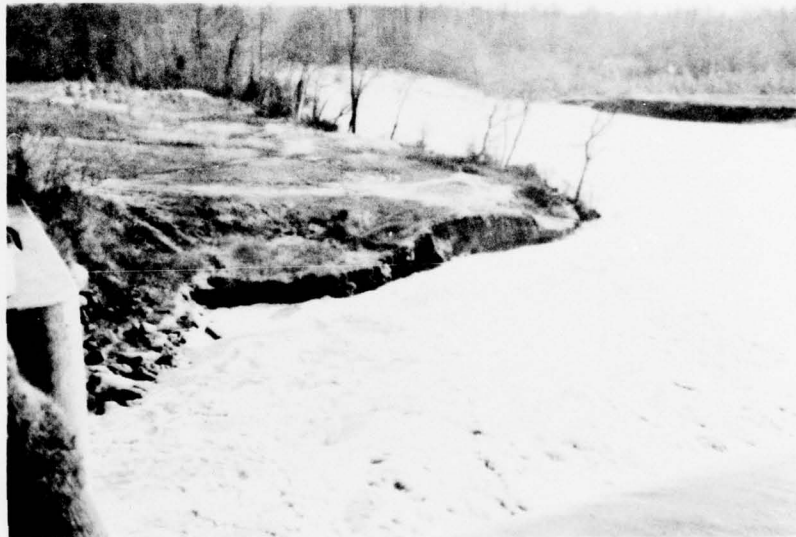
6.1 Conditions: The downstream channel narrows from approximately 840 feet at the base of the dam to approximately 300 feet at a distance of 200 feet from the toe. Miscellaneous fill from the foundation excavation has been randomly placed on the downstream slopes adjacent to the existing channel. The fill does not appear to impede the flow. The overbank areas immediately downstream of the dam are heavily wooded.

GEORGE F. BRASFIELD - VIEW OF DOWNSTREAM CHANNEL

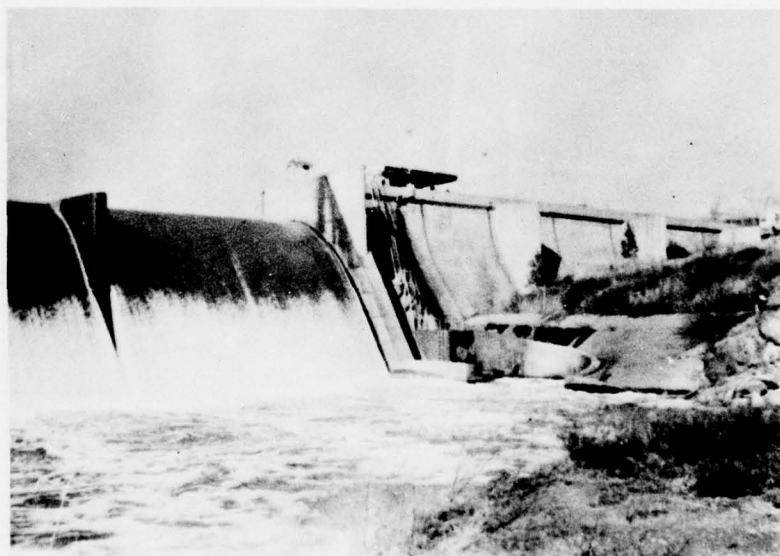
2.3.1 Observations: The outlet channel is approximately 52' in length. The downstream discharge channel is protected by a concrete retaining wall. Riprap and concrete have been added above the retaining wall to protect the upper slopes from erosion when the cone valve is operational. Surface runoff from the adjacent slopes have partially undermined portions of the concrete and riprap blanket causing severe cracking and partial collapses.

GEORGE F. BRASFIELD - VIEW OF LEFT ABUTMENT AND SPILLWAY  
OUTLET CHANNEL UNDER PUMPING STATION

2.3.2 Recommendations: The collapse of the protective rip-rap and concrete blanket is not considered detrimental to the operation of the outlet channel. However, if the cone valve is used in the future, the downstream slope should be protected against erosion.
