POTOMAC RIVER BASIN

Name Of Dam: SOUTH RIVER NO. 10A  
Location: AUGUSTA COUNTY, STATE OF VIRGINIA  
Inventory Number: VA 01504

**PHASE I INSPECTION REPORT**  
**NATIONAL DAM SAFETY PROGRAM**

SEPTEMBER 1978

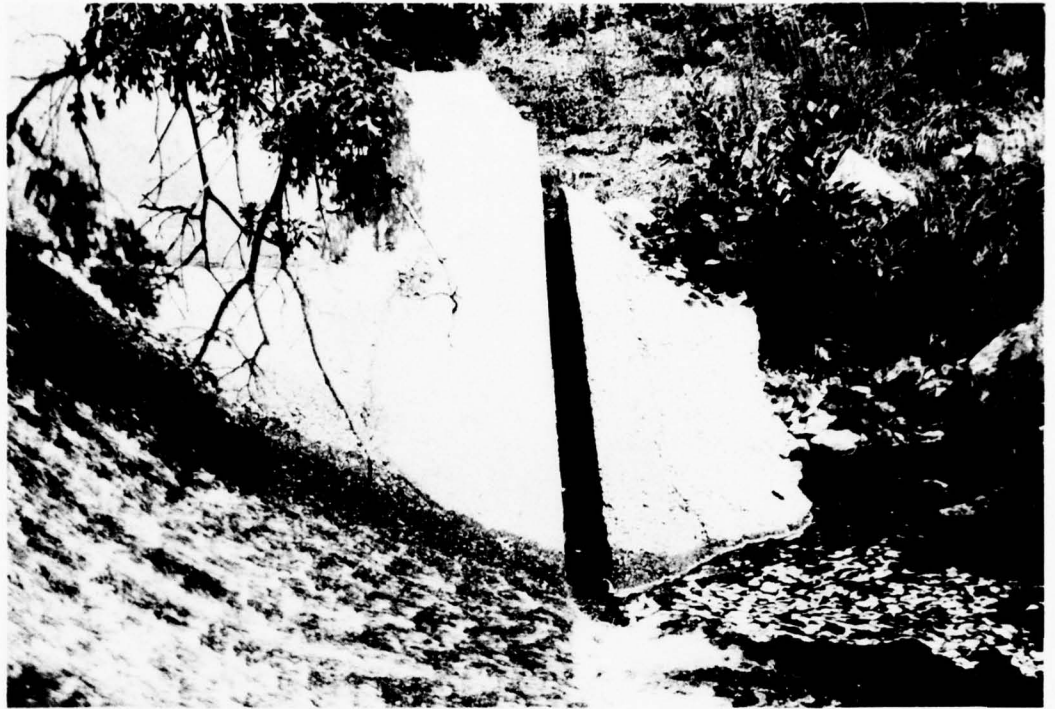
3.1.3 Appurtenant Structures: The water supply intake (currently not in use) located at the outlet of the principal spillway conduit has some erosion beneath its downstream end. This has caused the concrete slab on the left side to drop and separate about eight inches at a construction joint (see Photo 1).

**PHOTO 1. Spillway and Wing Wall of Outlet Structure**

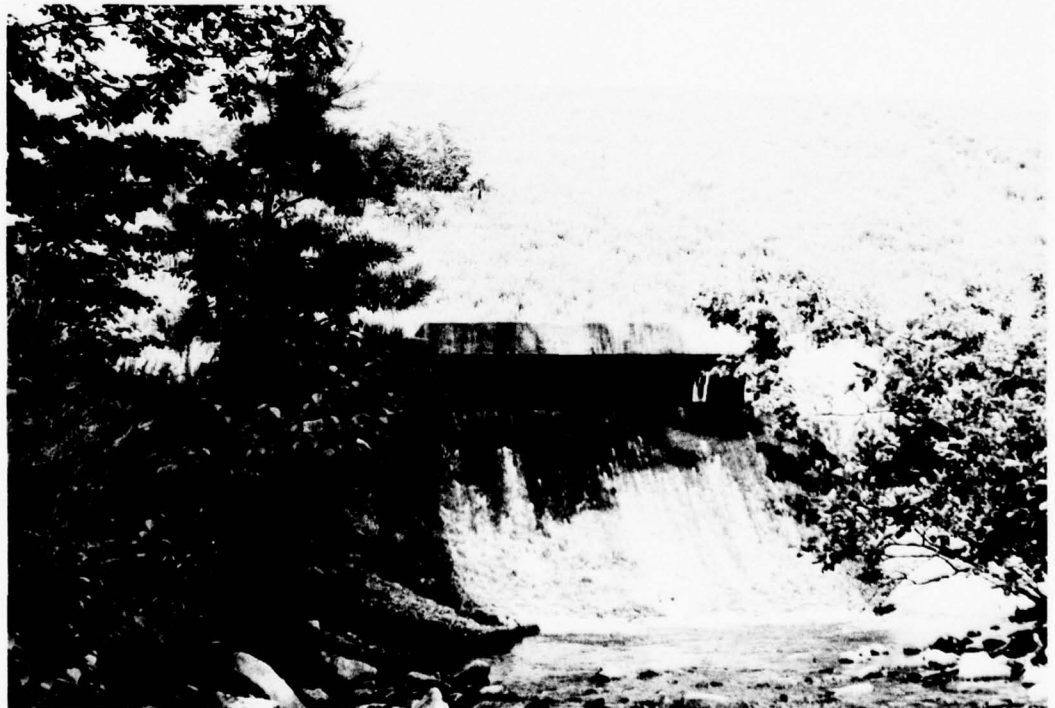
**PHOTO 2. View of Outlet Structure Below the Embankment**

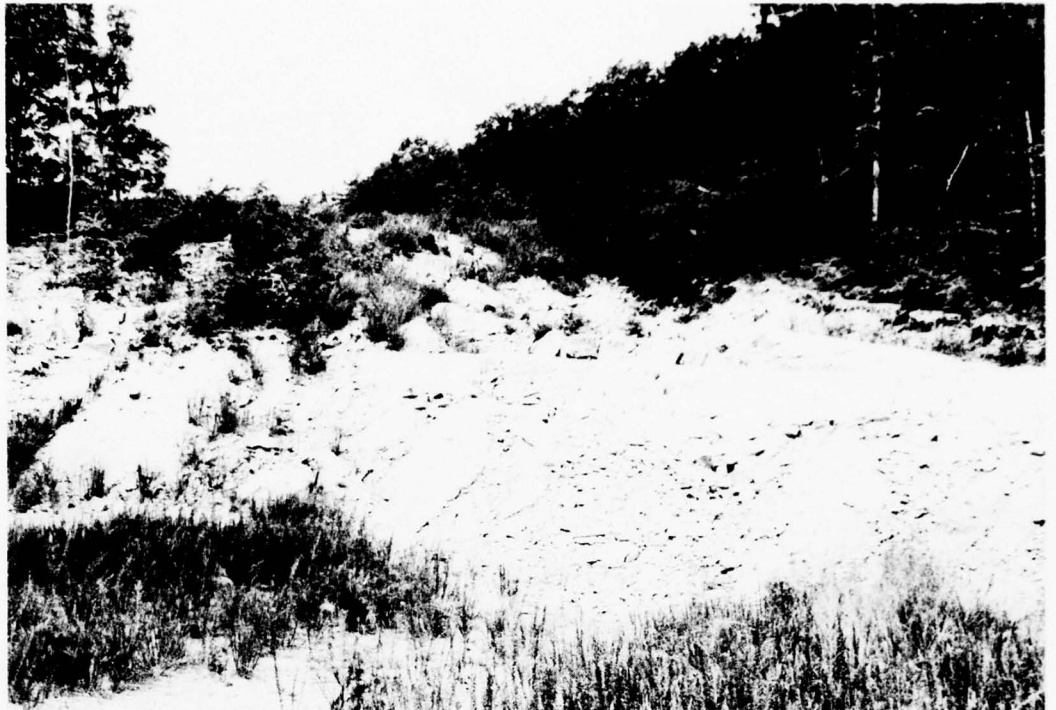
**Photo 3. Looking Upstream Towards Drop Off at Downstream  
End of Emergency Spillway**

- 7.2.2 Other Recommendations: Repair of the eroded areas on the upstream and downstream slopes of the dam, and the channel downstream of the emergency spillway will be necessary. The erosion channel at the downstream side of the embankment - left abutment contact should be filled in and seeded. All small trees growing on the embankment should be removed. The vegetation covering the rock toe should also be removed. Riprap should be placed in the stilling basin to the level of the concrete toe to prevent further erosion in this area. The handwheels for slide gates 2 and 3 should be removed or securely fastened to prevent their unauthorized use. The heavy brush growing on the banks of the outlet channel should be cleared periodically. These items can be accomplished through the annual maintenance program. It is also recommended that the grass on the embankment and abutment be cut before the annual maintenance inspection. Stability analyses should be performed on the upstream slope assuming full drawdown conditions.

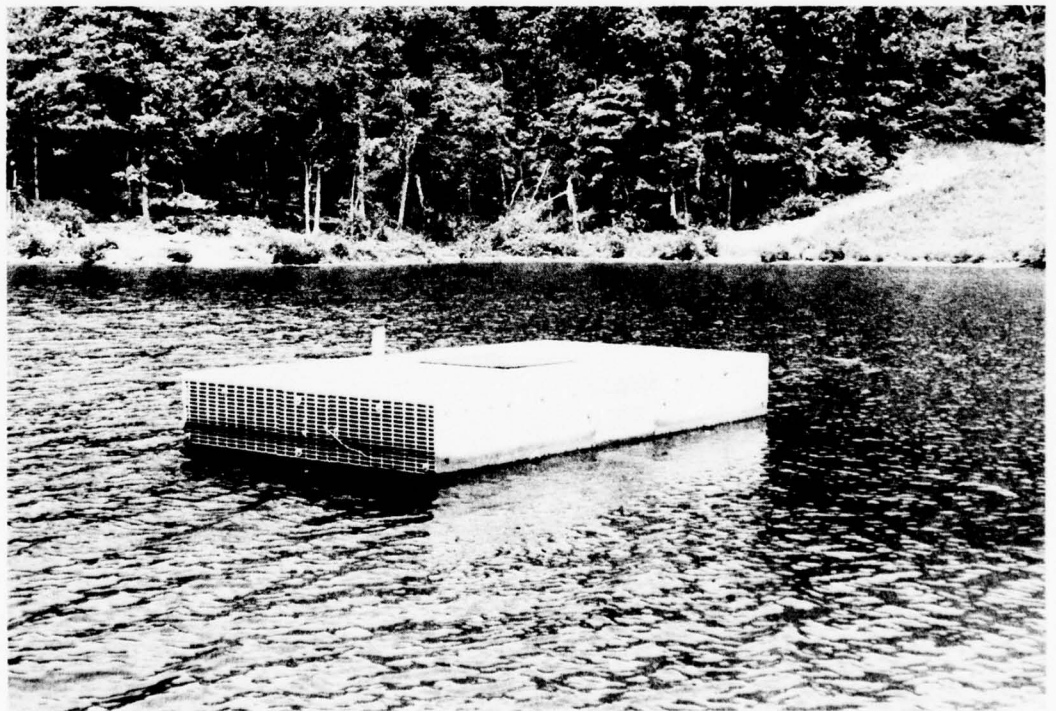
**PHOTO 4. View of Outlet Structure in the Reservoir**

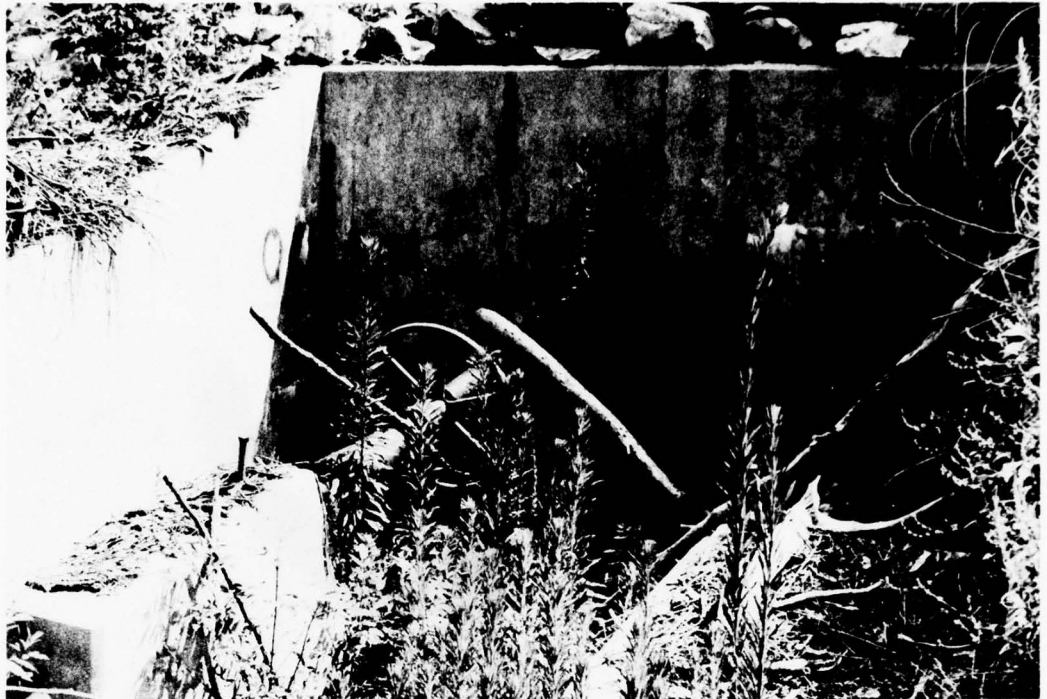
**PHOTO 5. Pit for Operational Valves at Base of Front Face of Embankment**

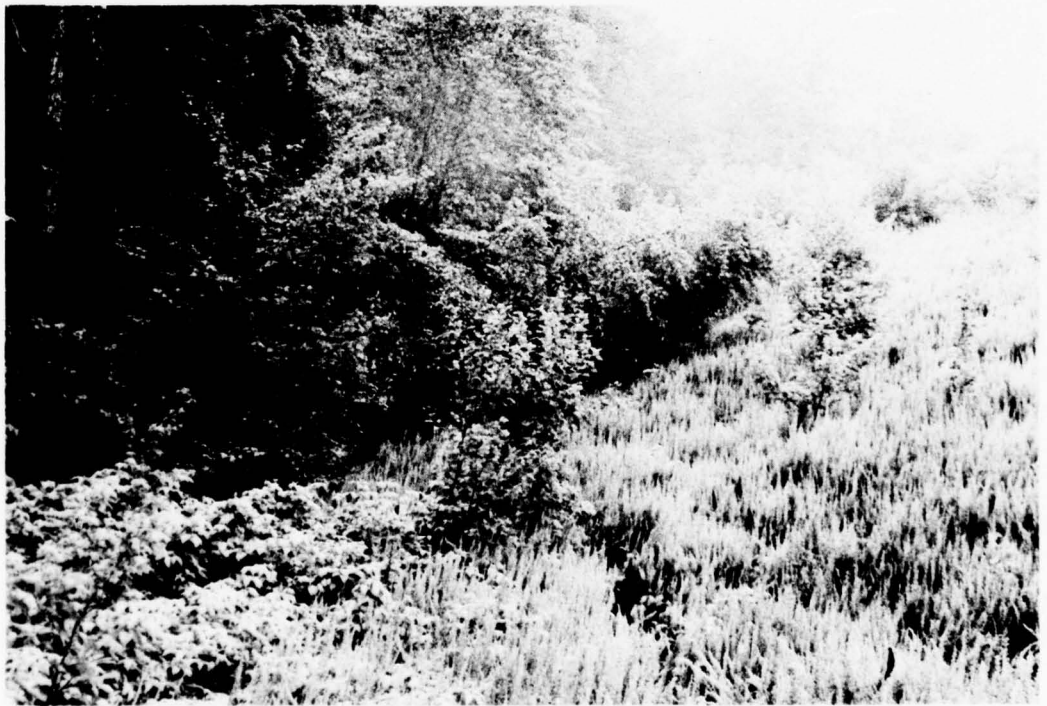
**PHOTO 6. Brush and Trees on Downstream Embankment Near  
Intersection With Right Abutment**

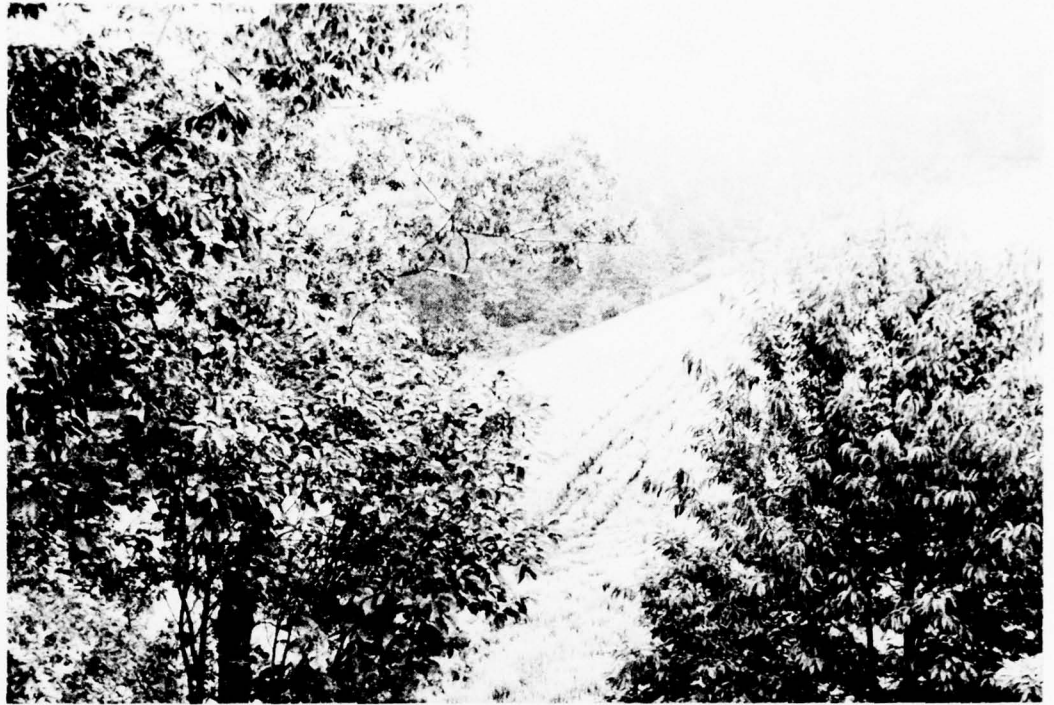
**PHOTO 7. Ruts Made by Vehicles on Bench Area**

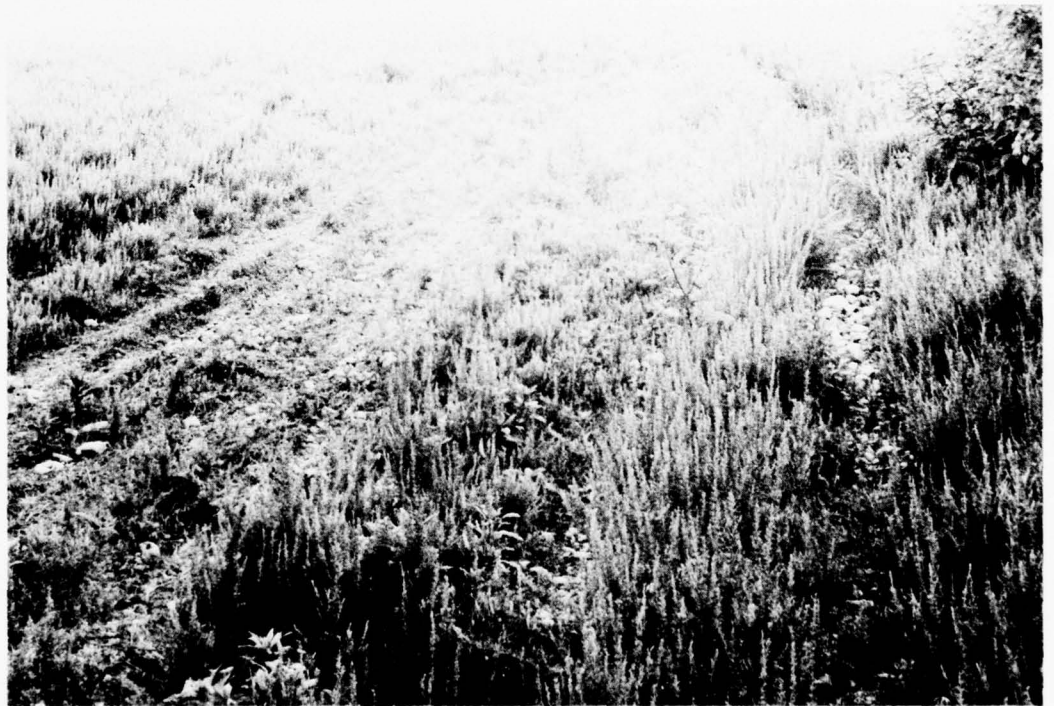
**PHOTO 8. Erosion From Vehicle Traffic on Downstream Face  
Near the Left Abutment**

The dam has been constructed with 2.5:1 slopes. No sloughing was observed; however, erosion caused by vehicular traffic was observed on the downstream face of the dam. Another eroded pathway was observed on the upstream face. Eroded channels were visible on the downstream bench and tire tracks were observed adjacent to the downstream toe. Small trees were observed on the downstream face of the dam.
