Name Of Dam: SOUTH RIVER NO. 11

Location: AUGUSTA COUNTY, STATE OF VIRGINIA

Inventory Number: VA 01512

PHASE I INSPECTION REPORT NATIONAL DAM SAFETY PROGRAM

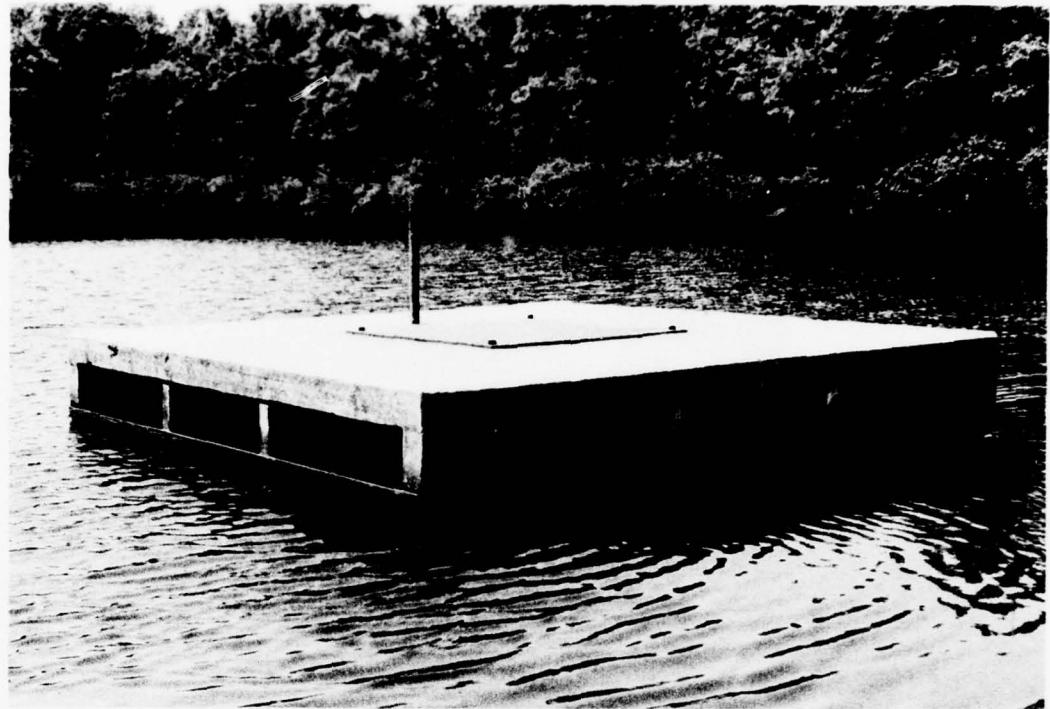
PHOTO 1. Inlet Riser in Reservoir

- 3.1.3 Appurtenant Structures: The inlet and outlet structures appeared to be in good physical condition and functioning properly; however, a heavy layer of rust covers the trash rack. No serious deficiencies were noted in the emergency spillway. Many small trees were present in both the approach and discharge channels.

- 2) The eroded pathways on both faces of the dam should be filled and reseeded.
- 3) The trash rack should be periodically cleaned and a rust preventive coating applied.
- 4) The banks of the downstream channel should be cleared periodically.

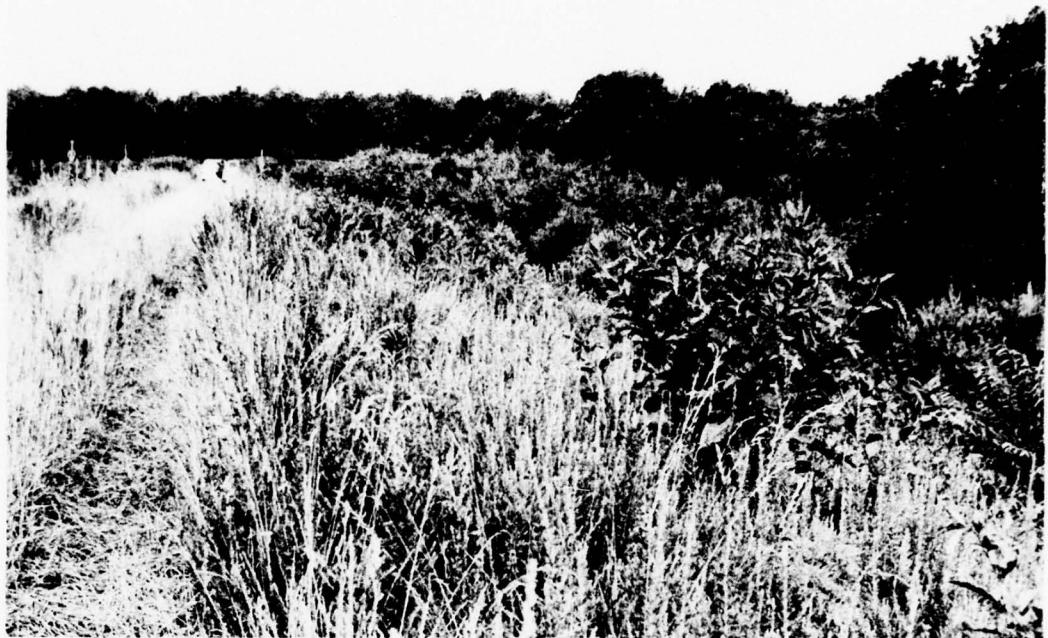
- 3.1.2 Dam: No seeping or sloughing was observed during the inspection. A few, eroded, pedestrian paths are present on both the upstream and downstream faces of the dam. Also, small trees and thick brush were noted growing on the embankment (see Photos 3 and 4).

PHOTO 3. Brush and Trees Growing on Downstream Face Looking From Right Side

- 1) The brush and small trees growing on the embankment and in the emergency spillway should be removed.

- 1) Cut and remove the brush and small trees from both faces of the dam and the emergency spillway.
- 2) Fill and reseed the eroded foot paths.
- 3) Periodically clean and paint the trash rack to prevent corrosion.
- 4) Periodically clear the banks of the downstream channel to prevent obstruction of flow.

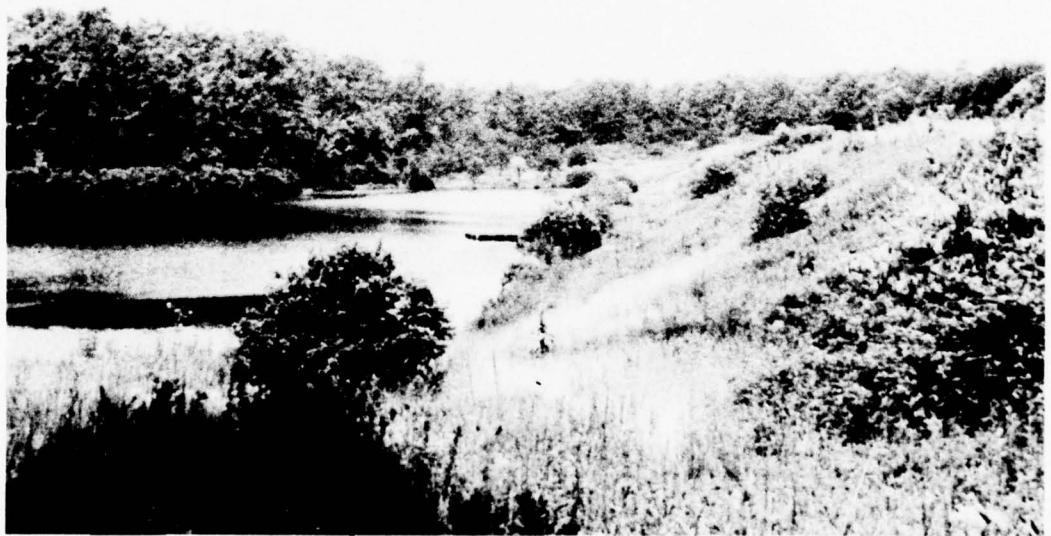
PHOTO 4. Brush and Trees on the Upstream Face Looking From Right Side
