Name of Dam: Coles Run *Dam*

Location: Augusta County, State of Virginia

Inventory Number: VA 01519

PHASE I INSPECTION REPORT

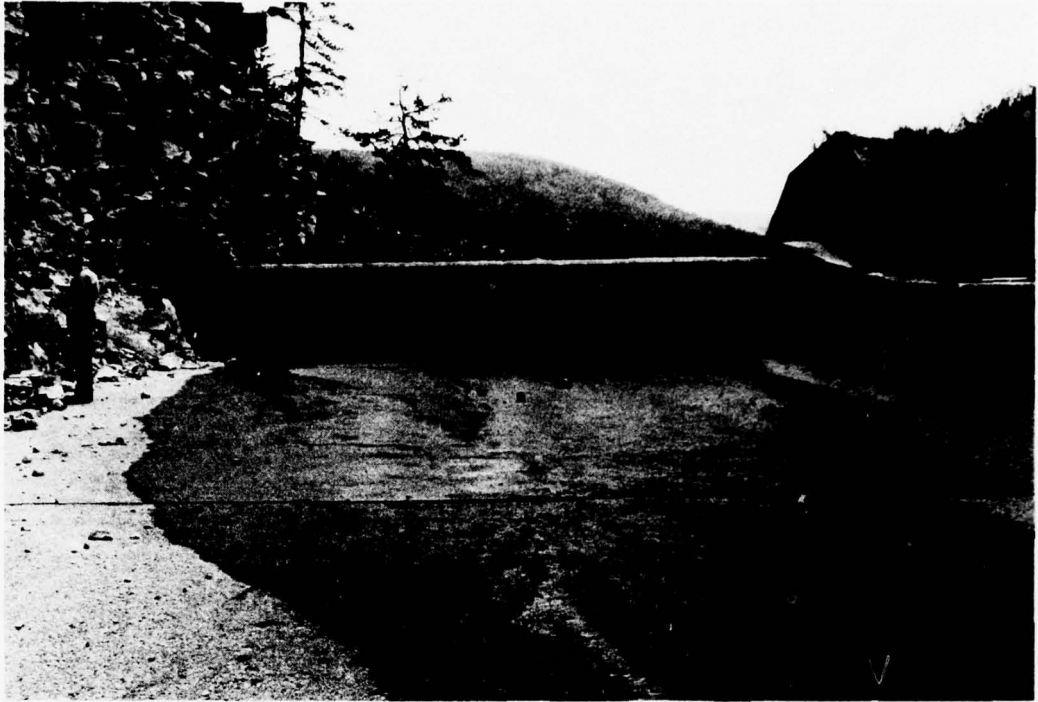
- 3.1.3 Appurtenant Structures: Some water was leaking through the flashboards at the areas of contact between the spillway concrete and the wood of the flashboard. Cracks have appeared at the jointure of the old and new concrete of the widened spillway.

- 3.2.2 Appurtenant Structures: The flashboards are leaking water but they appear to be in good physical condition. The cracks in the spillway bottom slab are minor.
- 3.2.3 Reservoir Area: The reservoir area is in good condition.
- 3.2.4 Downstream Channel: The downstream channel is in good condition.

PHOTO 1. Weir in Spillway With Leakage Principally on Right Side Near Dam

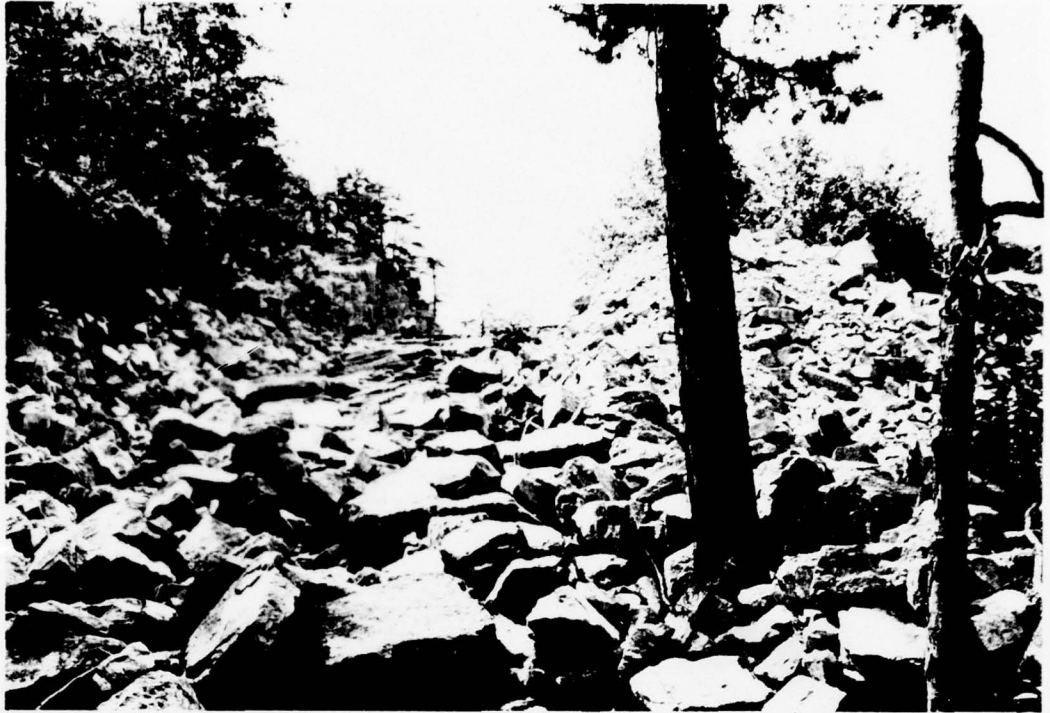
PHOTO 3. Rocks in Channel Downstream From Open Spillway

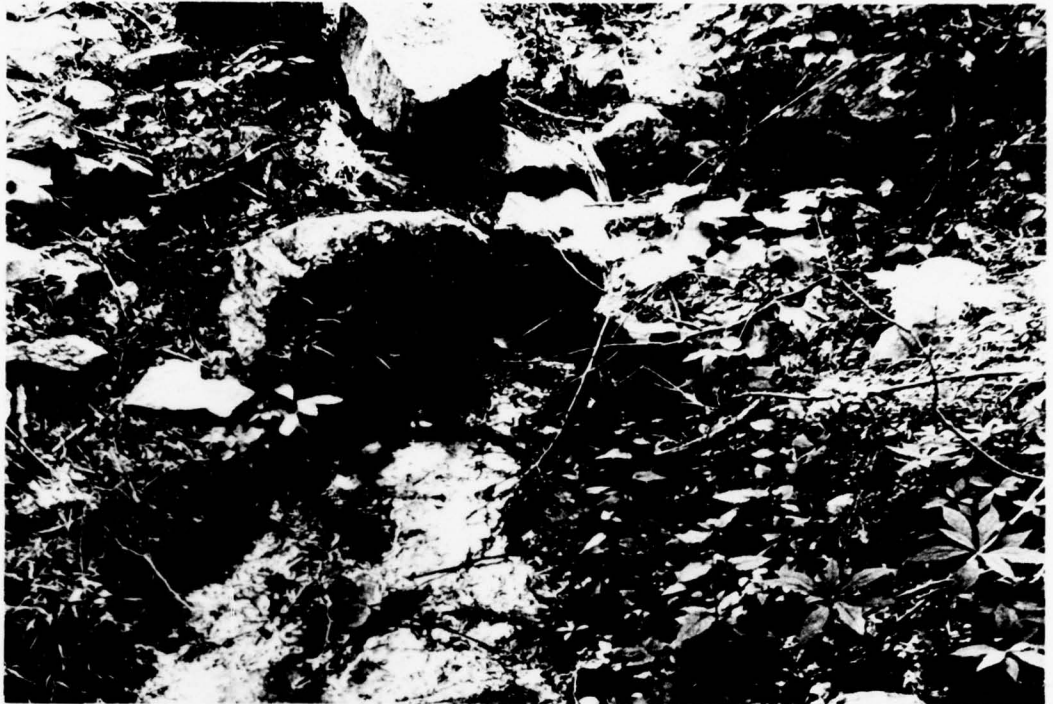
- 3.1.2 Dam: The embankment was in good condition with minor clear seepage noted at two places. Non-measurable seepage was observed from sandstone and rockfill near the 72 inch conduit outlet. Clear seepage (red in color due to iron staining) amounting to 0.25 g.p.m. was observed near the downstream toe. In addition, an eight inch drainpipe from the rock toe on the right side of the dam was flowing at 10 g.p.m. There is a heavy growth of small trees and brush on the downstream face and a few bushes on the upstream face.

**PHOTO 5. Seepage of Red Water at 0.25 G. P. M. From Downstream
Rock Toe Drain in Old Channel**
