**Name Of Dam:** UPPER NORTH RIVER, NO. 77 (HEARTHSTONE LAKE)

**Location:** AUGUSTA COUNTY, STATE OF VIRGINIA

# PHASE I INSPECTION REPORT

## NATIONAL DAM SAFETY PROGRAM

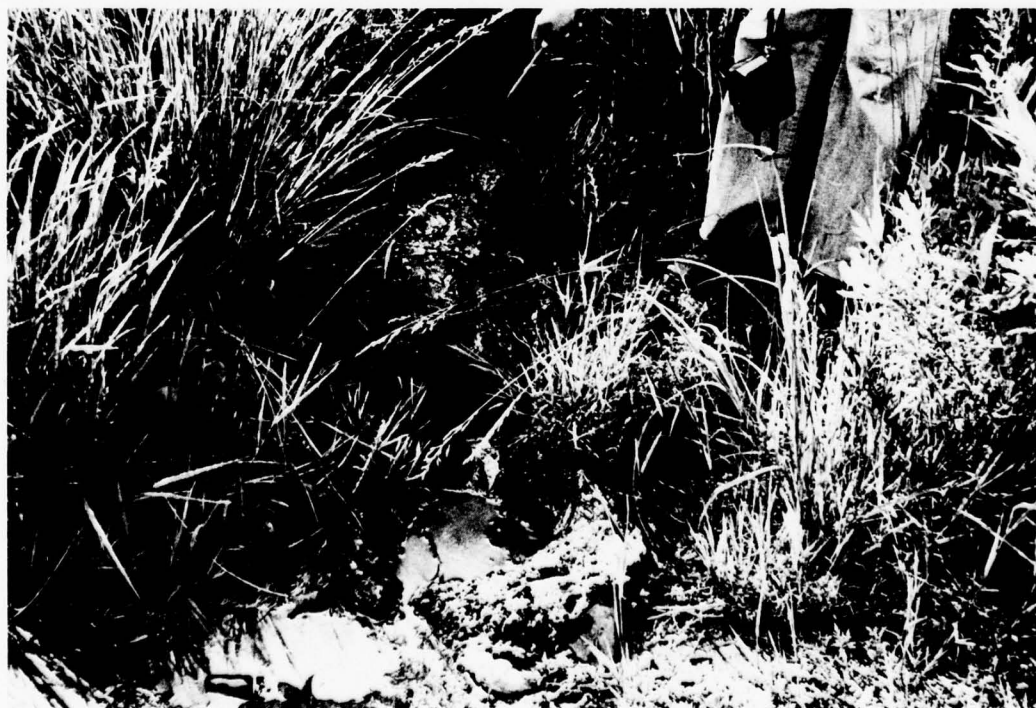
PHOTO 2

- 3.1.2 Dam: A small clear seep (see Photo 2) was noted during the visual inspection on the downstream face of the dam approximately 65 feet to the left of the outlet pipe along the upslope side of the bench on the embankment. The clear seep, approximately 25 feet higher than the outlet and one foot above the bench, is at an elevation of 1773 feet. The flow from the clear seep was not measurable and was estimated at less than one-half g.p.m. The reservoir elevation at the time of inspection was approximately 1778.5.

- 6.2.1 Visual Observations: No tension cracks or other evidence of movement such as sloughing of the embankment slopes, or movement at or beyond the toe was observed. One clear seep was observed on the downstream slope about one foot above the berm at an approximate elevation of 1773 feet. The flow from this clear seep was estimated to be less than 0.5 g.p.m. However, the reservoir level at the time of the inspection was only at elevation 1778.5.

- 6.3 Evaluation: The stability analysis for the upstream slope is compatible with as-built conditions. However, the clear seepage on the downstream slope may indicate a phreatic line that exits on the downstream slope rather than terminating near the toe of the center core. (Considered for design because of the moderately permeable transition and shell materials.) If further observation indicates that the clear seepage is originating from the reservoir, additional stability analysis should be made using the existing phreatic surface.

- 7.1 Dam Assessment: The dam is designed to prevent overtopping under P.M.F. conditions. One clear seep was observed on the downstream face. The consequences of this clear seep depend on whether the source of water is the reservoir or infiltration on the embankment crest and slopes, and the effect of the clear seepage on embankment stability. There is a potential for piping if the clear seepage originates from the reservoir.

- 7.2.1 Clear Seep: Immediately, the owner should set up and maintain a regular observation schedule of inspecting the clear seep to determine its source, prevent erosion and prevent a worsening condition from going unobserved. If as a result of these periodic inspections, it is found that the flow is originating from the reservoir then an in-depth investigation including a test boring program and piezometers is recommended. An inverted filter may be needed to prevent piping if the source of the clear seep is determined to be the reservoir.
