14. MONITORING AGENCY NAME & ADDRESS (If different from Controlling Office) 6 National Dam Safety Program. Meherrin River Dam at Emporia (VA 08101), Chowan River Basin, Greenville County, Virginia. Phase I Inspection Report.		12. REPORT DATE 11 August 1978

PHASE I INSPECTION REPORT

MEHERRIN RIVER DAM AT EMPORIA - OVERVIEW

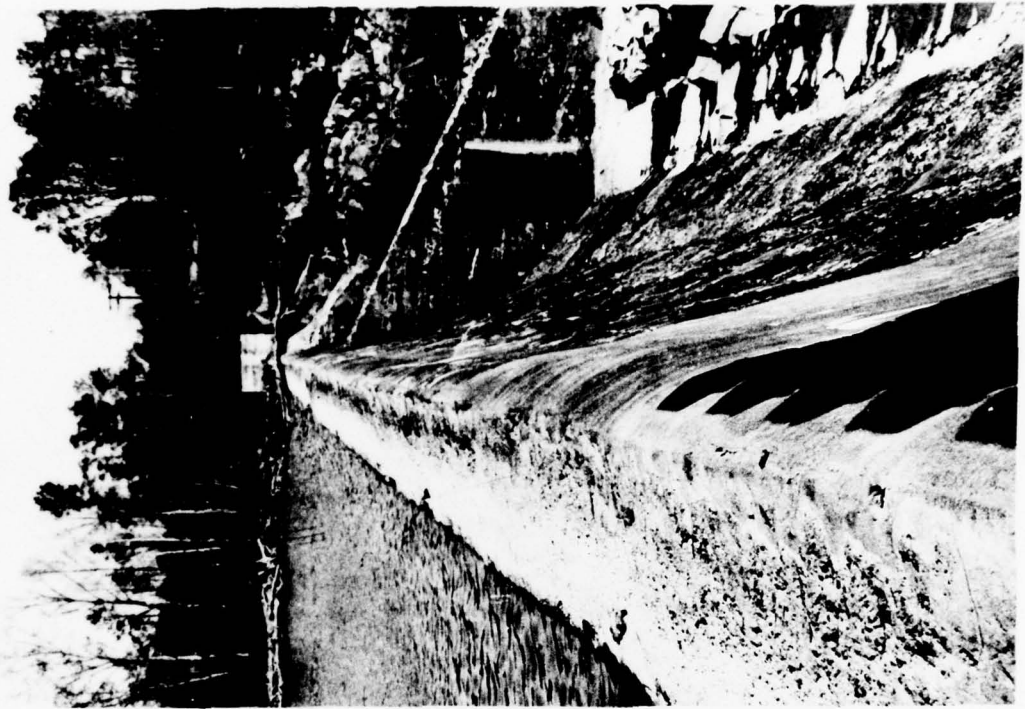
MEHERRIN RIVER DAM IN 1963

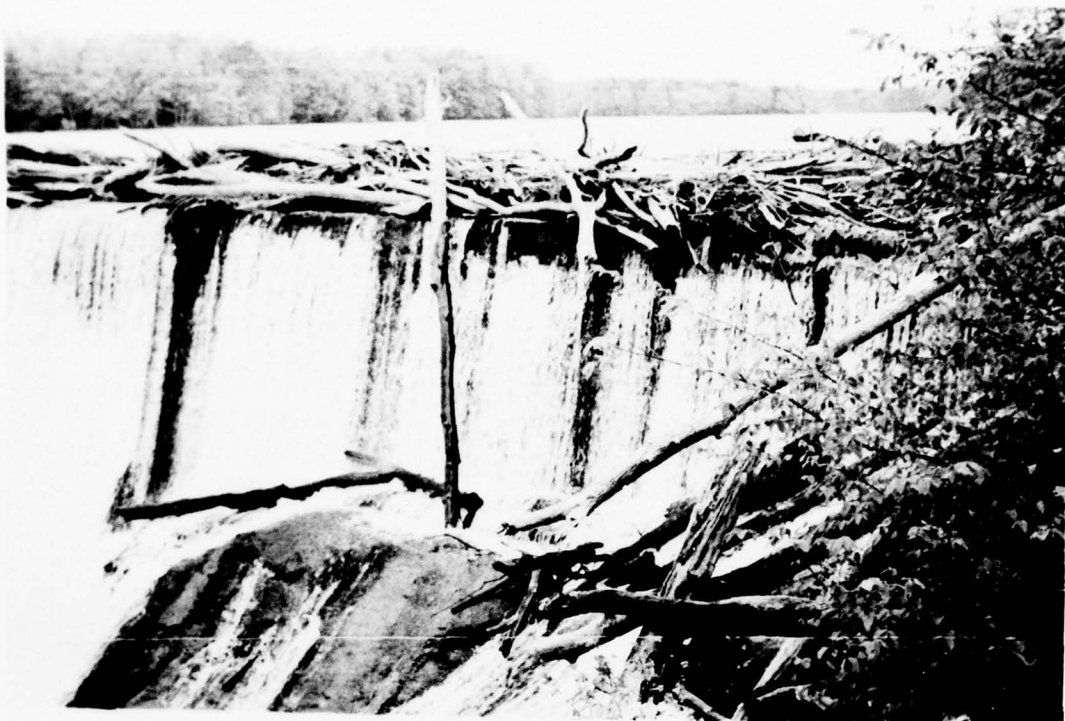
Serious erosion was noted on the downstream slope of the left abutment adjacent to the existing wing wall. It is believed that the erosion is the result of channeled surface runoff rather than flows over or through the dam. In addition to the erosion, numerous debris in the form of logs and limbs had accumulated in the downstream area adjacent to the left abutment and upstream of the dam. The debris on the upstream face of the dam was impeding the flows over the dam.

DEBRIS

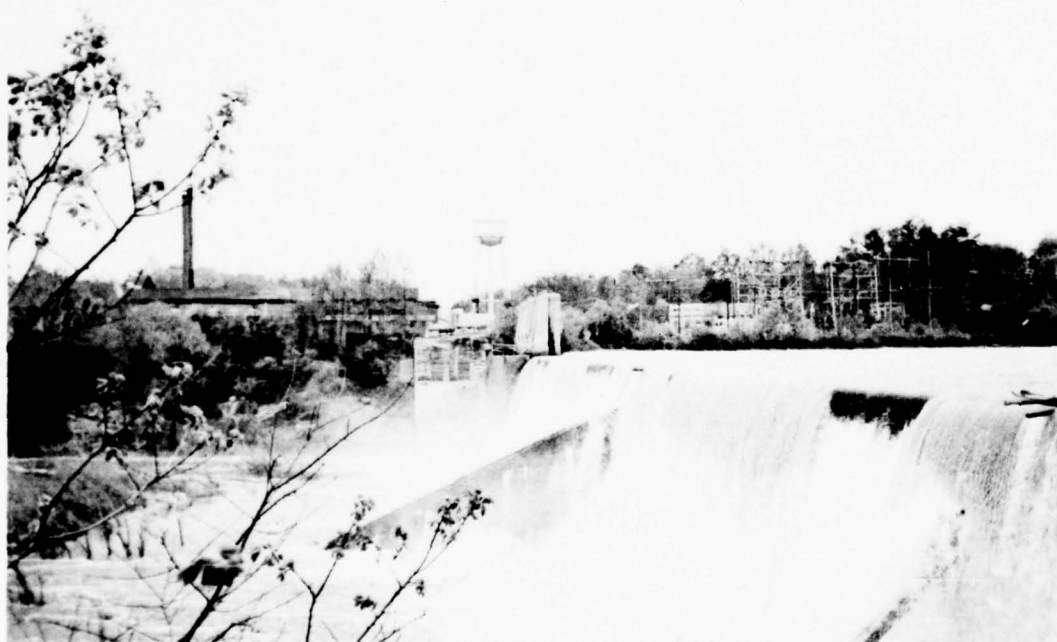
VIEW OF DAM FROM LEFT ABUTMENT

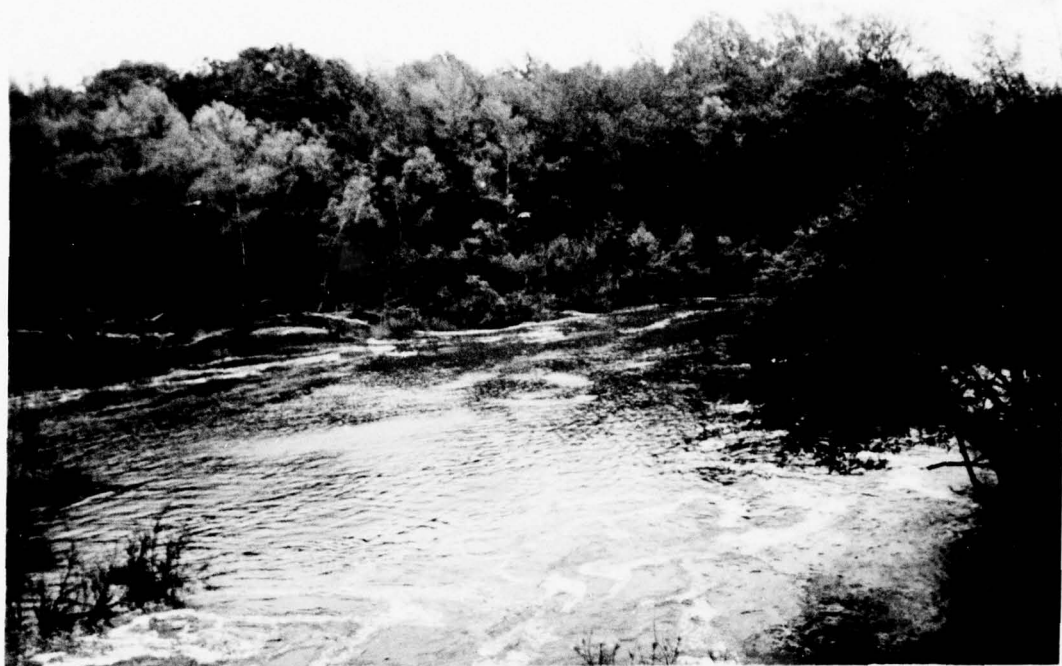
VIEW DOWNSTREAM FROM RIGHT ABUTMENT

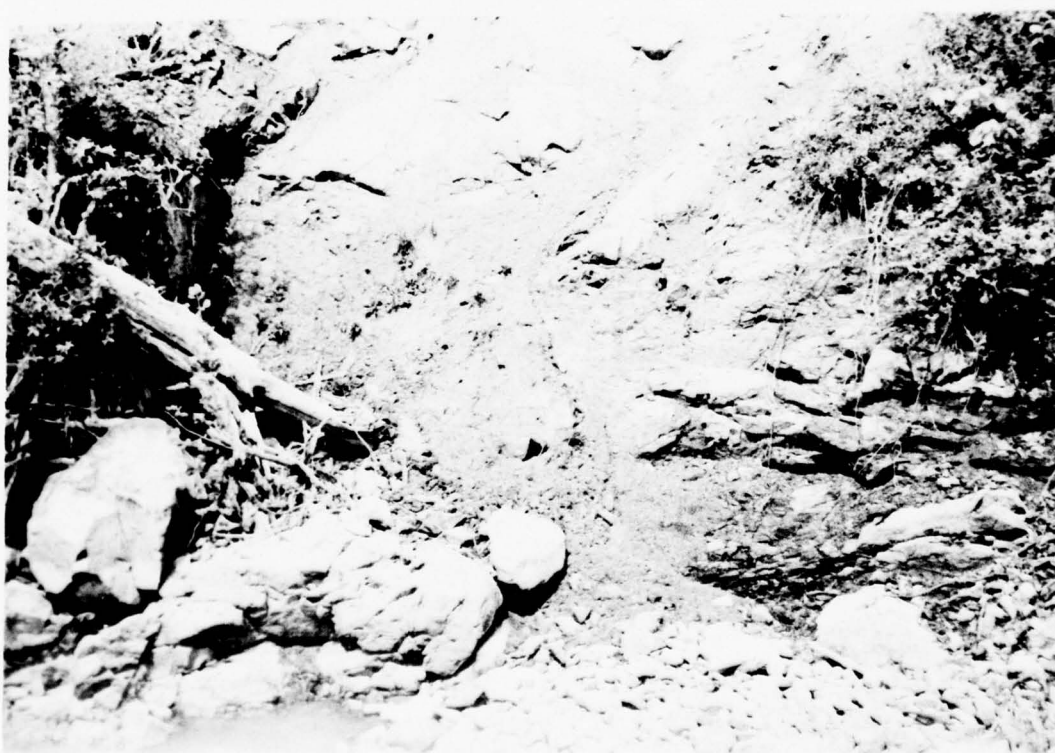
EROSION DOWNSTREAM LEFT ABUTMENT

7.2.4 Remedial Treatment: It is recommended that the sluice gates recommended by Wiley & Wilson be installed as soon as possible to provide a positive means of lowering the reservoir level and controlling the level of siltation. Erosion adjacent to left abutment should be corrected as soon as practical.

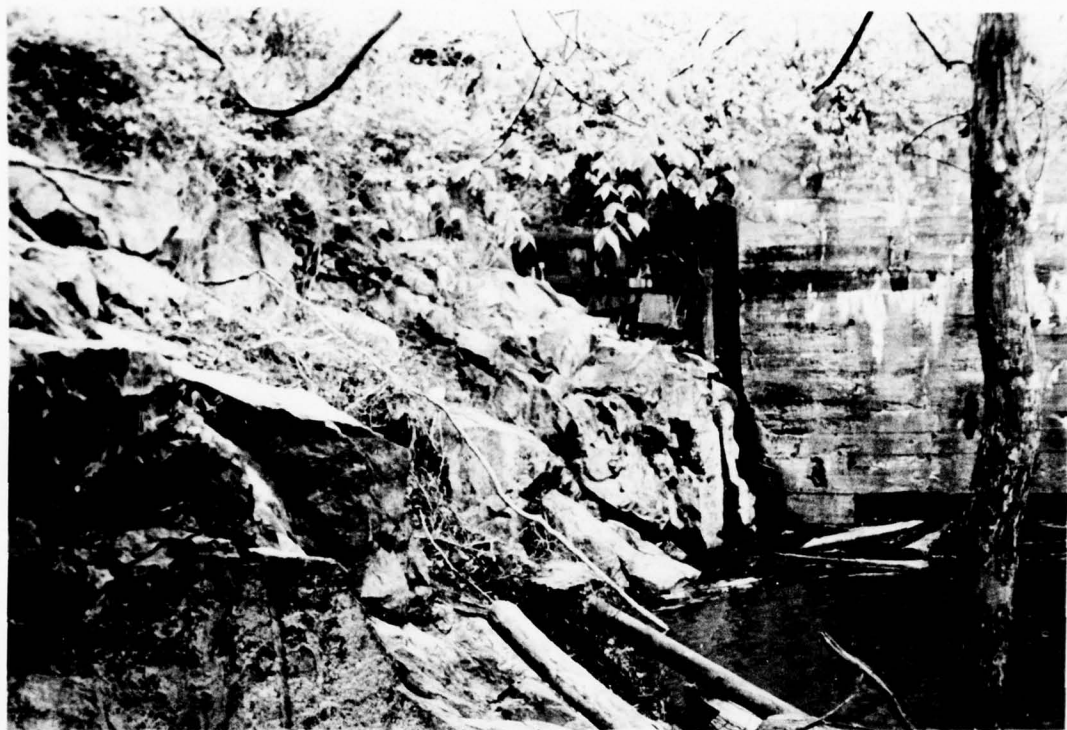
RIGHT ABUTMENT DOWNSTREAM OF POWERHOUSE

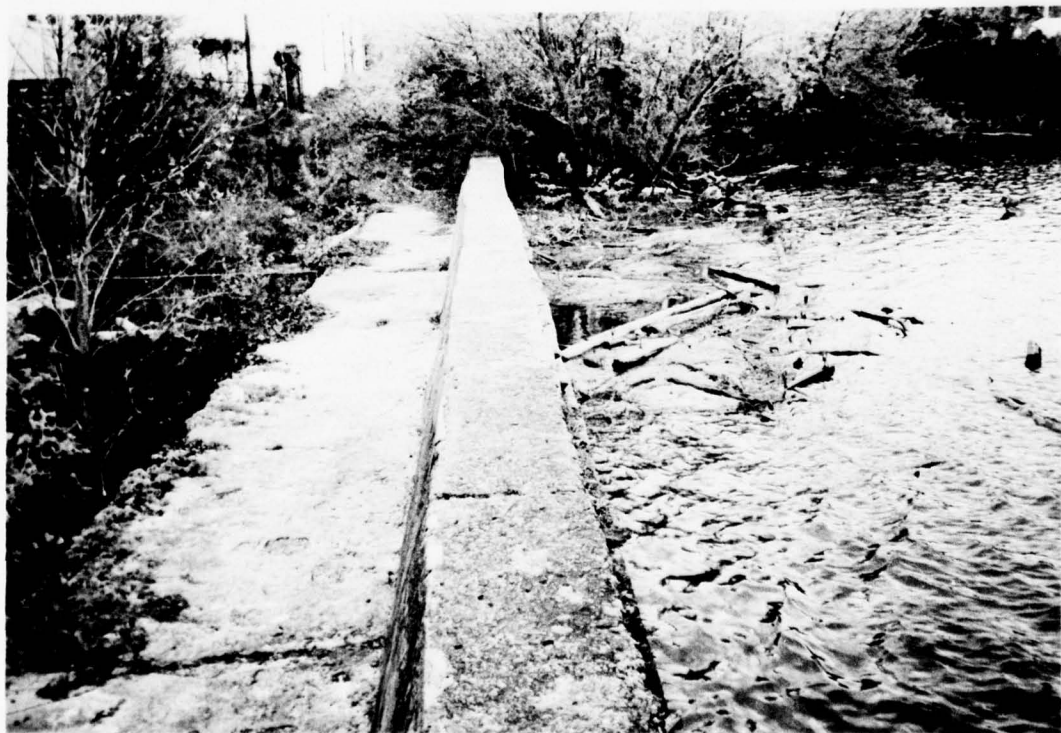
RIGHT ABUTMENT

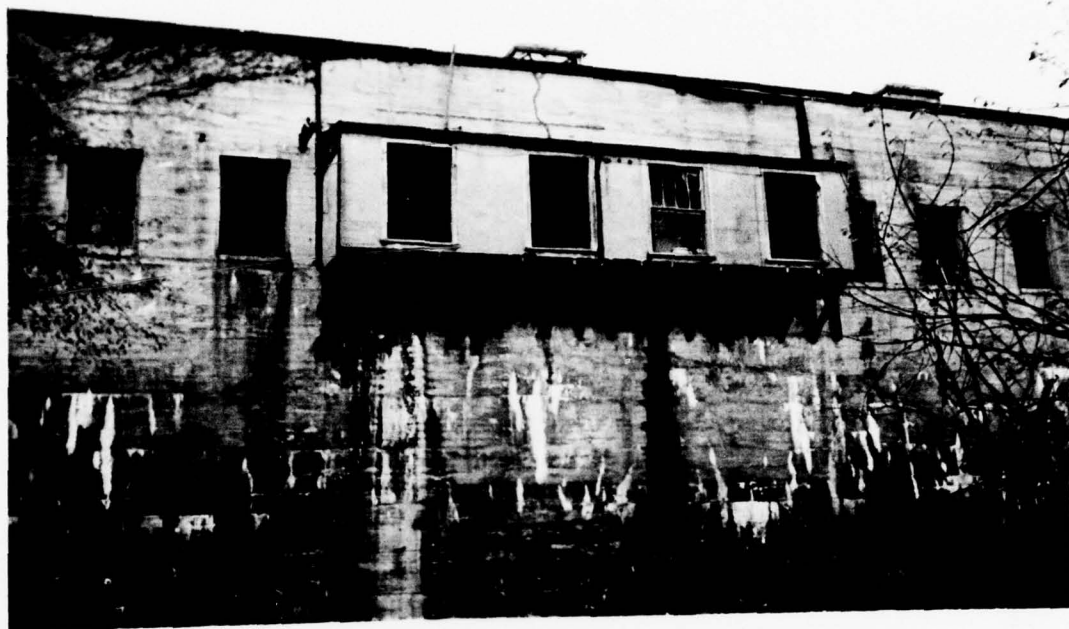
DOWNSTREAM OLD POWERHOUSE

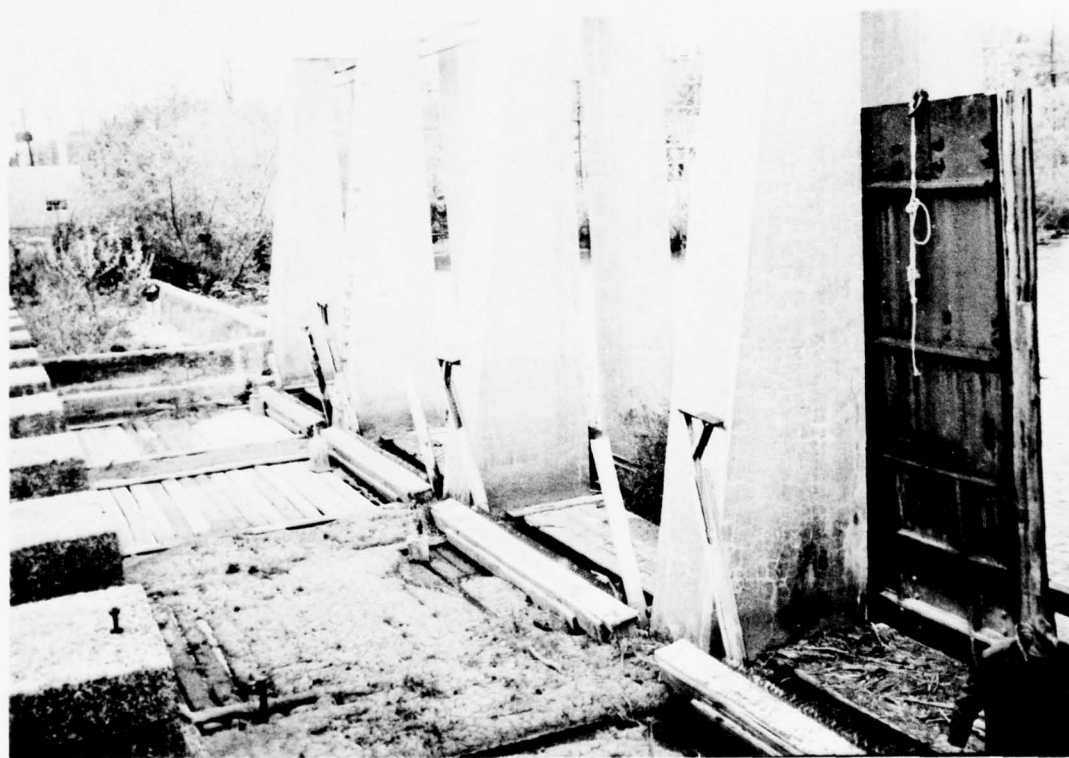
UPSTREAM OLD POWERHOUSE

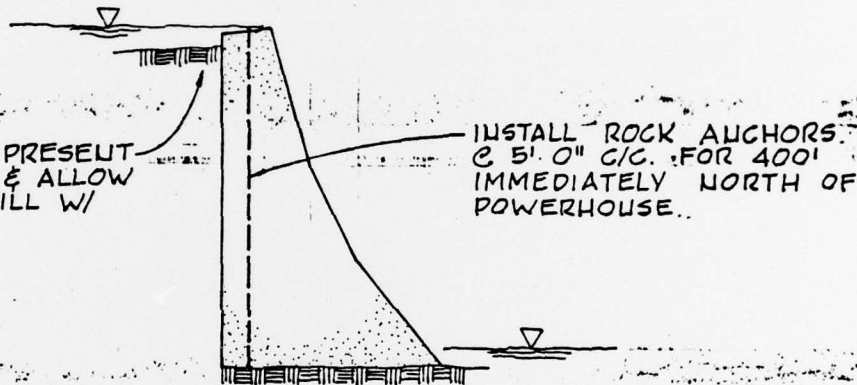
2

MAINTAIN PRESENT
DAM HGT. & ALLOW
DAM TO FILL W/
SILT.

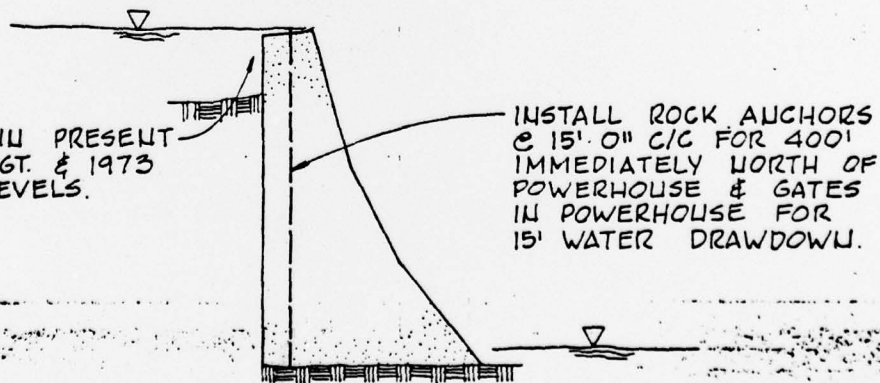
3

MAINTAIN PRESENT
DAM HGT. & 1973
SILT LEVELS.
