# CRANBERRY LAKE DAM

## PHASE I INSPECTION REPORT

### NATIONAL DAM SAFETY PROGRAM

NY 00397

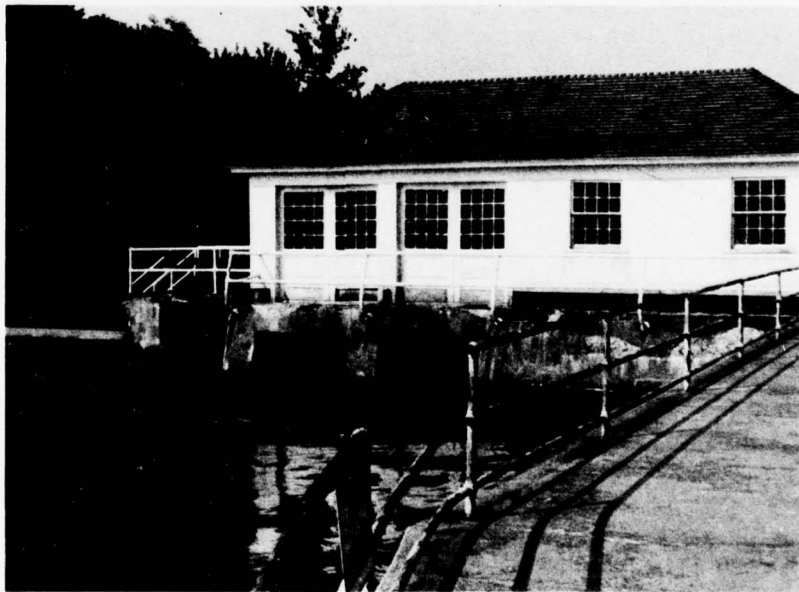
GATE HOUSE

The downstream face of the gatehouse and sluiceway is protected with a gunite surface treatment. The gunite surfacing has cracked over most of this area and spalled concrete was noted in a few of the areas where the gunite had scaled from the structure. Severe erosion of the gunite is evident at the base of the piers separating the individual gates and stoplog slots.

The concrete on the upstream side of the gatehouse appears to be in good condition. Some spalling of concrete was observed above the intakes to the gatehouse. The spalling is localized; no exposed reinforcing steel was noted.

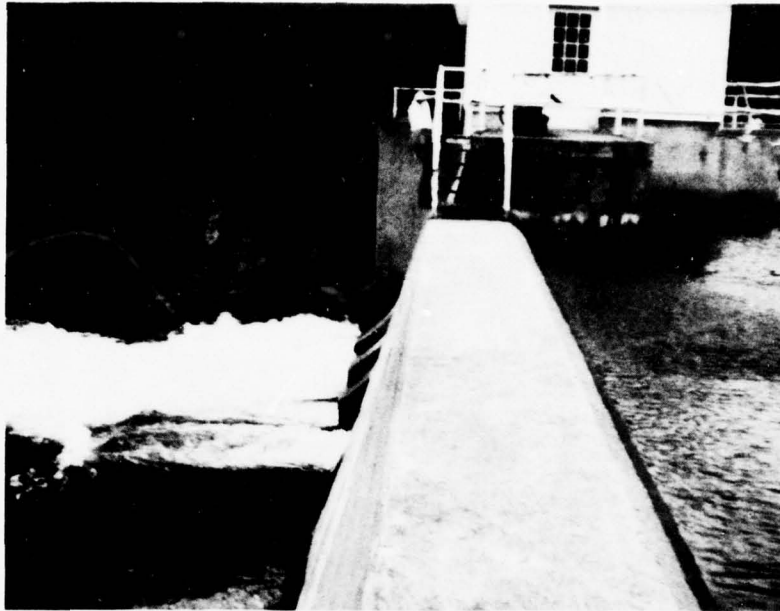
SPILLWAY CREST

d. Spillway - The upstream slope of the spillway is severely spalled below the water line. Large cracks are apparent throughout the portion of the slope which is visible. The concrete spillway crest shows no significant deterioration. There were no noticeable deviations in the crest alignment.

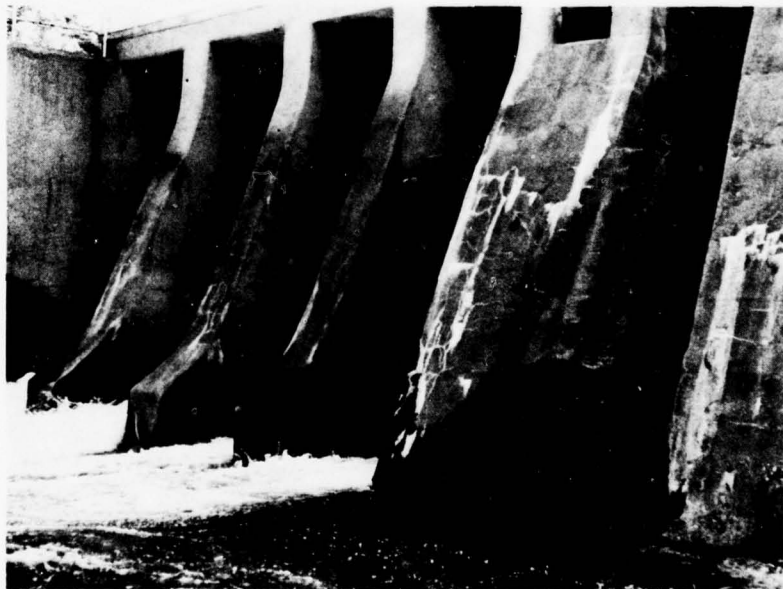
GATE HOUSE PIERS

VISUAL EXAMINATION OF	OBSERVATIONS	REMARKS OR RECOMMENDATIONS
<p>CRACKING AND SPALLING OF CONCRETE SURFACES IN OUTLET CONDUIT</p>	<p>The gunite surface treatment on the piers separating the discharge channels is cracked and has eroded along the base of the openings.</p>	
<p>INTAKE STRUCTURE</p>	<p>The concrete surface above the intakes is spalled. Minor corrosion was noted on the trash rack structure.</p>	
<p>OUTLET STRUCTURE A-9</p>	<p>N/A</p>	
<p>OUTLET CHANNEL The water passages discharge to the river. No erosion was evident.</p>	<p>N/A</p>	
<p>EMERGENCY GATE</p>	<p>N/A</p>

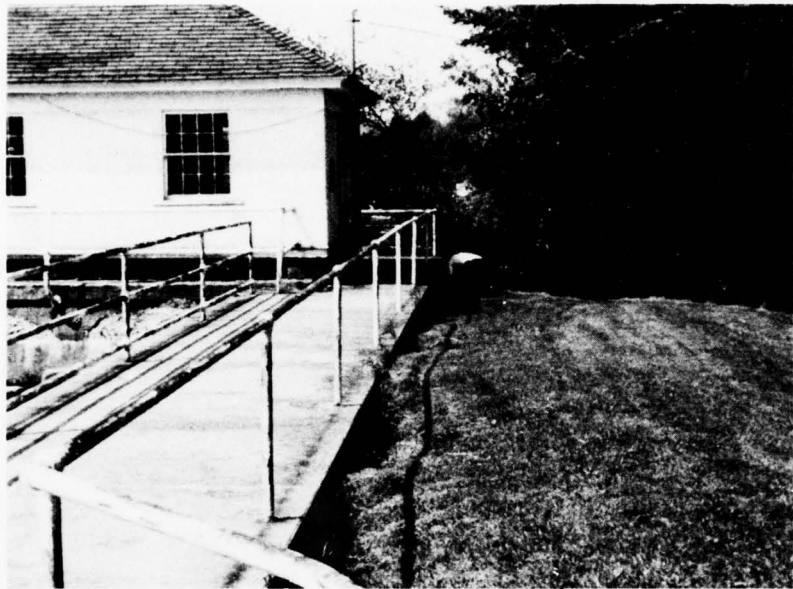
Settlement in the material used to backfill the training wall was noted at several locations along the length of the wall. Indications of erosion were evident at the junction of the embankment with the concrete gravity structure.

Settlement and erosion in the backfill adjacent to the training wall and a sinkhole type depression in the embankment area behind the training wall were noted. These conditions have not been investigated.

SETTLEMENT ALONG TRAINING WALL

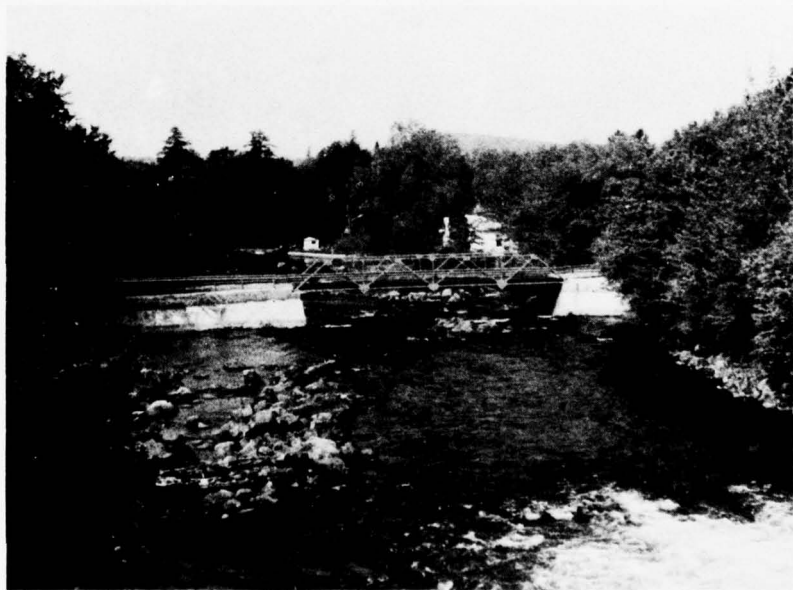
DOWNSTREAM CHANNEL

g. Downstream Channel - The channel bottom downstream of the gatehouse is protected with rock set in place; the channel immediately below the spillway is protected by a concrete apron. No indications of erosion were observed at either location although the surface of the concrete slab is noticeably pitted and spalled.

The south bank of the channel is unprotected and comprises natural slopes. No erosion or slope instability was observed along this bank. The north bank is protected by riprap supported by steel rails and cribbing for about 100 feet below the gatehouse. Some erosion or slumping of bank and fill, in and behind the cribbing, was noted. A highway bridge is located about 300 feet downstream from the dam.

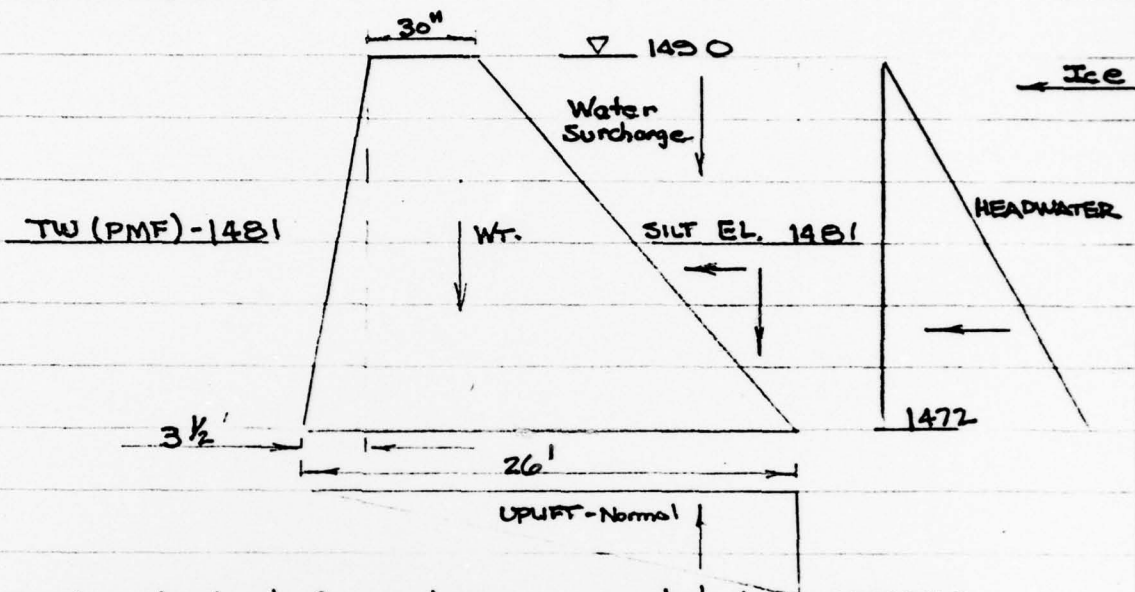
SPILLWAY SECTION

Section developed from drawings provided by NYSDEC  
and OR-CRC and from visual observations

- Assumptions:
- Unit weight of concrete = 144 pcf
  - Unit weight of silt (wet) = 86 pcf
  - internal  $\angle$  of friction for silt =  $30^\circ$
  - ice pressure = 5 ksf (2 foot thickness) Assumed at dam location
  - $\angle$  of friction - concrete/foundation =  $30^\circ$
  - shear resistance - concrete/<sup>rock</sup> foundation = 100 psi
  - seismic coeff. of acceleration = .1g
  - negative pressures resulting from separation of lower nappe are beyond the scope of this phase of study and are not included.

LOADING CONDITION	SF - OVERTURNING	SF - SLIDING	BEARING PRESSURES
NORMAL POOL	2.05	1.84	17.8 psi 1.4 psi
PMF	1.90	1.73	20.1 psi 4.6 psi
EARTHQUAKE	1.86	1.29	19.8 psi - .6 psi
ICE LOADING	1.35	1.04	27.2 psi - 8.8 psi
