STILLWATER RESERVOIR DAM

PHASE I INSPECTION REPORT NATIONAL DAM SAFETY PROGRAM

NY 00316

Prepared by: O'Brien and Gere Engineers, Inc.

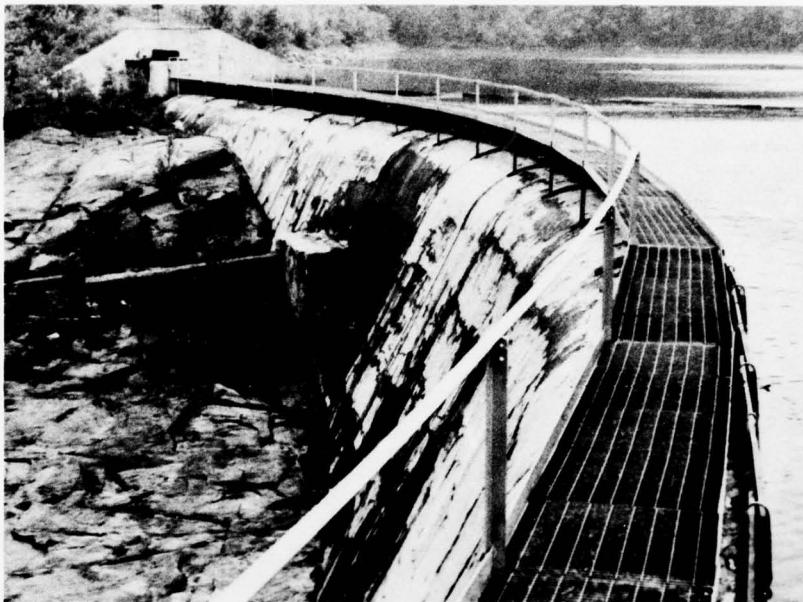
VIEW OF CONCRETE SPILLWAY AND ROCK OUTCROP

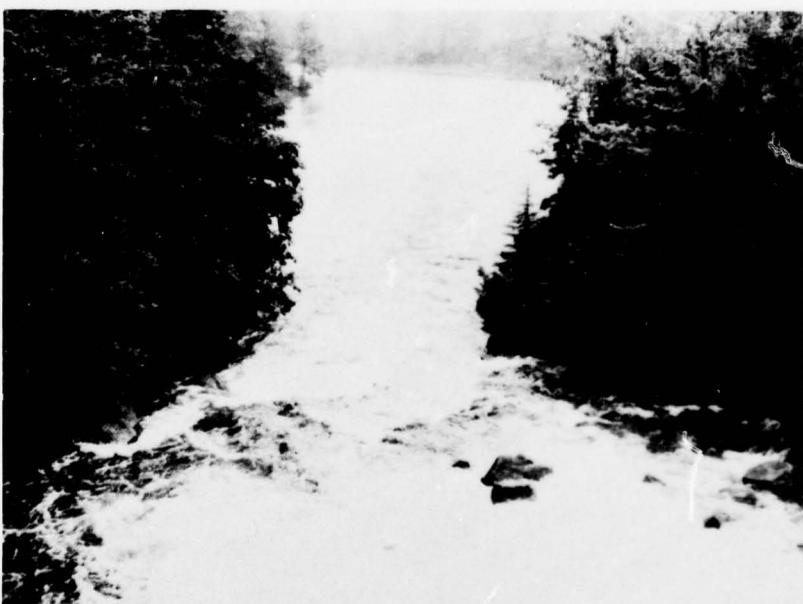
The channel below the gatehouse and spillway is formed in natural massive rock outcrops. No erosion of the rock was observed.

DOWNSTREAM CHANNEL

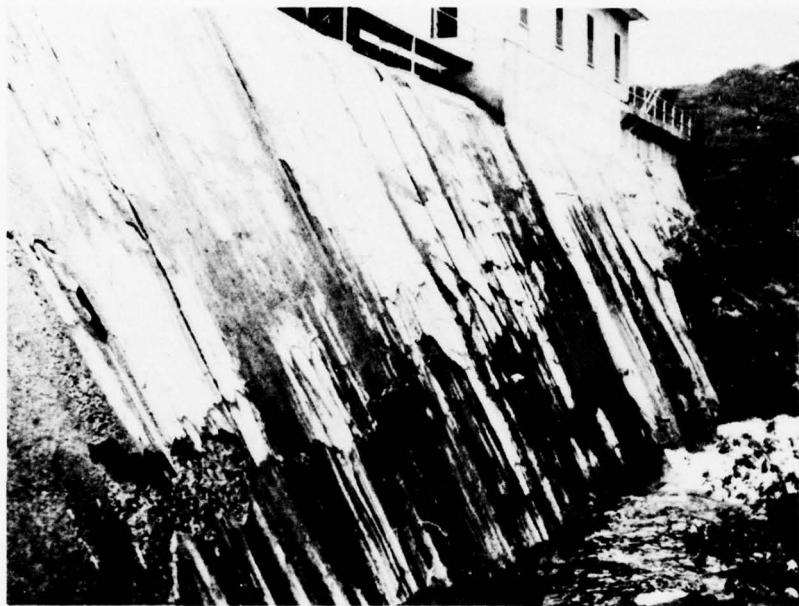
The downstream face of the spillway has also been surfaced with a protective material. A much more significant deterioration of the material than observed on the non-overflow section was evident. In areas where the material had dislodged from the structure, spalled concrete was again noted. No seepage was observed in the toe area of the gravity section.

DOWNSTREAM SLOPE OF SPILLWAY

3. Remove and replace the deteriorated concrete surface protection material as required.

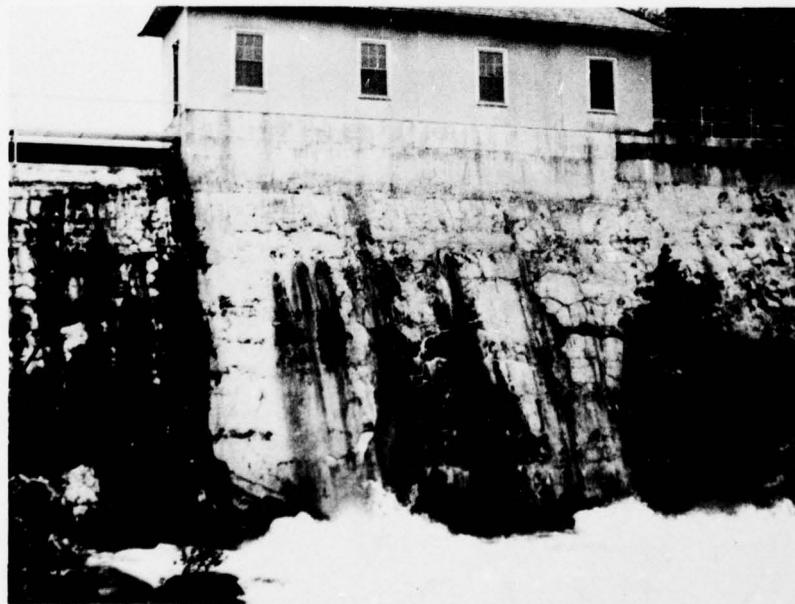
The downstream face of the non-overflow section shows signs of deterioration. A protective surface treatment (gunite) which was applied to the structure has weathered and cracked. Some spalling of the gunite was noted in the downstream slope of the non-overflow section.

DOWNSTREAM FACE OF GATE HOUSE

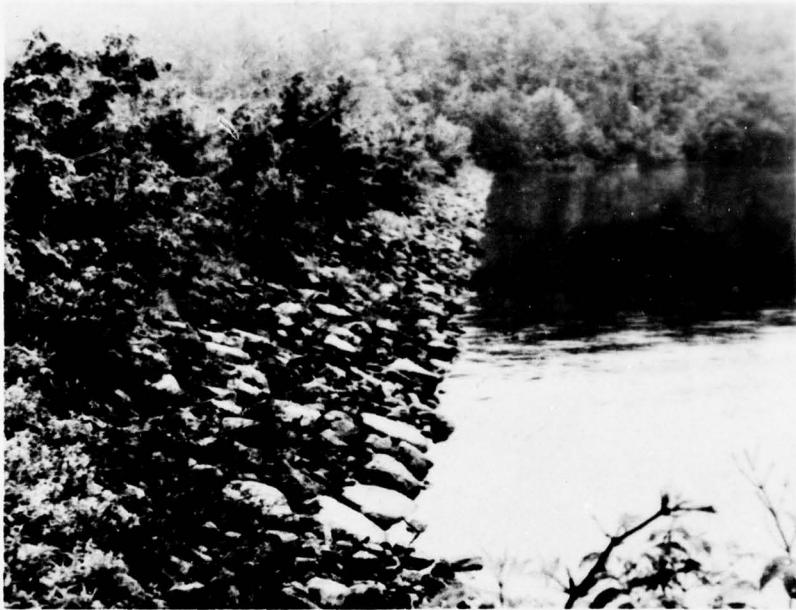
The upstream slope is protected with a blanket of dumped granitic type riprap, ranging in nominal sizes from 4 inches to 24 inches. A significant growth of small sapling trees and brush are located along the crest and upstream slope. No significant settlement or erosion were observed along crest. Two capped galvanized metal pipes about two inches in diameter were located in the center of the crest. Operating personnel indicated no knowledge of these pipes or their function.

NORTH DAM (UPSTREAM SLOPE) LOOKING NORTH

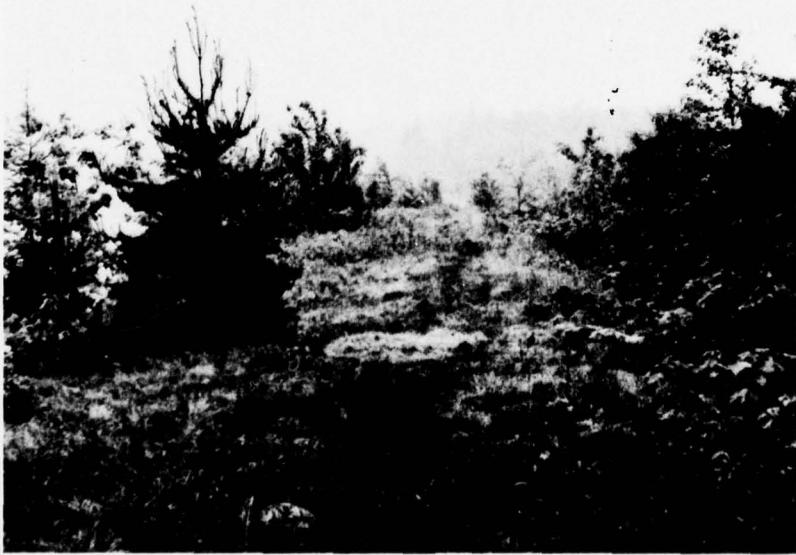
CREST OF NORTH DAM LOOKING SOUTH

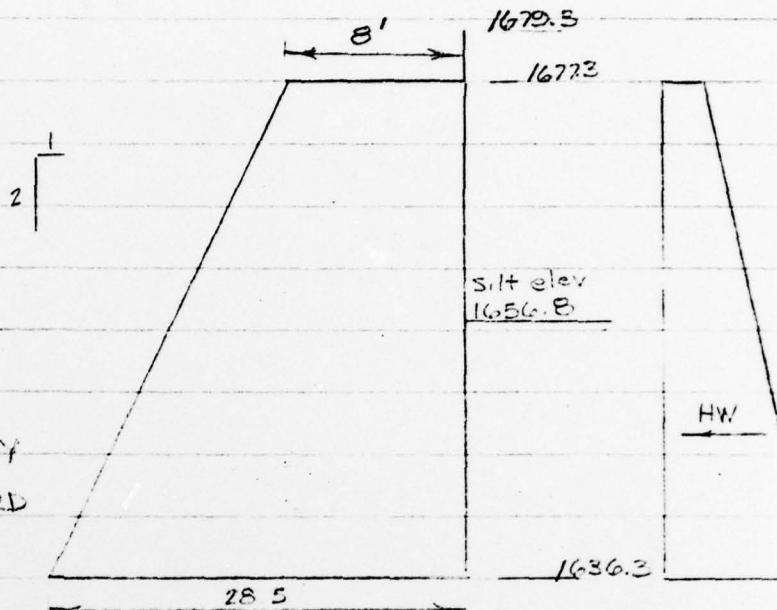
SPILLWAY SECTION

A review of the results indicates that the resultant is located a significant distance outside of the middle third of the base for the normal and PMF loading conditions; the resultant of the seismic loading falls within the limits of the base width.

A review of the stability analysis indicates that the spillway is structurally unstable relative to resultant location for normal and PMF loading conditions. However, in the analyses, the spillway was evaluated as a simple gravity structure; no consideration was given to the curvature of the spillway which could significantly improve the stability of the structure.

LOADING CONDITION	SF-AGGRAVATION	SF-SLICING	BEARING PRESSURES
NORMAL Pool	1.2	7.1	46.7 psi - 14.3 psi (Tension)
EARTHQUAKE	1.0	5.6	60.9 psi - 28.5 psi (Tension)
PMF	1.0	6.0	59.6 psi - 29.2 psi (Tension)

Review of the stability analyses indicates that the resultant is located a significant distance outside the middle third of the base width for the normal and PMF loading conditions. The analyses considered a simple gravity structure. However, the structure is arched in plan. Further stability analyses evaluating the dam as an arched/gravity structure are recommended.
