National Dam Safety Program. Big Spring Dam (NDS I.D.-461), Ohio River Basin, Big Spring Run, Westmoreland County, Pennsylvania. Phase I Inspection Report.

BIG SPRING DAM

PHASE I INSPECTION REPORT
NATIONAL DAM INSPECTION PROGRAM

JUNE 1978

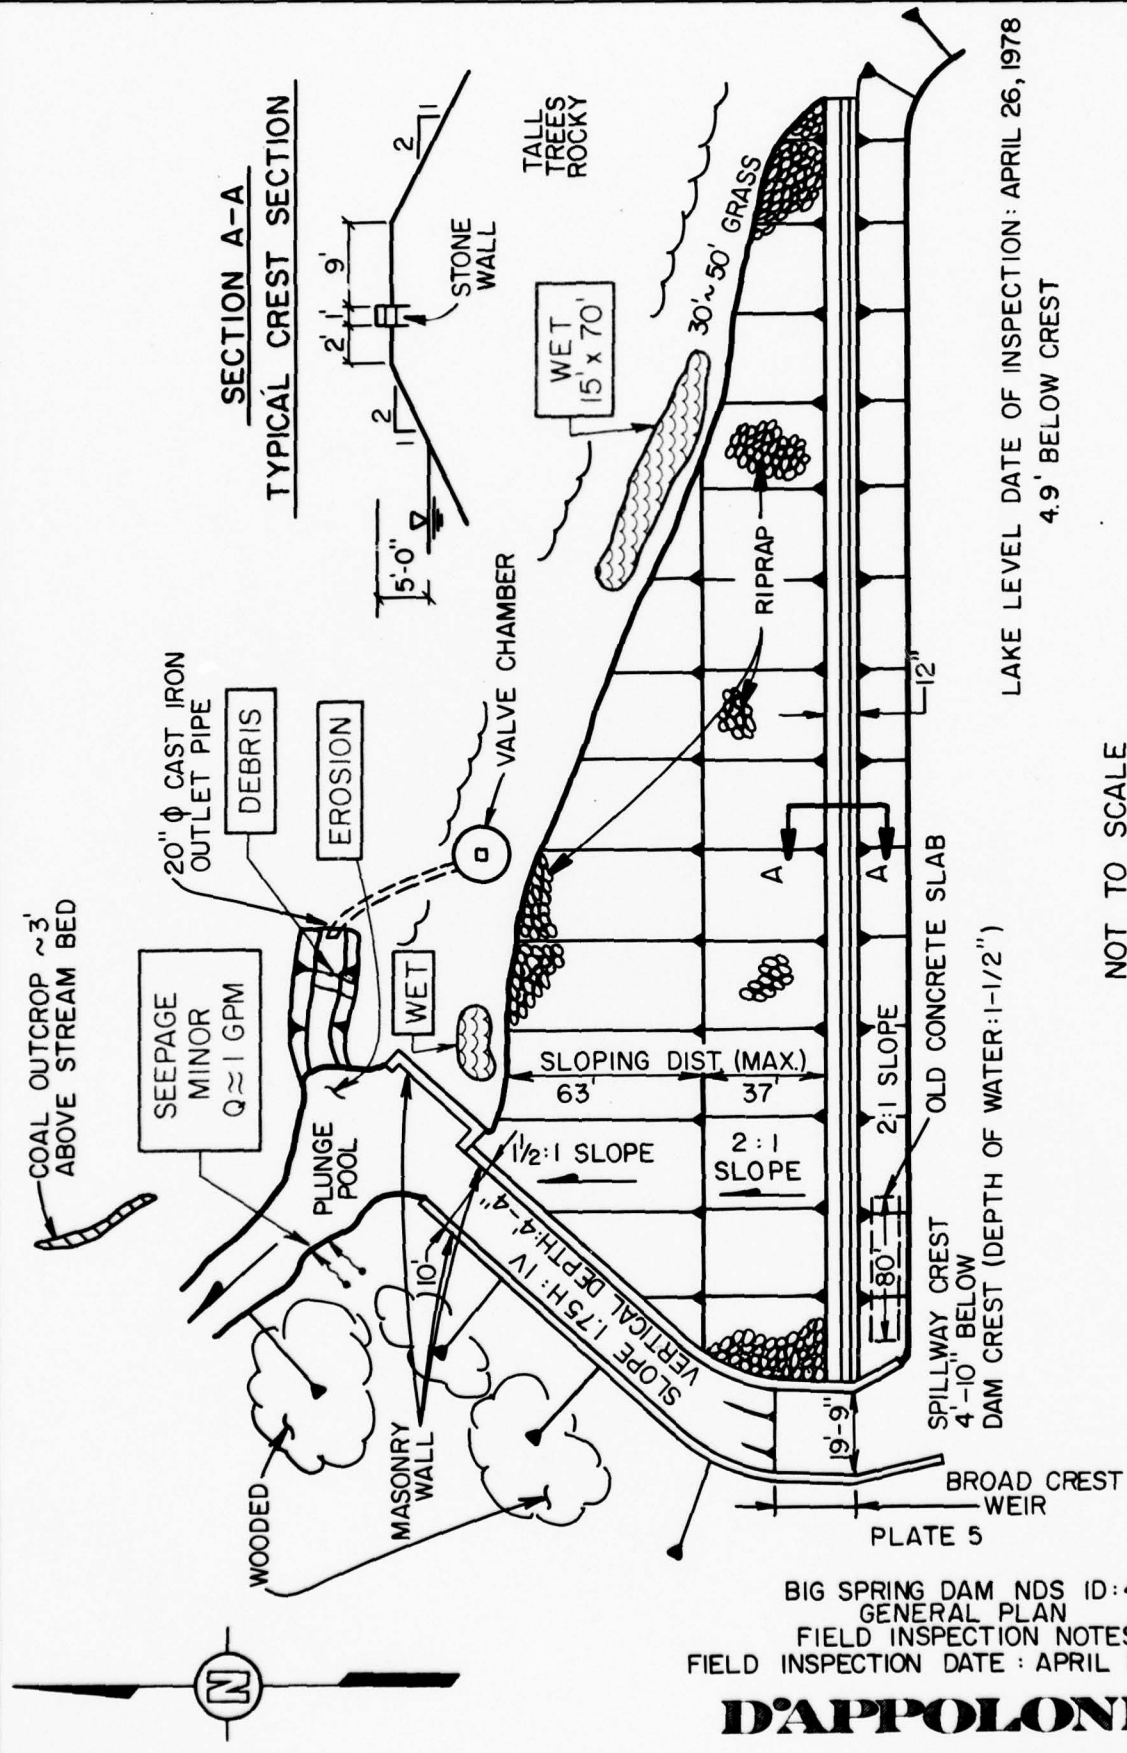
1. Two wet areas were observed at the toe of the dam (Plate 5): one to the right of the spillway channel and another to the right of the center of the embankment. No perceivable seepage was associated with these wet areas.
2. Minor seepage was observed on the left abutment draining into the streambed approximately 50 feet downstream of the plunge pool.
3. The outlet channel of the "blow-off" pipe was noted to be partially obstructed with fallen trees and other debris.

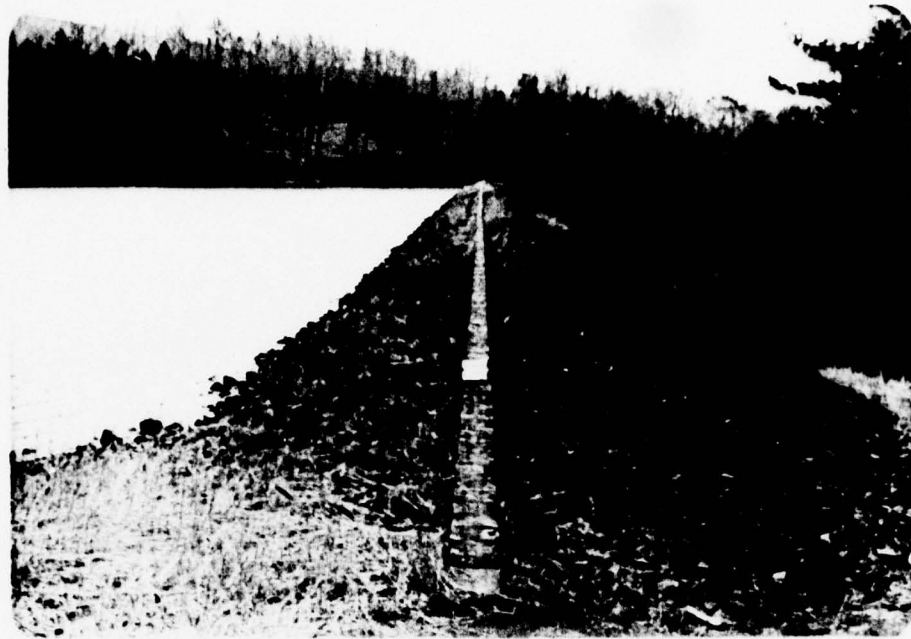
Photograph No. 1
Crest (looking west).

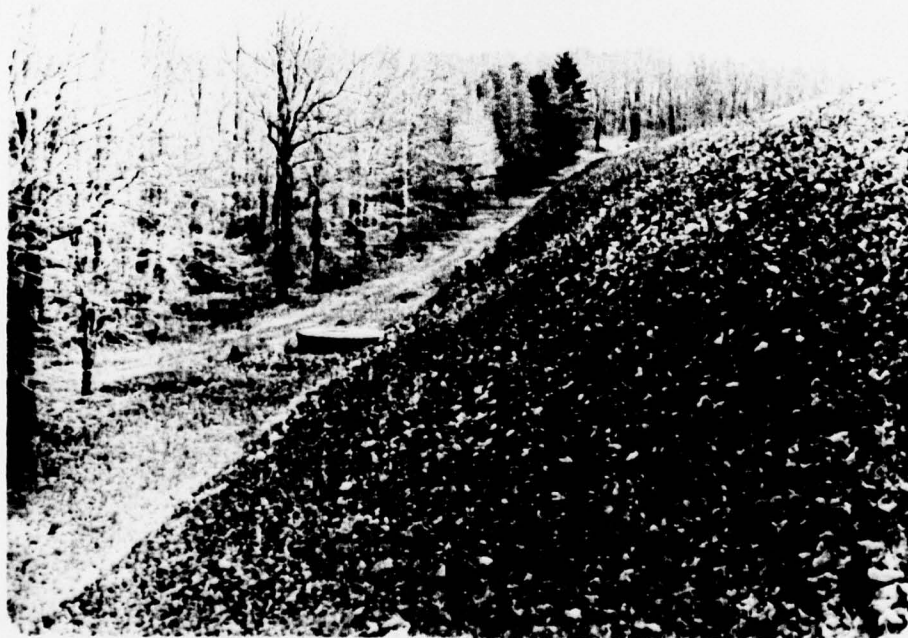
Photograph No. 2
Downstream slope (looking east). Note gate chamber in
middle of photograph.

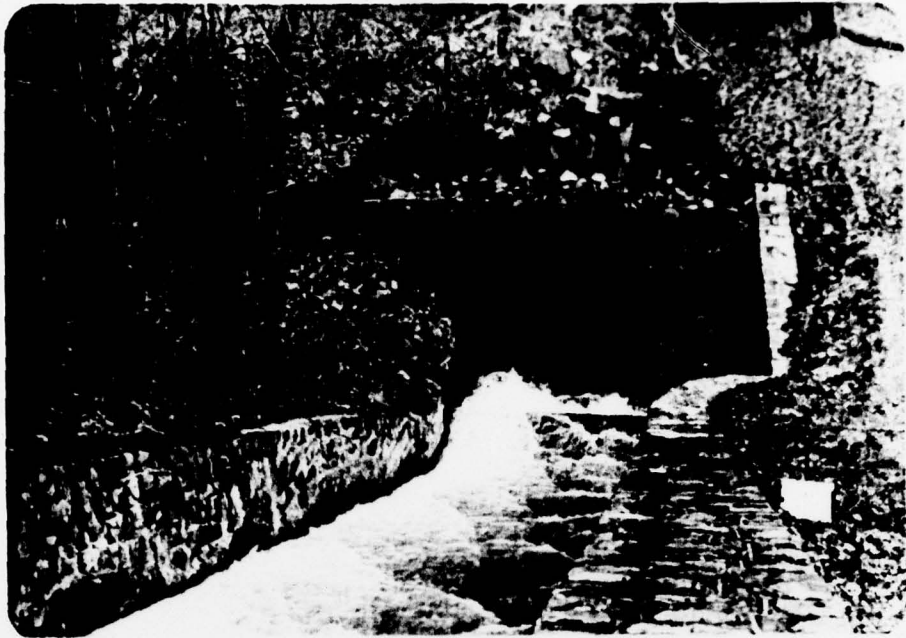
c. Appurtenant Structures. The spillway structures, spillway crests, channels, and plunge pools were examined for deterioration or other signs of distress and obstructions that would limit flow. In general, the structures were found to be in good condition. The plunge pool was examined and scouring and erosion were observed (Photograph 5).

Photograph No. 5
Spillway plunge pool (note erosion).

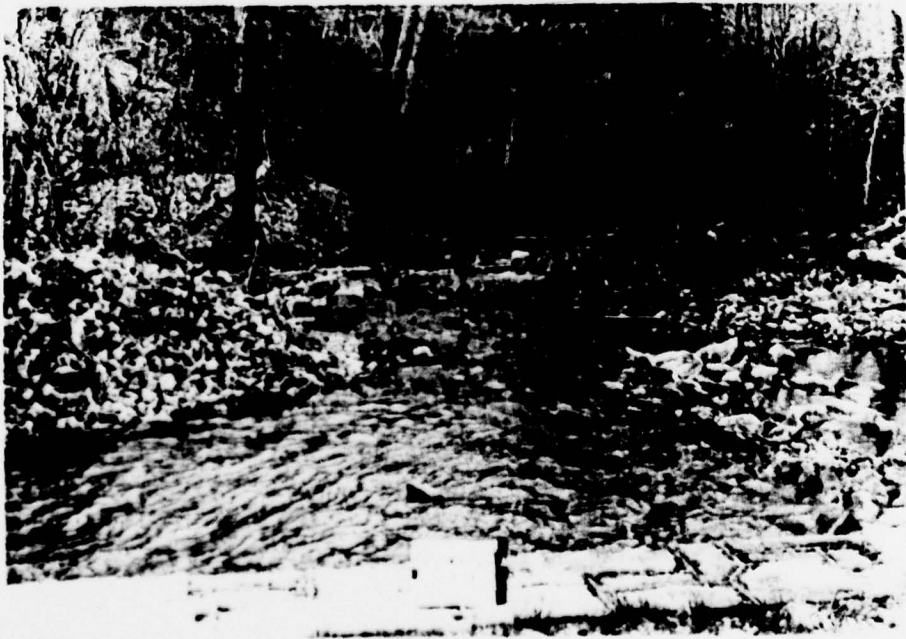
VISUAL EXAMINATION OF	OBSERVATIONS	REMARKS OR RECOMMENDATIONS
CONDITION (OBSTRUCTIONS, DEBRIS, ETC.)	TYPICAL MOUNTAIN STREAM CHANNEL OCCASIONAL FALLEN TREES. NO MAJOR OBSTRUCTION.	
SLOPES	ROCKY NO SIGNIFICANT EROSION.	
APPROXIMATE NUMBER OF HOMES AND POPULATION	ONE GASOLINE STORAGE TANK AND AN ADJACENT BUILDING. ONE SHOPPING CENTER STREAM CROSSES A STATE ROUTE. PT 711. (SHOPPING CENTER @ ~ MILE 1.6	SEE PLATE I

Photograph No. 6
Stream channel downstream of plunge pool.

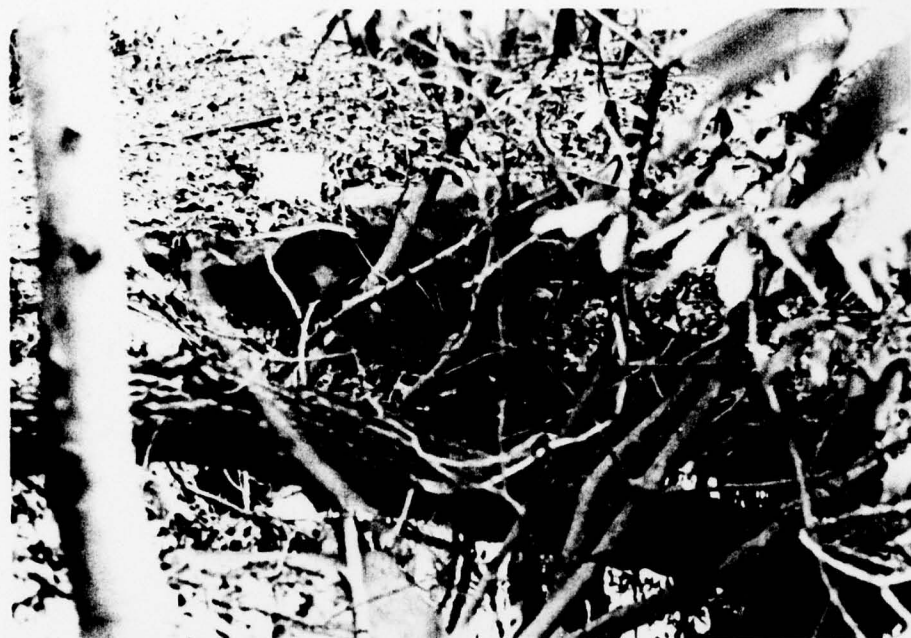
The downstream end of the outlet pipe was examined and was found to be in fair condition.

Photograph No. 7
Outlet end of "blow-off" pipe.

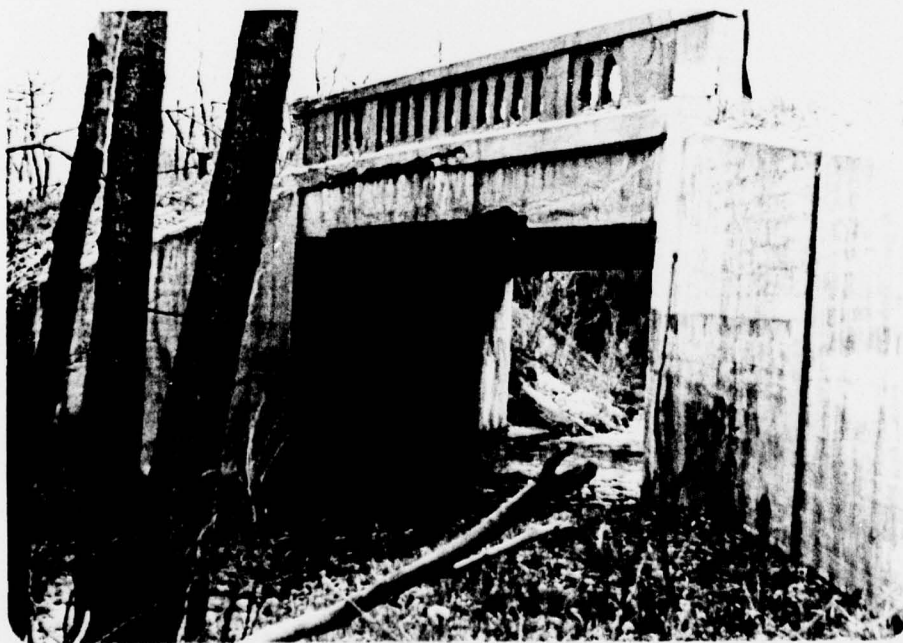
Photograph No. 8
Bridge on Route 711 (Bridge No. 1).

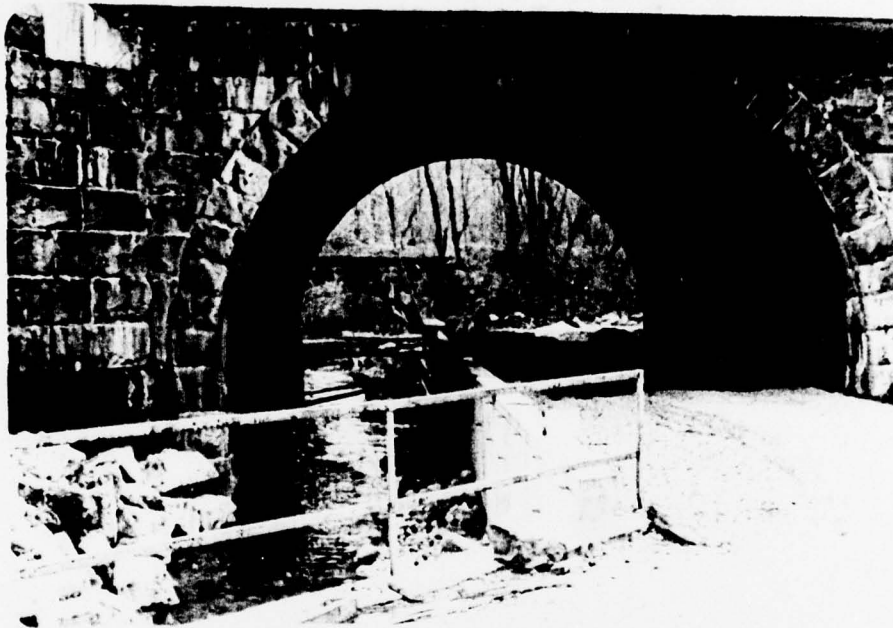
Photograph No. 9

Bridge on Penn-Central Railroad (Bridge No. 3).
Bridge on abandoned railroad bed (Bridge No. 2)
background.
