National Dam Safety Program. Tipton Dam (NDI I.D.-525), Susquehanna River Basin, Tipton Run, Blair County, Pennsylvania. Phase I Inspection Report.

TIPTON DAM

NDI I.D. NO: 525

PHASE I INSPECTION REPORT NATIONAL DAM INSPECTION PROGRAM

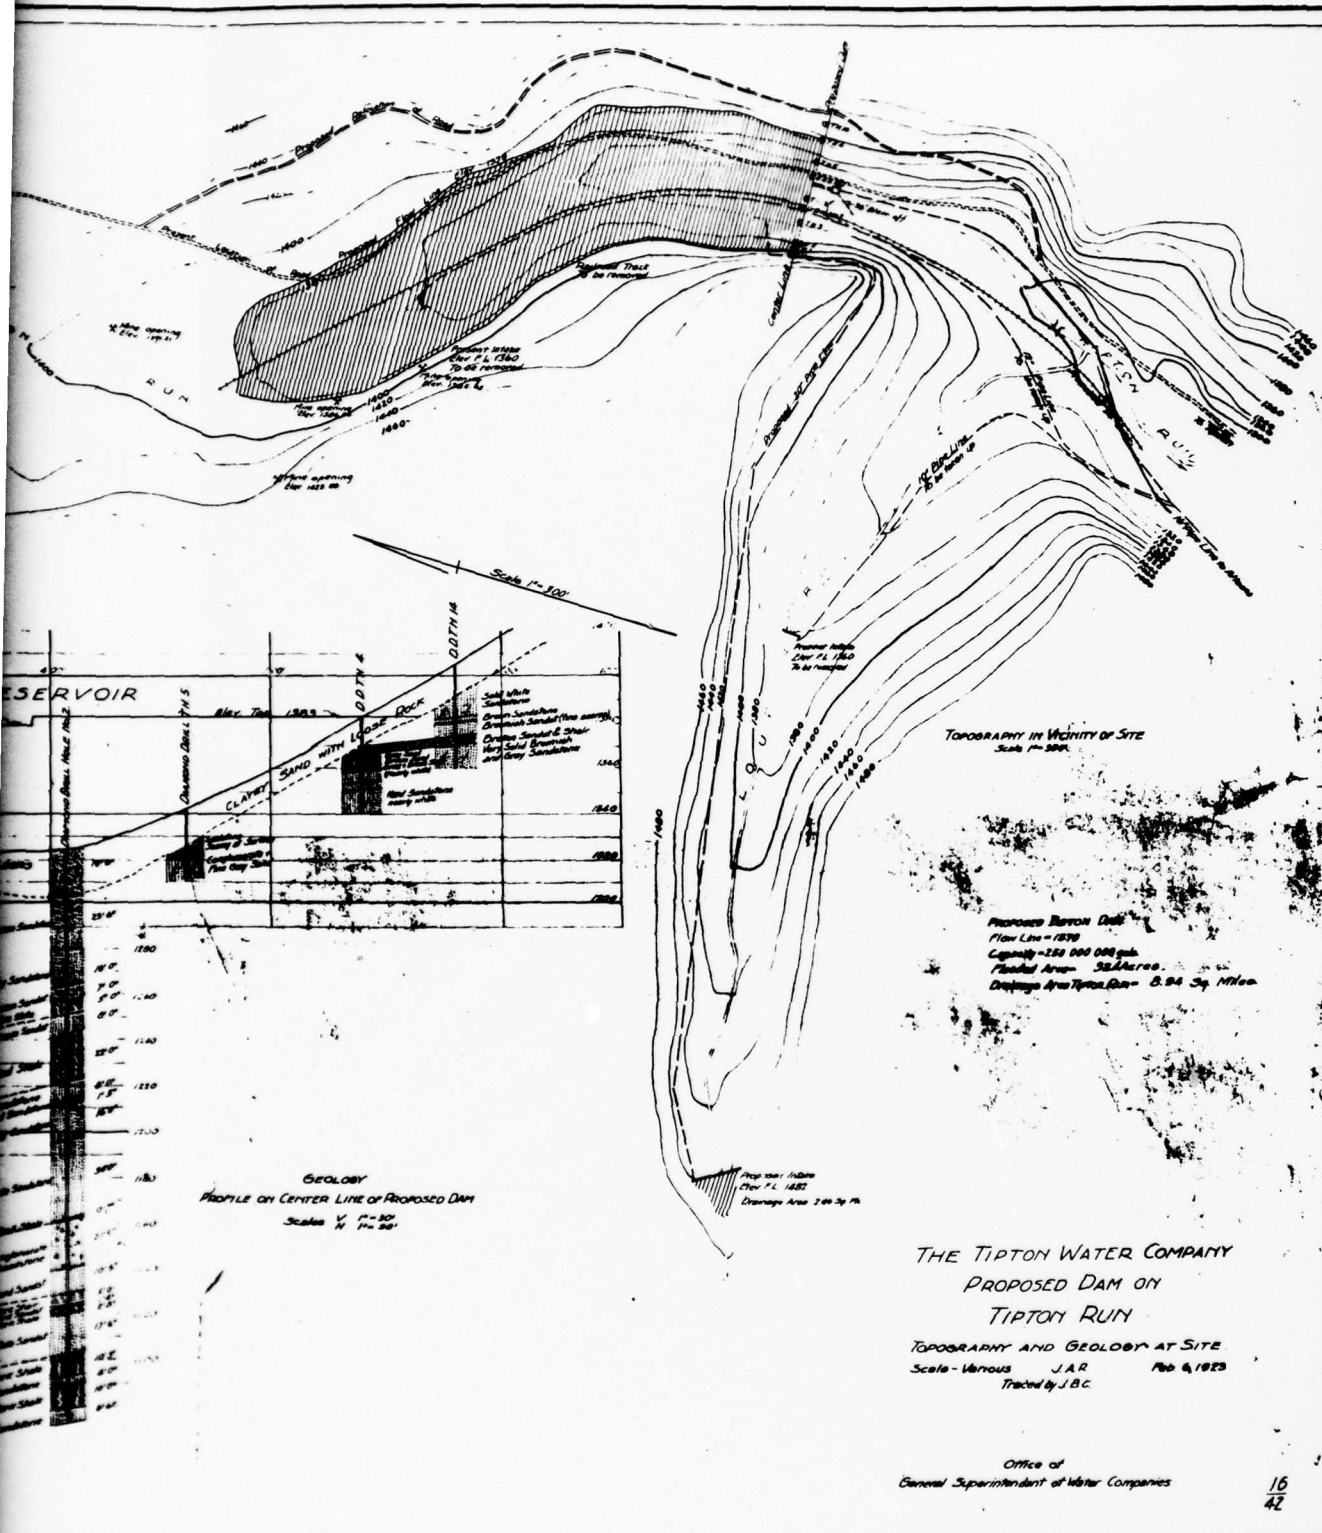
PLATE 3

1. Preliminary subsurface exploration at the site consisted of numerous test pits and borings. Plate 3 illustrates the subsurface conditions at the site which consists of layers of sandstone and shale. In addition to the borings shown in Plate 3, two additional borings were drilled to a depth of 250 feet for the investigation.

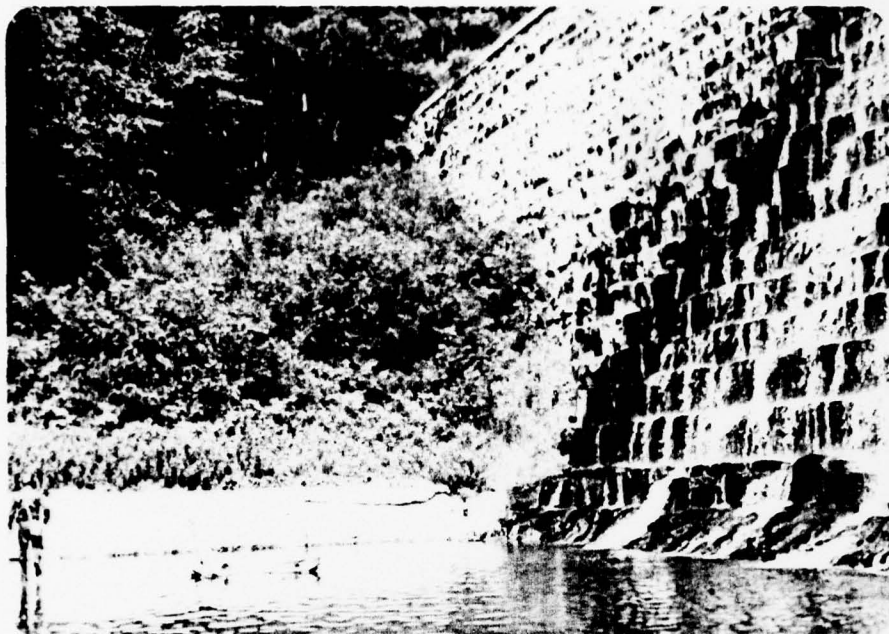
Photograph No. 1
Right abutment.

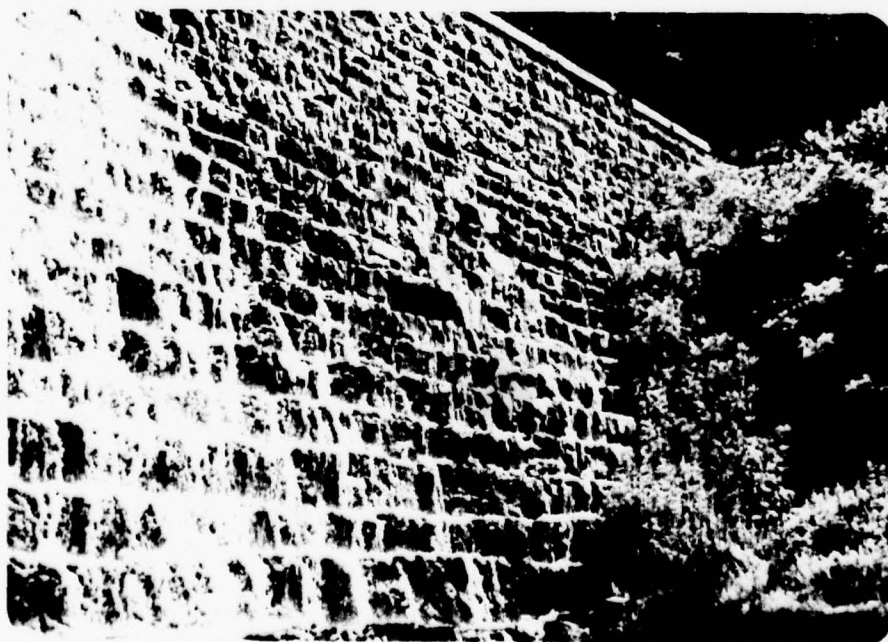
Photograph No. 2
Left abutment.

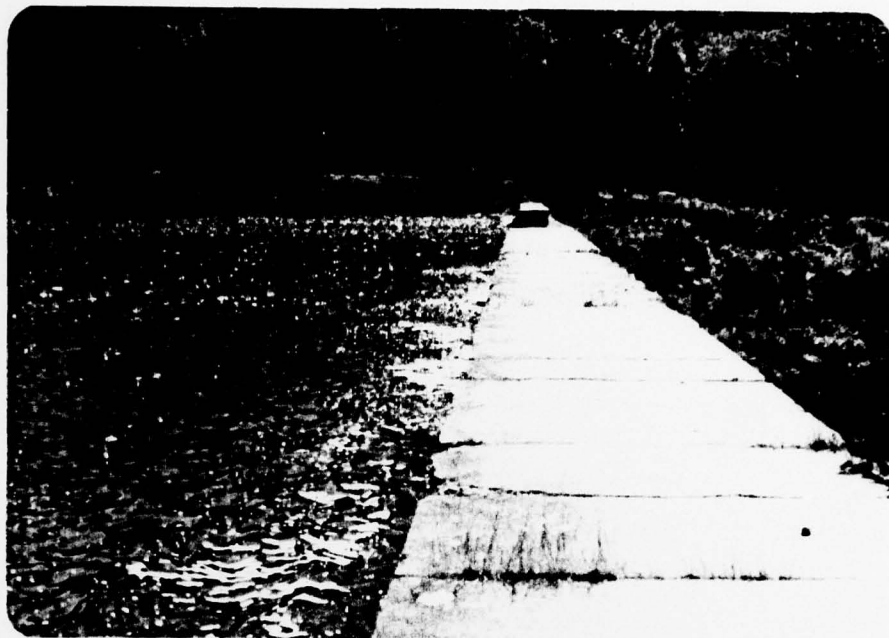
Photograph No. 3
Crest (looking east).

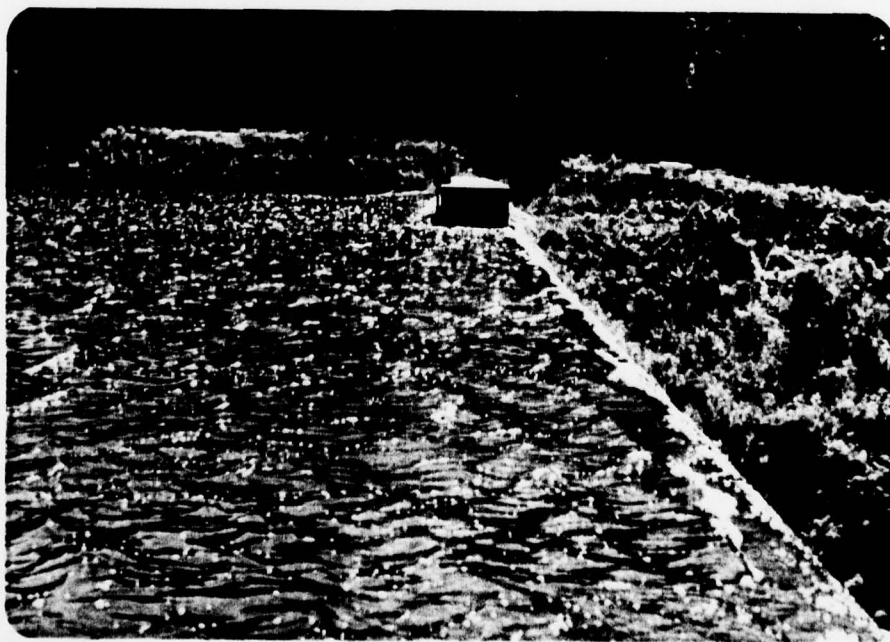
Photograph No. 4
Spillway crest (looking east).

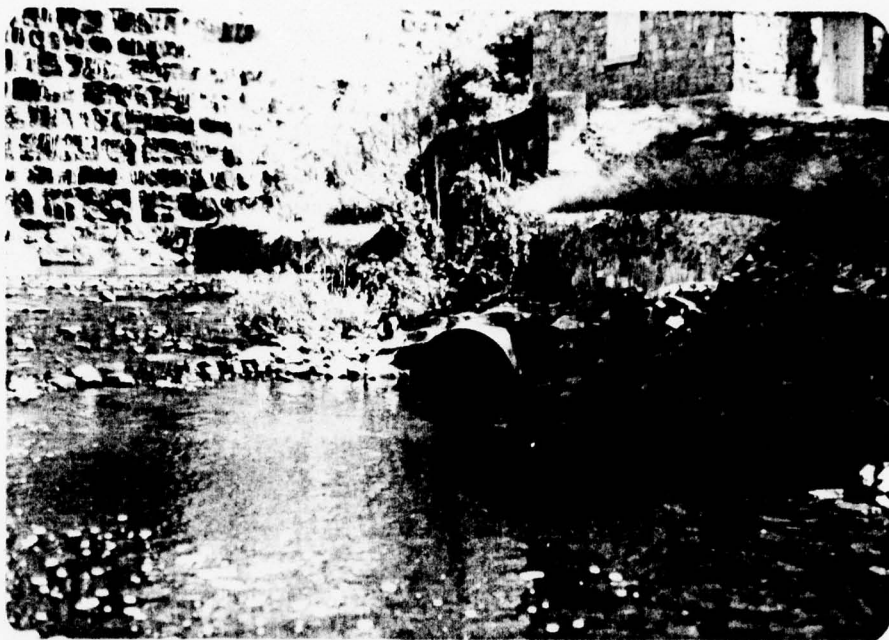
Photograph No. 7

4.3 Maintenance of Operating Facilities. The water company declined to operate the blow-off valve to demonstrate its functional condition without compensation for its operation and compensation for any damage that would result due to its operation. Therefore, the operative condition of the drawdown facilities could not be assessed. In general, the equipment appears to be in fair condition.

Blow-off pipe (note valve house in
righthand corner).

1. It is recommended that the owner immediately evaluate the operational condition of the reservoir blow-off valve and perform necessary maintenance.
2. Spalling concrete capping blocks and plunge pool side walls should be repaired as soon as practicable.
3. Because the dam may overtop during unusually high runoff, it is recommended that during such periods the owner should provide around-the-clock surveillance for early detection of problems, such as erosion of the abutments.
4. It is recommended that brush and trees on the abutments should be cleared over a distance of approximately 20 feet from the dam to permit adequate future visual inspection of the abutment areas.

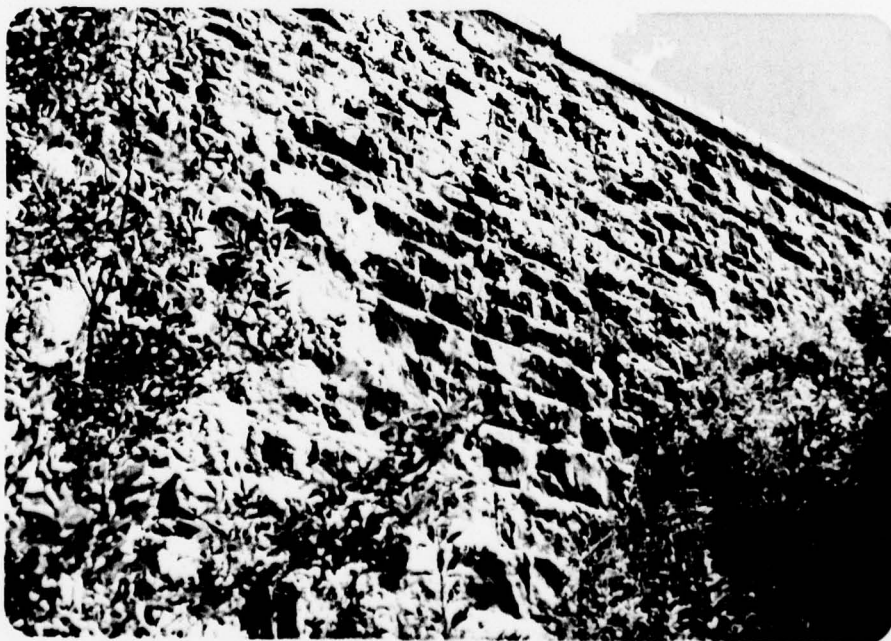
Photograph No. 8

1. One area of the dam on each side of the spillway was found to be wet. Several seeps were located on the left, about 10 feet below the crest of the dam over a distance of about 20 feet. Total seepage from the left side was estimated to be 4 to 6 gallons per minute (gpm). Seepage through the right side of the spillway was estimated to be 2 to 4 gpm.
2. Several concrete capping blocks on the crest of the dam have deteriorated, exposing reinforcing. They should be repaired before further weathering occurs.

VISUAL EXAMINATION OF	OBSERVATIONS	REMARKS OR RECOMMENDATIONS
ANY NOTICEABLE SEEPAGE	LEFT SIDE OF SPILLWAY ABOUT 10 FT. BELOW CREST LEVEL SEVERAL SEEPS THROUGH JOINTS. TOTAL FLOW \approx 4 TO 6 GPM.	
STRUCTURE TO ABUTMENT/EMBANKMENT JUNCTIONS	NO VISUAL SIGNS OF DISTRESS. NO SEEPAGE ON ABUTMENTS.	
DRAINS	NONE FOUND.	
WATER PASSAGES	NONE	
FOUNDATION	NO PERCEIVABLE SIGN OF DISTRESS.

Minor seepage through the dam (left of
spillway).

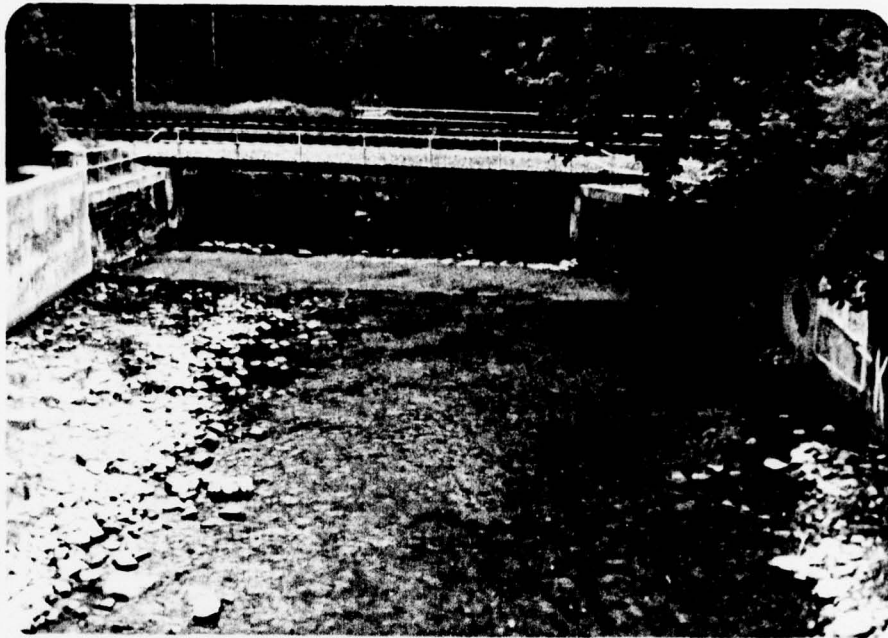
Photograph No. 9
Bridge on Penn-Central Railroad.

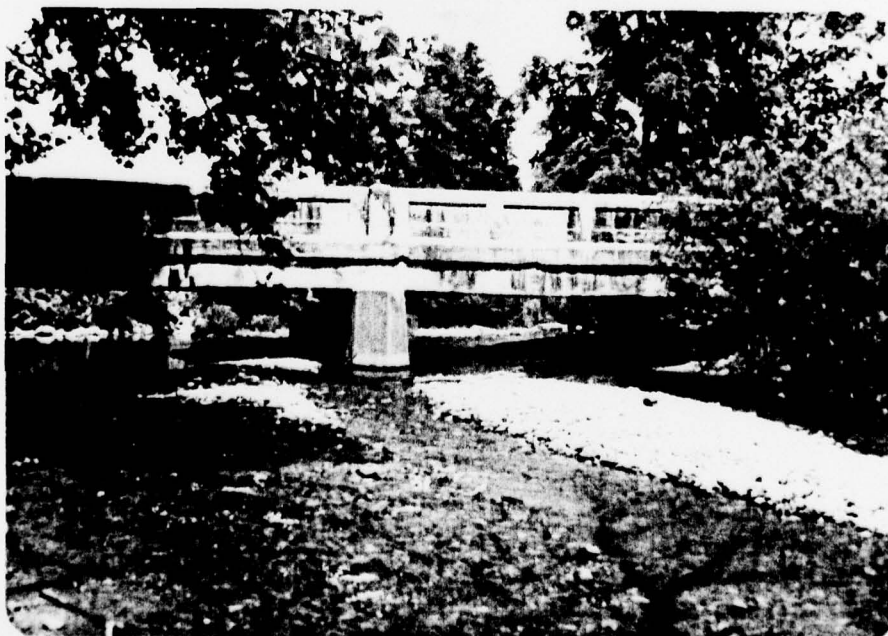
Photograph No. 10
Bridge on Route 220 (confluence of Tipton Run and
Little Juniata River, Little Juniata River merges
from the right).
