BEAVERDAM RUN DAM

FD-NO. PA. 805

PHASE I INSPECTION REPORT

Beaverdam Run Dam (PA 805), Ohio River
Basin, Beaverdam Run, Cambria County,
Pennsylvania. Phase I Inspection Report.

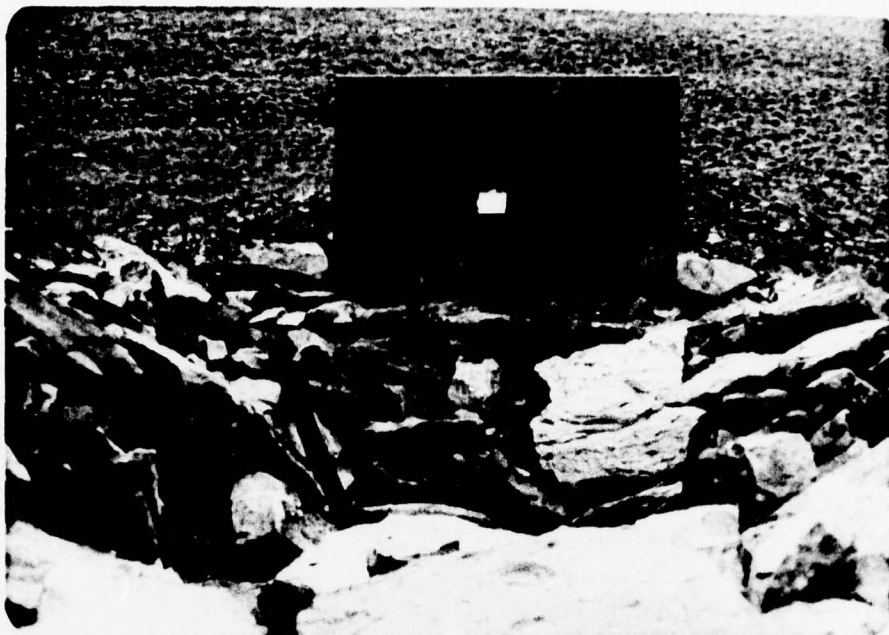
Photograph No. 3
Primary spillway discharge pipe.

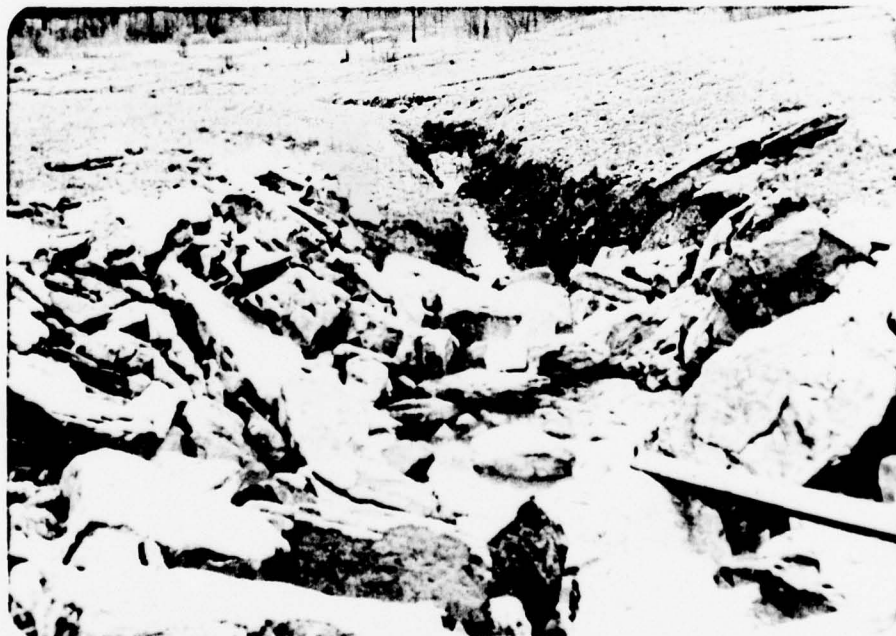
Photograph No. 4
Primary spillway, plunge pool, and discharge channel.

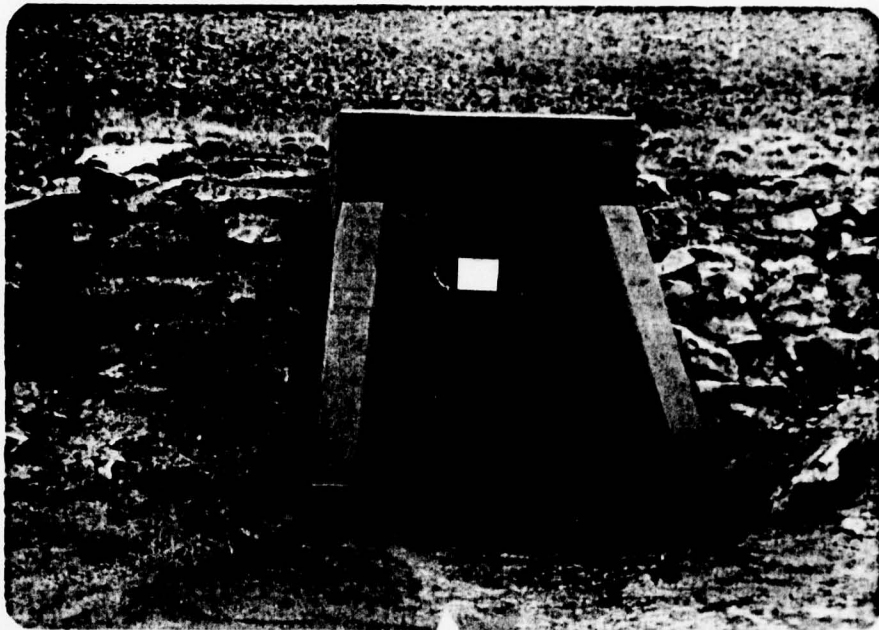
Photograph No. 5
Blow-off pipe outlet.

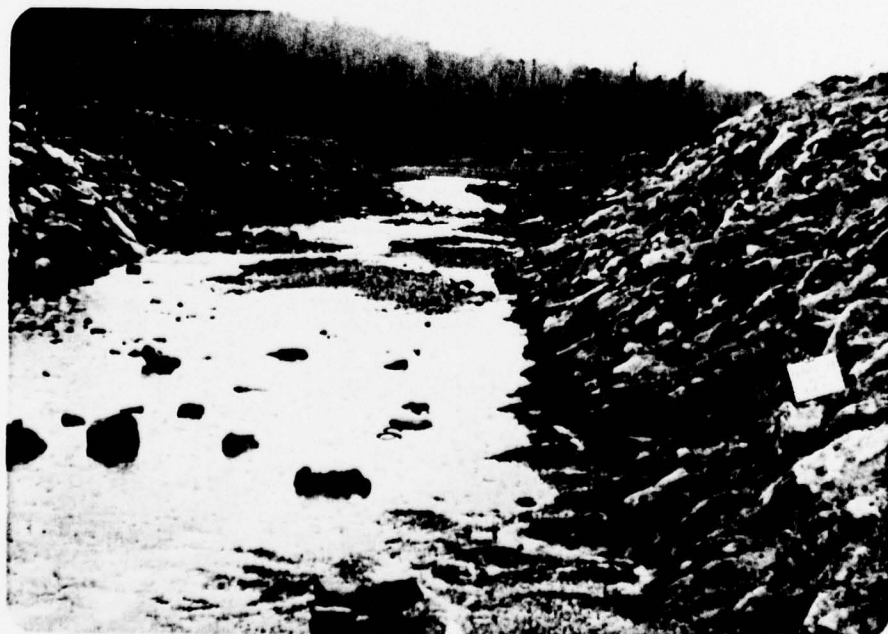
Photograph No. 6
Blow-off pipe plunge pool and discharge channel.

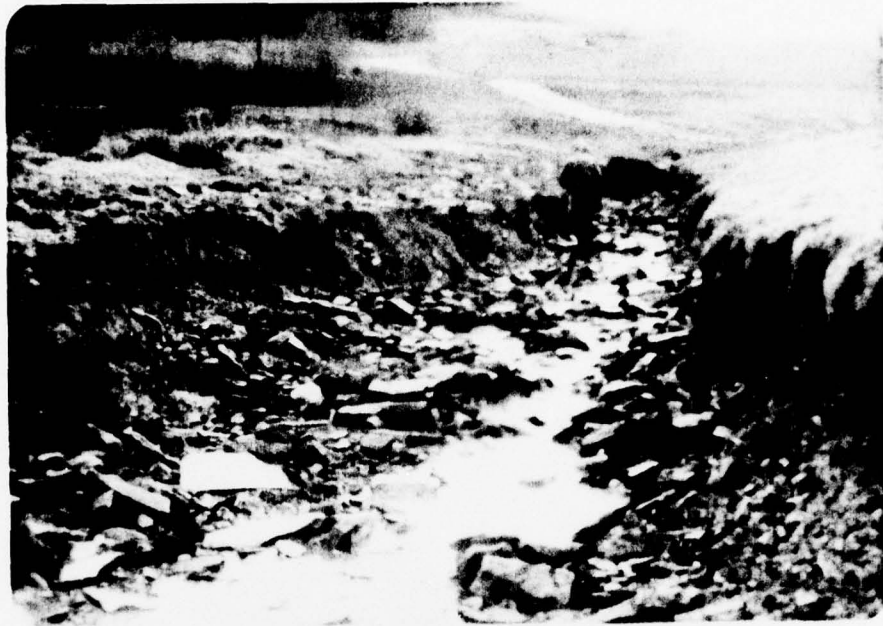
In general, the structures were found to be in good condition, with the exception of major erosion observed in the primary spillway discharge channel (Photograph 7) downstream from the plunge pool. This condition is not considered to be a safety hazard at its present extent. However, it should continue to be monitored to assure that it will not affect the performance of the plunge pool. The riprap at the emergency spillway entrance channel is inadequate to protect the embankment from erosion during high flows. Approximately 100 feet downstream from the crest, the left side of the emergency spillway channel is too low to contain major flows through the spillway. At flow depths of two to three feet over the spillway crest, it appears that the channel would overflow downslope toward the toe of the embankment.

Photograph No. 7
Erosion in discharge channel.

1. The owner should be advised to make appropriate repairs to the outlet pipe gate immediately.
2. The adequacy of riprap at the entrance channel of the emergency spillway should be evaluated to determine if it provides sufficient protection against erosion of the embankment during high flows.
3. Necessary corrective measures should be taken to prevent overflow from the emergency spillway discharge channel from flowing towards the toe of the dam.
4. The seepage at the toe of the dam should be monitored and recorded.
5. Attention should be given to the scour problem in the primary spillway discharge channel to prevent this condition from becoming a threat to the integrity of the dam.

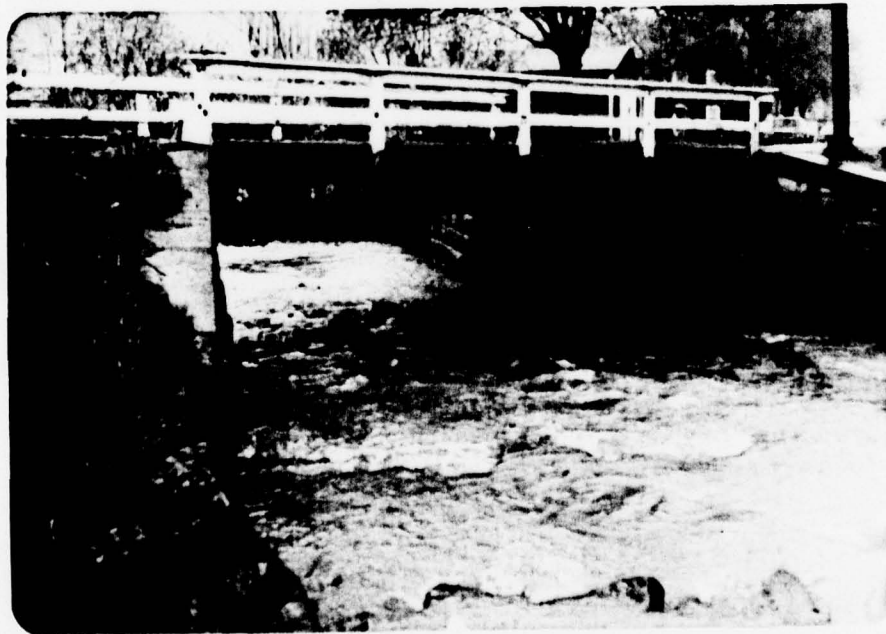
Photograph No. 8
Bridge No. 1.

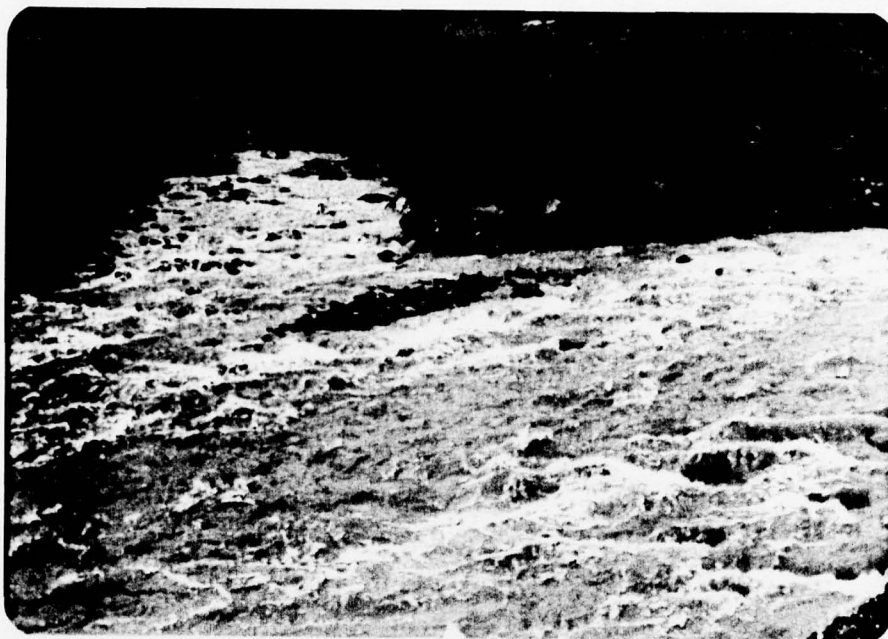
Photograph No. 9
Confluence of Beaverdam Run and South Fork
of Little Conemaugh River.

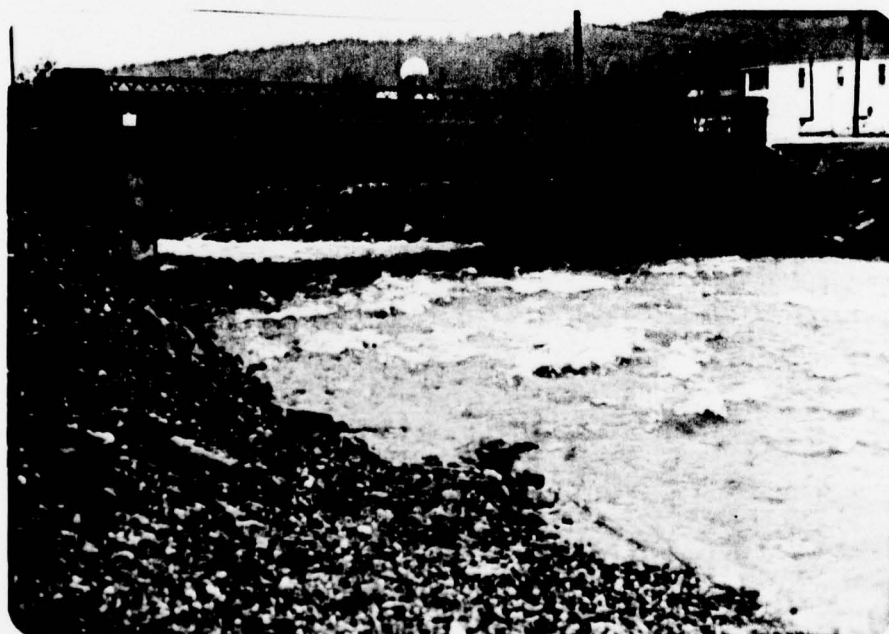
Photograph No. 10
Bridge No. 2.
