BOYD KELLER RESERVOIR DAM

INVENTORY NUMBER NDS 745

### PHASE I INSPECTION REPORT

## PHASE I REPORT NATIONAL DAM INSPECTION PROGRAM

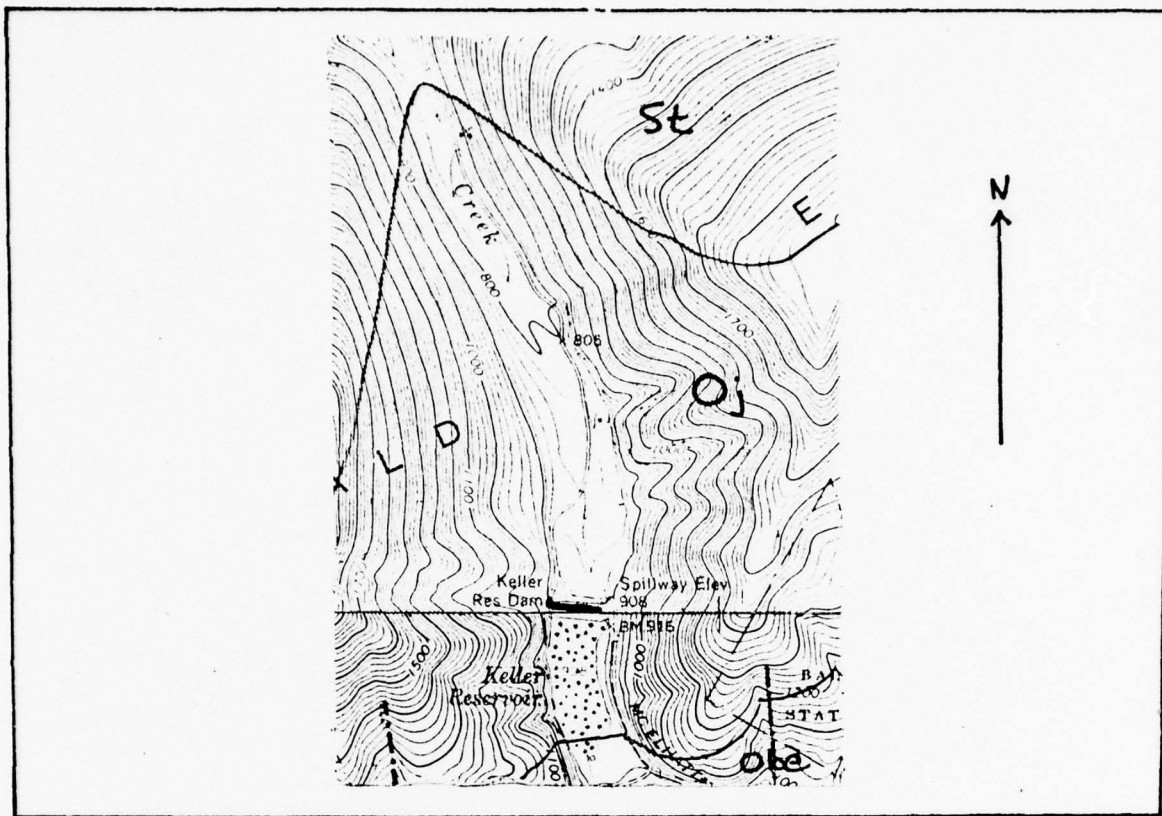
GEOLOGIC MAP - Boy Keller Dam

The dam is located on the northwest limb of the Nittany Anticline. The beds strike N65°E and dip 10° to 15°NW. The Nittany Anticline is now known to have major thrust faulting on its northwest limb, but no faults are mapped in the vicinity of the dam. No cross faulting is mapped and none is visible on the air photographs. The valley of McElhattan Creek is probably controlled by N5°W to N10°W fractures. Parallel fracture traces were noted on the air photos and are shown on the map, Fig. 1.

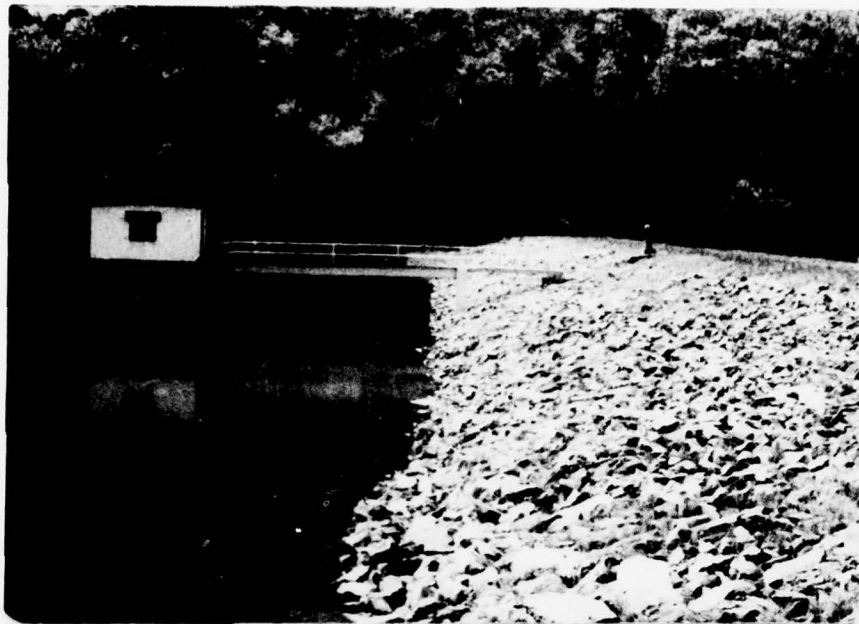
The upstream embankment slope is covered with riprap to an elevation eight feet below normal water level and appears stable. No failures or unusual conditions were noted. The downstream slope is seeded and in good condition. One low area was noted near the left abutment at the top of dam, but the cause could not be determined. The top of the backfill adjacent to the spillway walls is approximately one foot below the top of wall and could cause an early overtopping of the dam. Drains and a collection system had been installed to eliminate a wet condition below the dam. The dark color green vegetation indicated where these drains had been installed. The collector is discharging in a ditch along the access road. The effluent was clear and no movement of fines was detected. No other seepage was detected at the site.

Upstream  
Slope

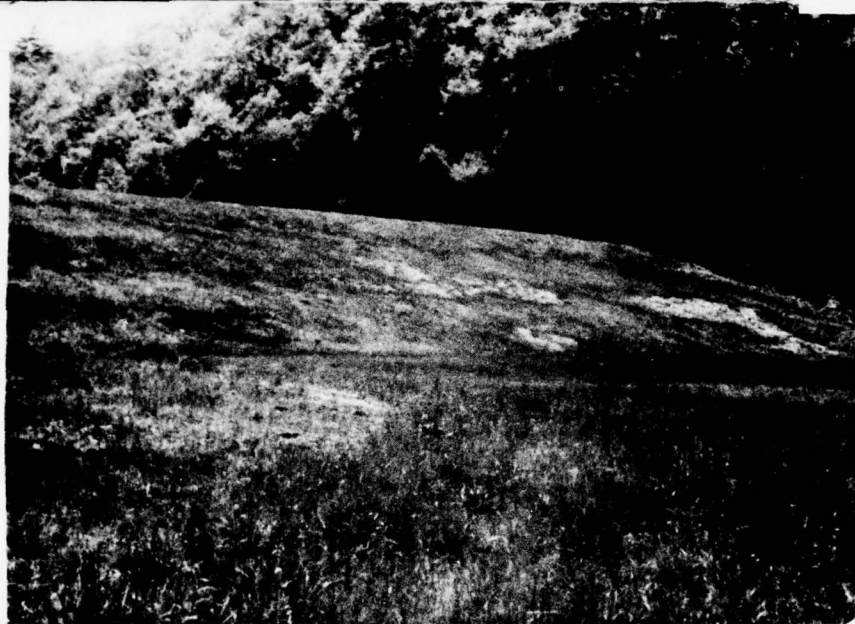
There were no observations of undue embankment distress. Considerable seepage does occur along the left abutment and the downstream toe, but the locations and extent of the leakage could not be determined because of the drains and collectors that have been installed below ground. This leakage was observed at the end of the discharge pipe.

Left Downstream  
Embankment

1. Owner should carefully monitor the volume of leakage discharged from the collector system, and observe any turbidity of the water, and contract for repairs if such need is indicated.
2. Owner should backfill to top of spillway walls and fill the low area on top of embankment.

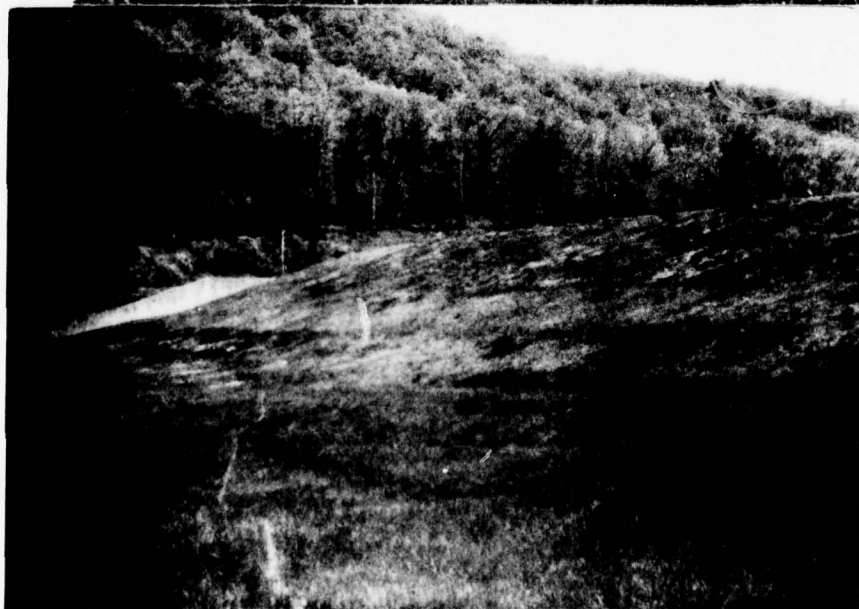
Right Downstream  
Embankment

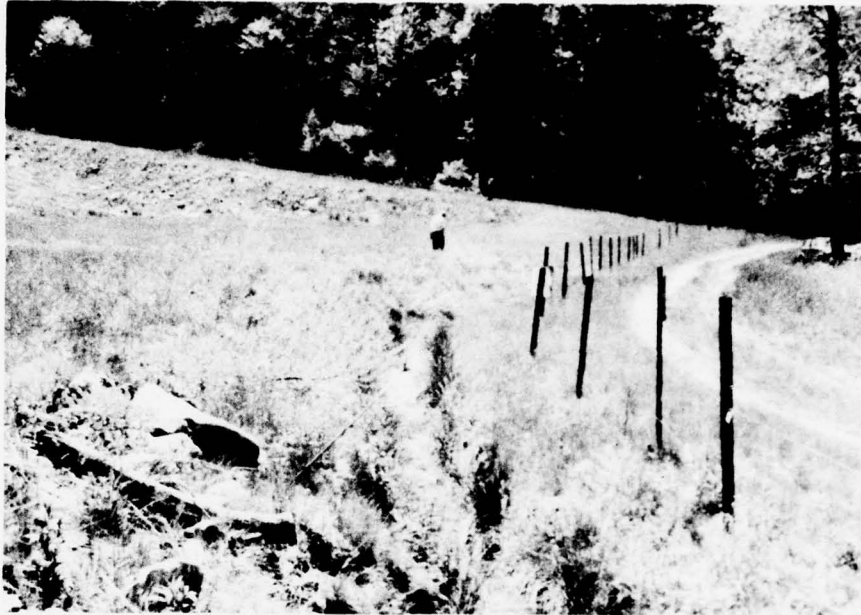
The only reported post construction has been the installation of drains and a collection system to eliminate a downstream wet condition. Seepage is discharging from this collector, but the water is clear, showing no movement of fines.

Downstream  
Toe

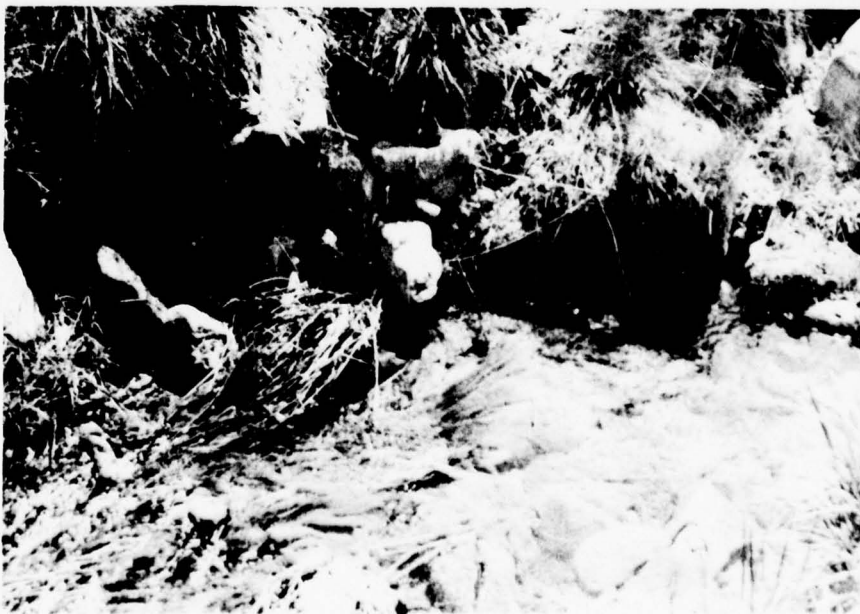
Downstream  
Creek

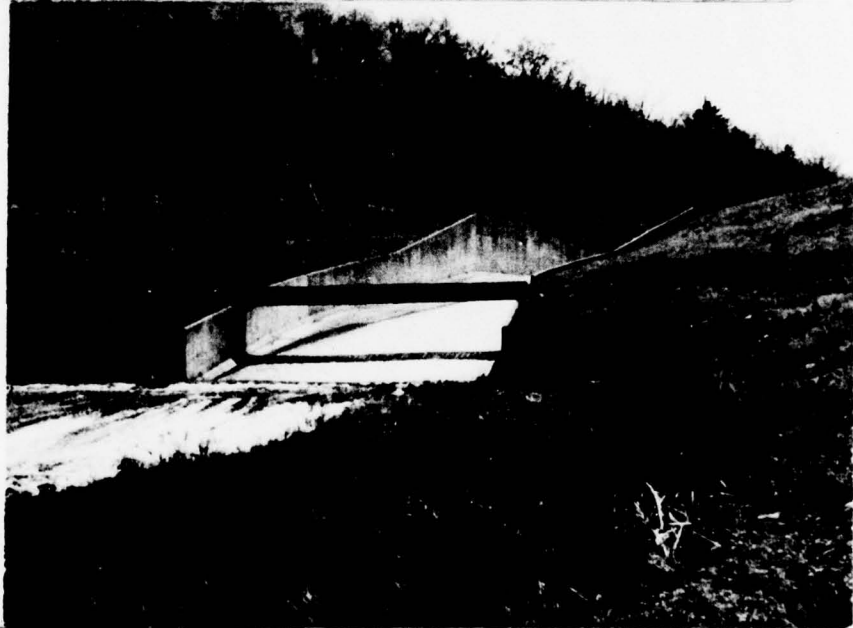
Spillway  
Chute

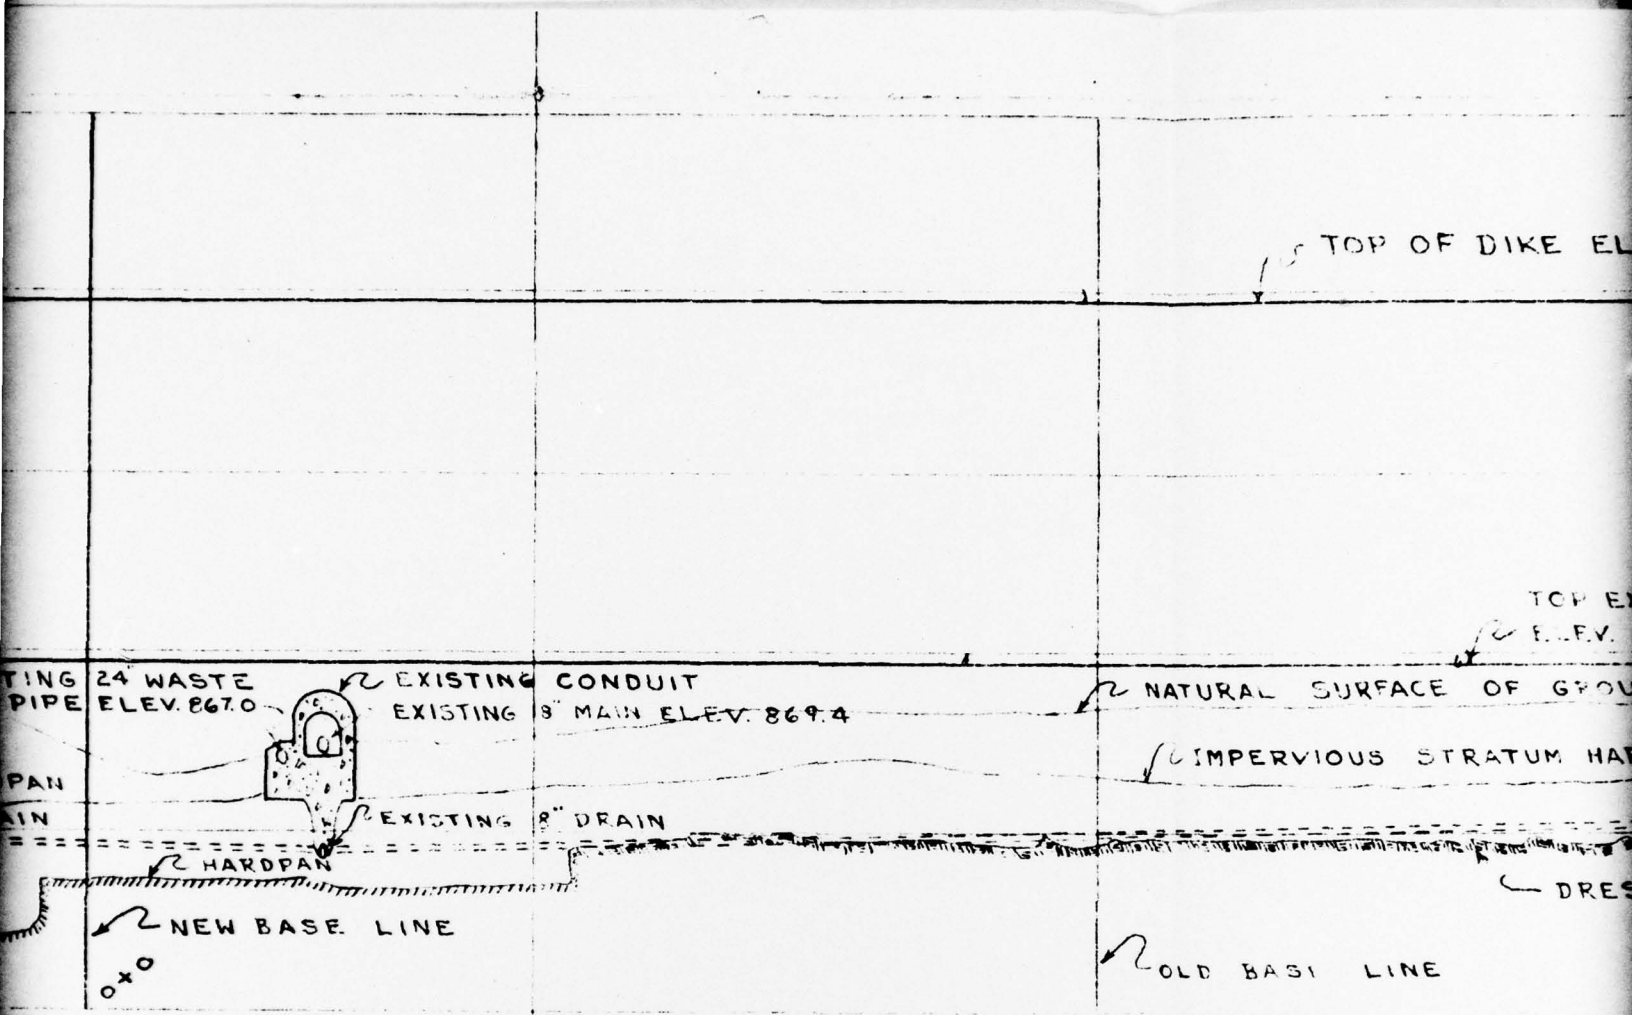
LONGITUDINAL SECTION THRU COREWALL  
 SCALE 1" = 20'

One drawing included with the contract drawings is a detail of the foundation conditions of the core wall constructed in 1912-15. This drawing indicates a portion of the corewall was constructed on "hardpan", since rock was evidently at a grade too low to reach.

However, not all of the core wall was founded in bedrock. The central area, identified as "hardpan" on the drawing, is on unknown and could be a point of weakness. Also, the east abutment of the core wall may have been founded in overburden, or at least, in partially disintegrated bedrock. If leakage is ever detected at either place, it should be carefully monitored.
