LAUREL CREEK DAM

PHASE I INSPECTION REPORT

NATIONAL DAM INSPECTION PROGRAM

Name of Dam: LAUREL CREEK DAM
State & State Number: PENNSYLVANIA - 44-62
County Located: MIFFLIN
Stream: LAUREL CREEK, SUSQUEHANNA
Date of Inspection: May 12, 1978

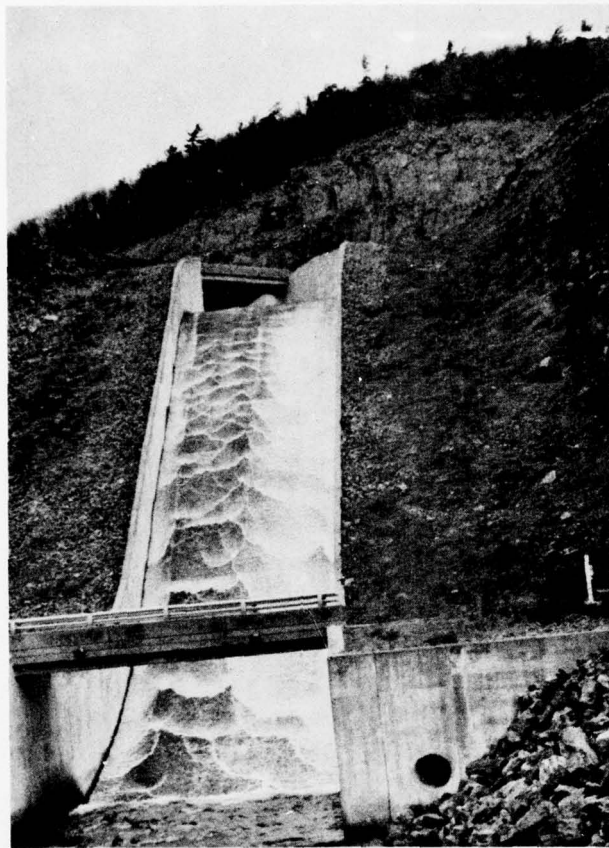
Spillway

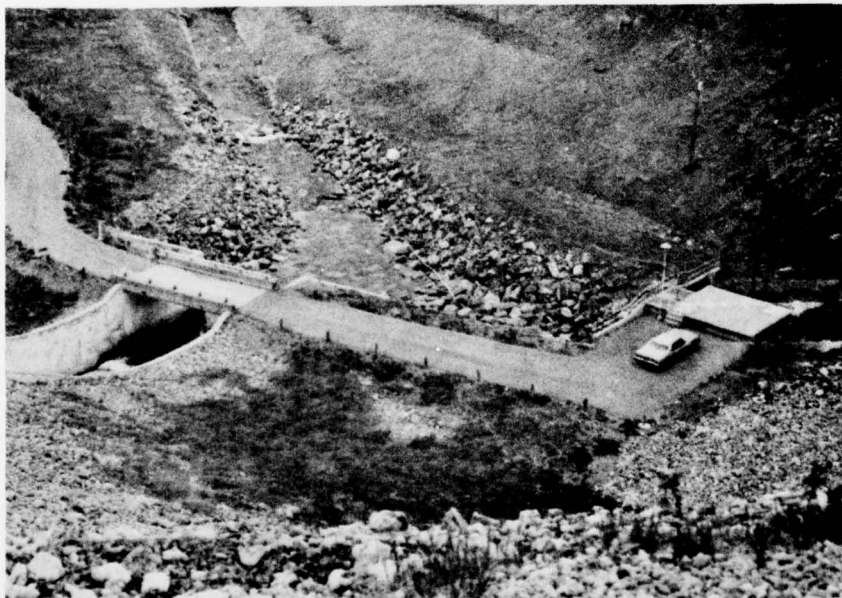
The downstream channel below the deflector bucket is well defined. The slopes are stable and protected with riprap. The creek flows past the treatment plant and under Route 322 through a large culvert. The Borough of Milroy is located approximately 2.3 miles downstream from the dam. Many houses and trailers in this community are located close to the stream. A failure of the dam would cause considerable loss of life and property and therefore, this dam is considered to be in the "High" Hazard Classification.

Downstream
Channel

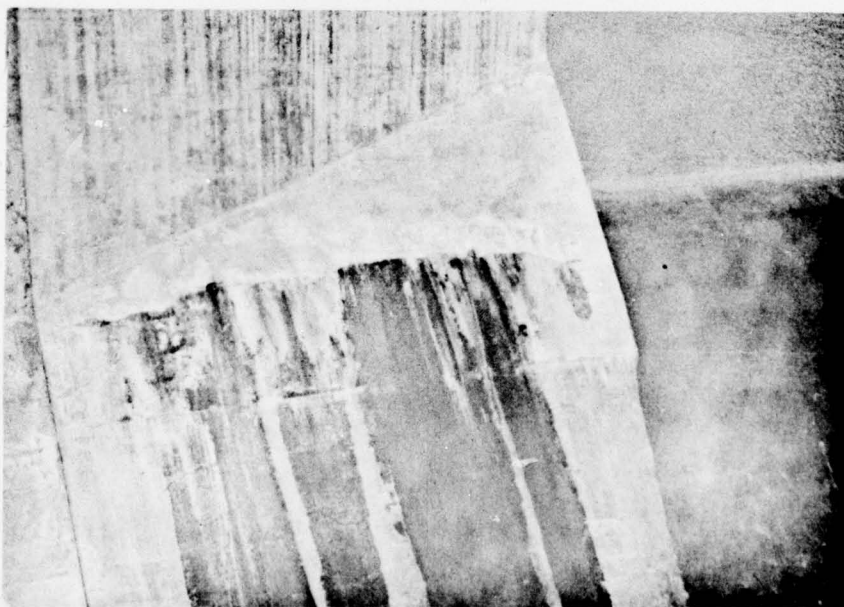
All appurtenant structures were in good condition. Besides some shrinkage cracking, a crack was noticed near the entrance of the spillway (Appendix D, Plate V). The manager stated that this crack will be pressure grouted during the summer (1978), when the pool level falls 3 or 4 feet below spillway crest. The cause of the crack could not be determined. Water over the spillway has not been high enough to cause any stresses in this wall. It could have been a cold joint with poor workmanship after the pour started.

Cracked Wall
At Spillway

1. The owner should install an outside staff gage on the control tower.
2. The owner should repair the crack in the wall near the spillway.

Indications are from representative of owner that when the reservoir gets below spillway level and the crack level repairs are going to be made. (7' to 8' normal drop below spillway during summer) has been as much as 14' below.
