Montgomery Dam (NDS 427), Susquehanna
River Basin, Clearfield County,
Commonwealth of Pennsylvania. Phase I
Inspection Report.

PHASE I REPORT
NATIONAL DAM INSPECTION PROGRAM

Name of Dam: Montgomery Dam
State and State No. Pennsylvania, 17-L04
County Located: Clearfield
Stream: Montgomery Creek
Date of Inspection: May 11, 1978

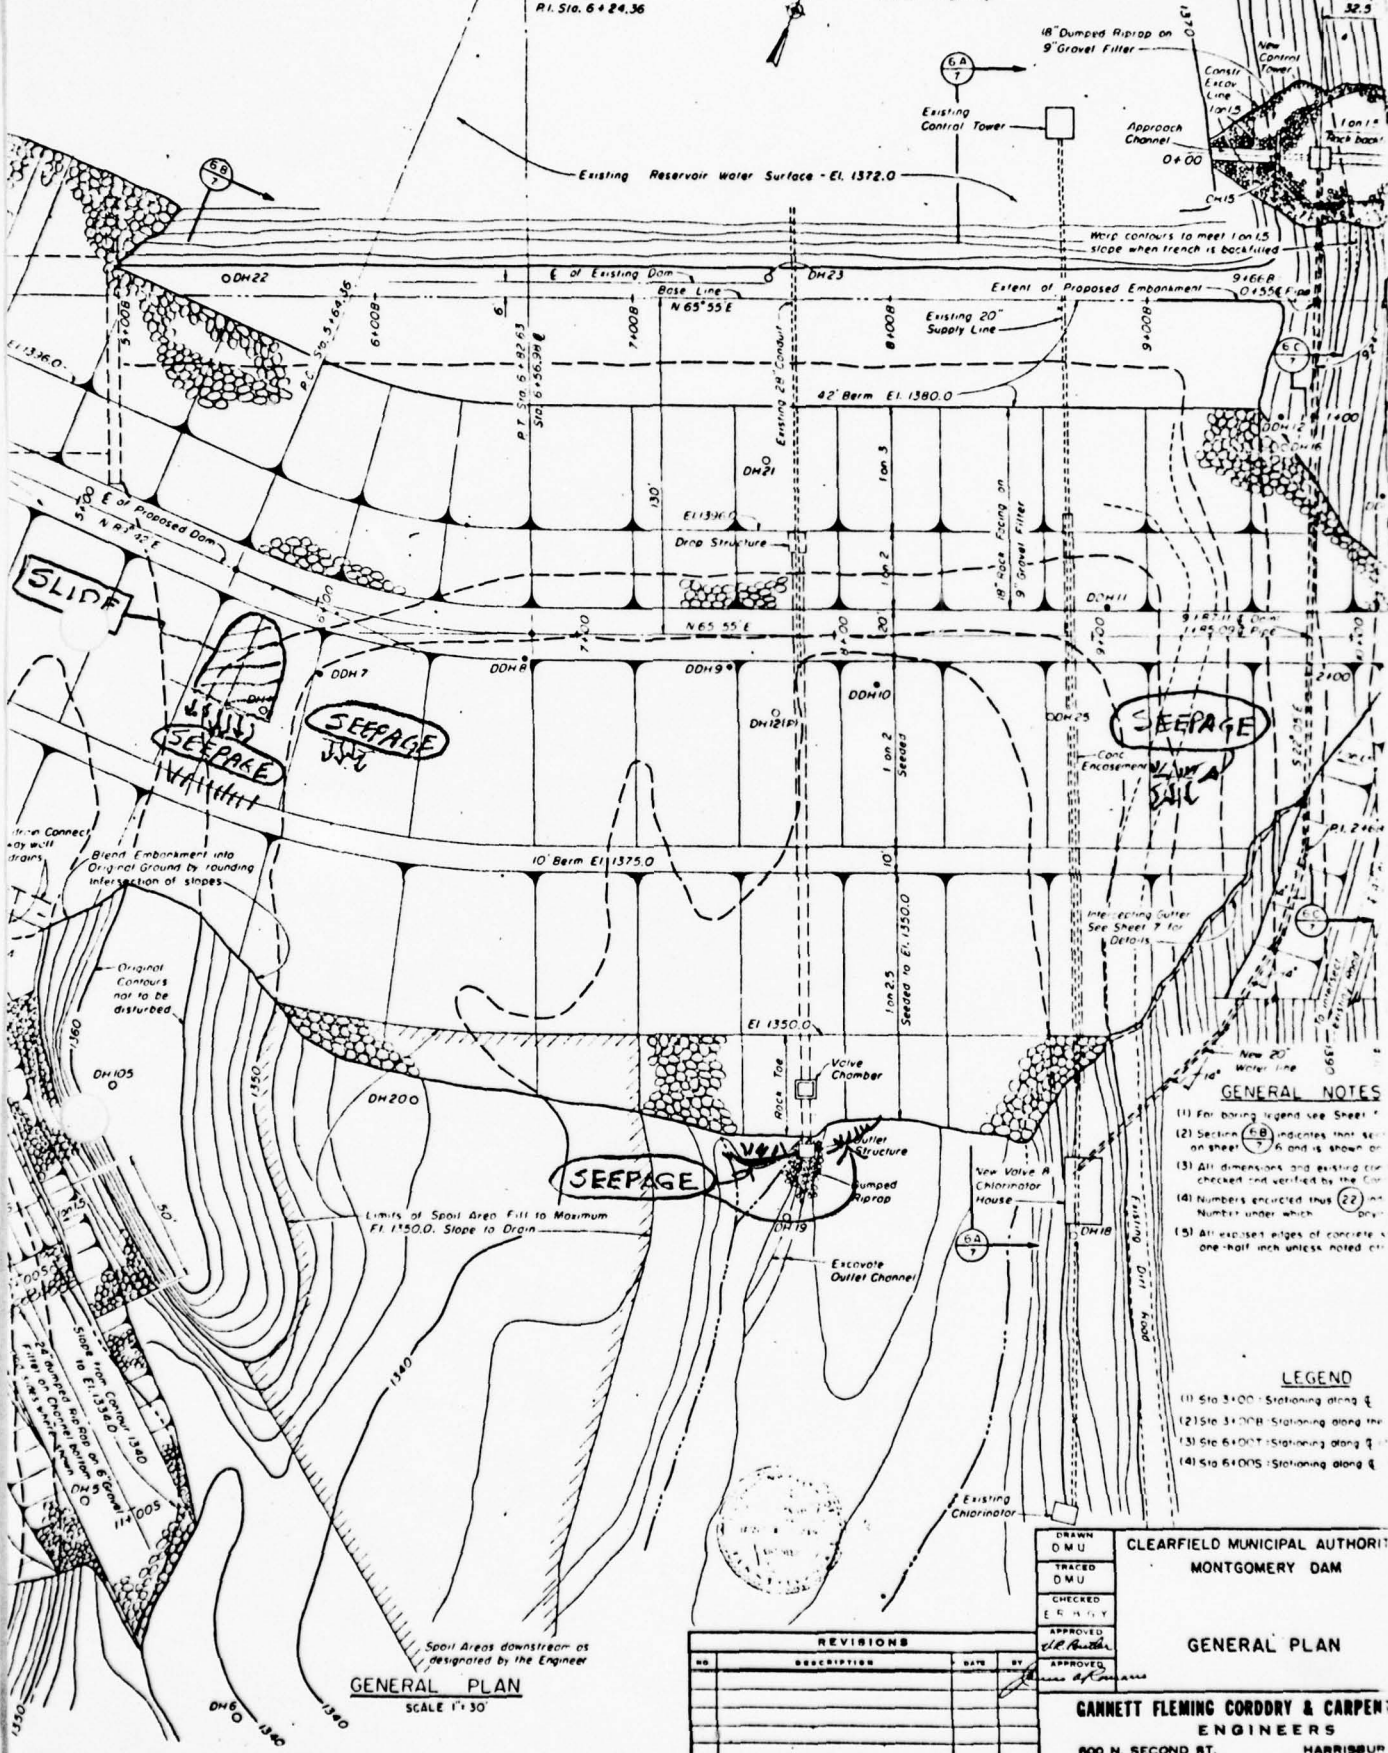
SLIDE

SEEPAGE

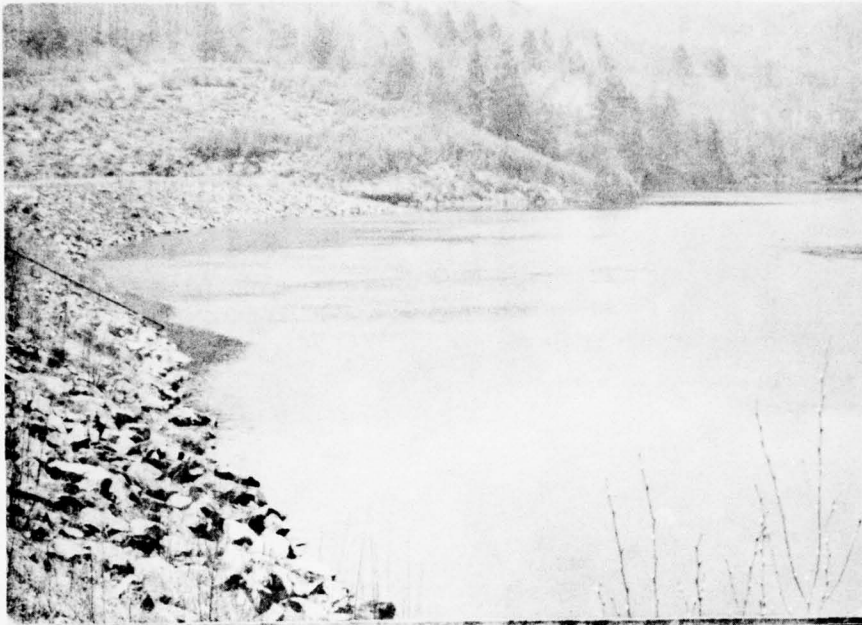
Upstream Slope

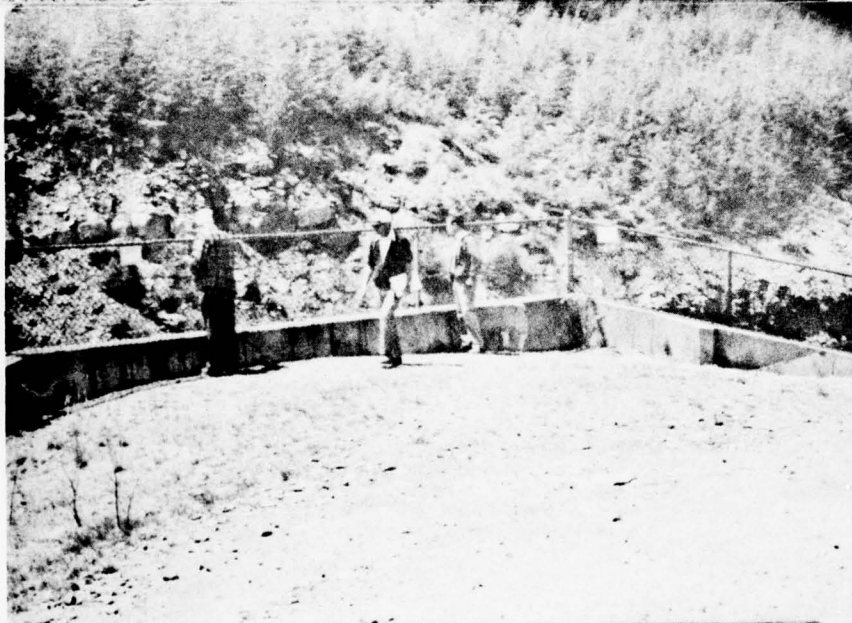
The top of the dam is cambered. Drawings indicate a low point on the breast of the embankment at Elev. 1411.0 or 6 inches below the spillway wall. As can be seen on the photograph Plate III, Appendix D, the dam breast is actually about 16 inches below the wall or at Elev. 1410.2. This low condition near the spillway is about 50 feet long and could have serious results if the lake would ever reach that level. The calculated discharge is 14,300 cfs for a pool elevation of 1411, but only 13,100 cfs for a pool elevation of 1410.2.

The visually observed low point in the embankment adjacent to the spillway could, however, seriously affect the capacity of retaining a high inflow without endangering the facilities.

Low Breast
At Spillway

4. The owner should correct the seepage condition at the end of the left spillway wall possibly by installing a drain and protecting the slope with riprap of sufficient size to control erosion.
5. The owner should raise the embankment adjacent to the spillway and should be aware that further erosion of the rock surface in the forebay area could become a hazard.

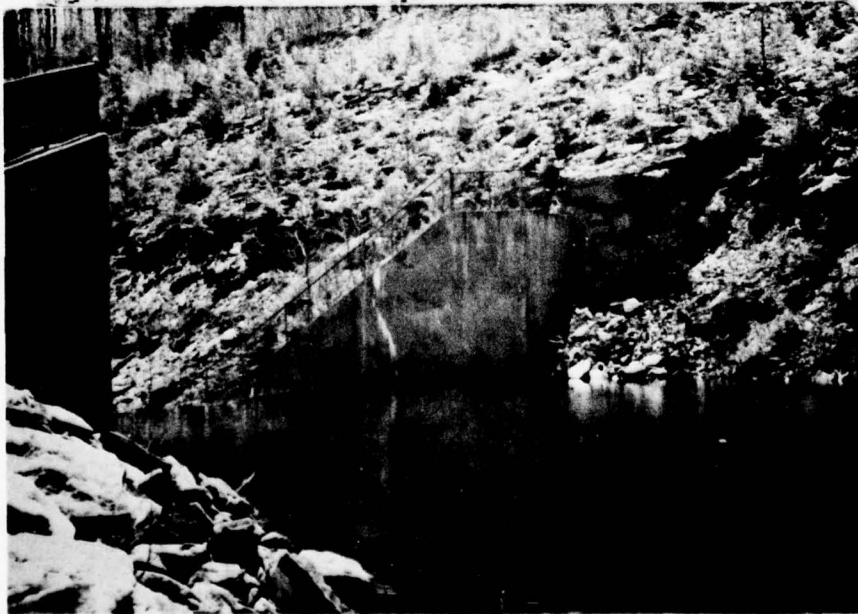
The rock at the right side of the approach channel is disintegrating and this could cause a dangerous situation in the future (Plate III, Appendix D).

Forebay

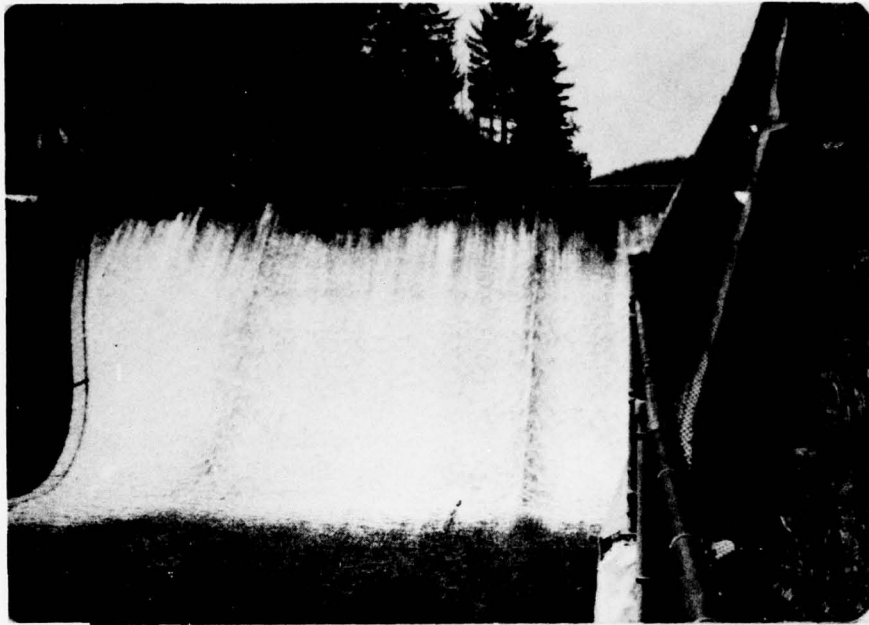
Spillway
Weir

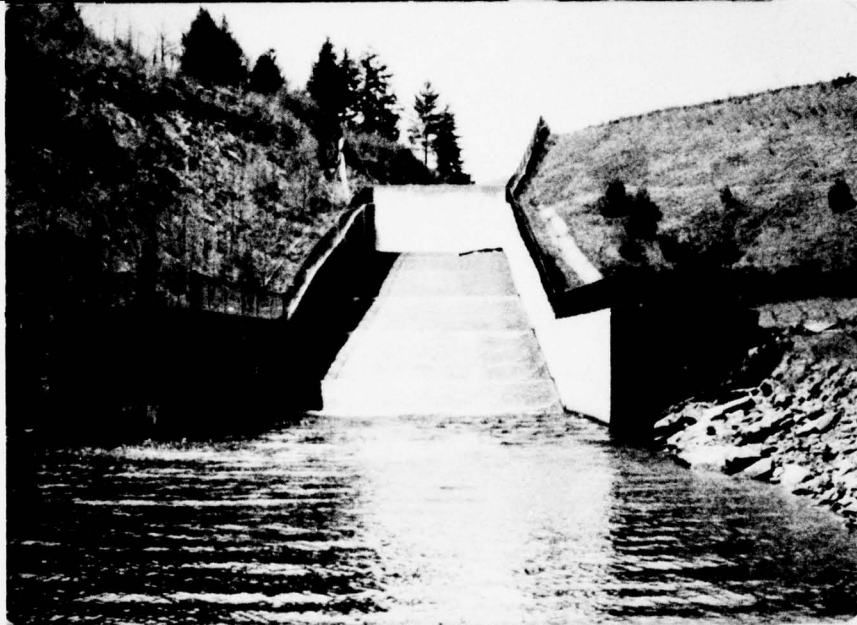
Spillway

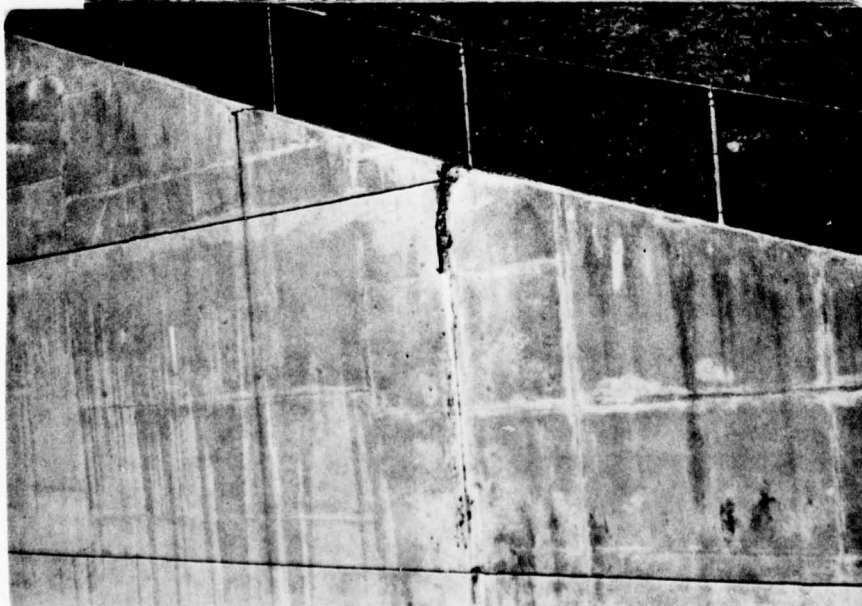
The appurtenant structures appear to be in good condition. The spillway had some cracking and spalling, mostly caused by shrinkage and temperature changes. The joint between the chute slab and walls should be inspected when pool level falls below spillway crest. This joint probably will require some grouting and sealing. The valves are operated at least once a year.

Spalling
Spillway Wall

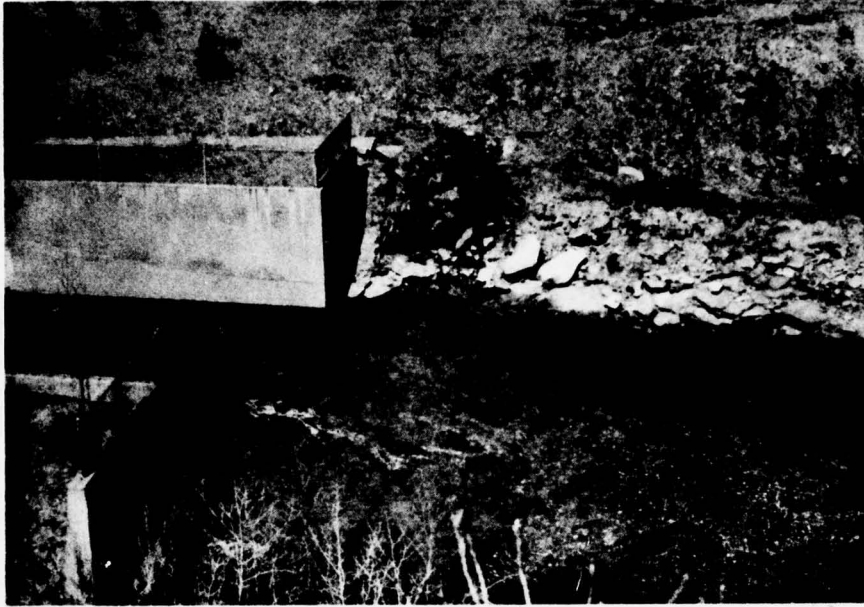
Erosion
Stilling Basin

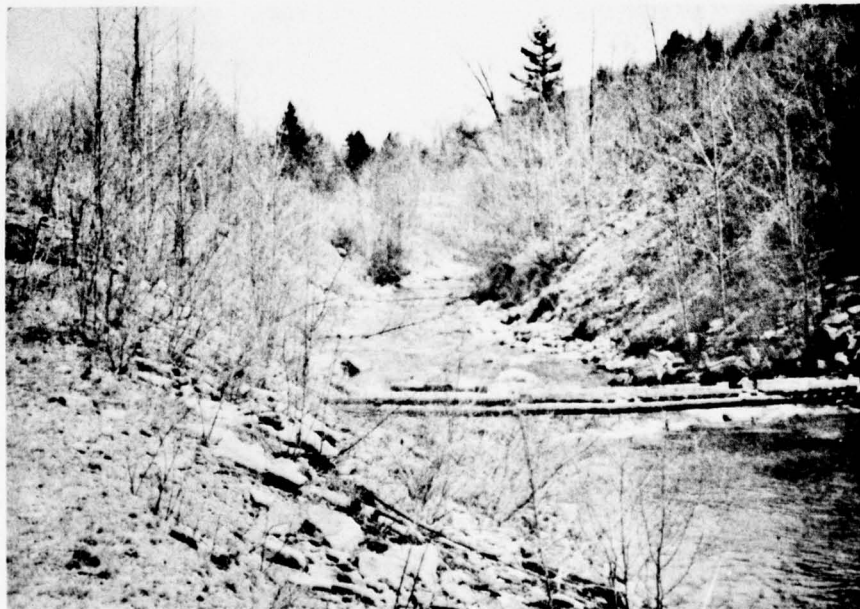
PLATE V

The immediate downstream channel appears to be clean and clear of obstructions (except a temporary wooden footbridge). See Appendix D, Plate V. A few log cabins and a camp are located about one mile downstream and close to the stream. The community of Hyde, Pennsylvania, is about three miles downstream and has several hundred homes and trailers. The area is very flat and a considerable loss of life and property could occur if the dam would fail. The hazard category for this dam is considered to be "High".

Downstream
Channel

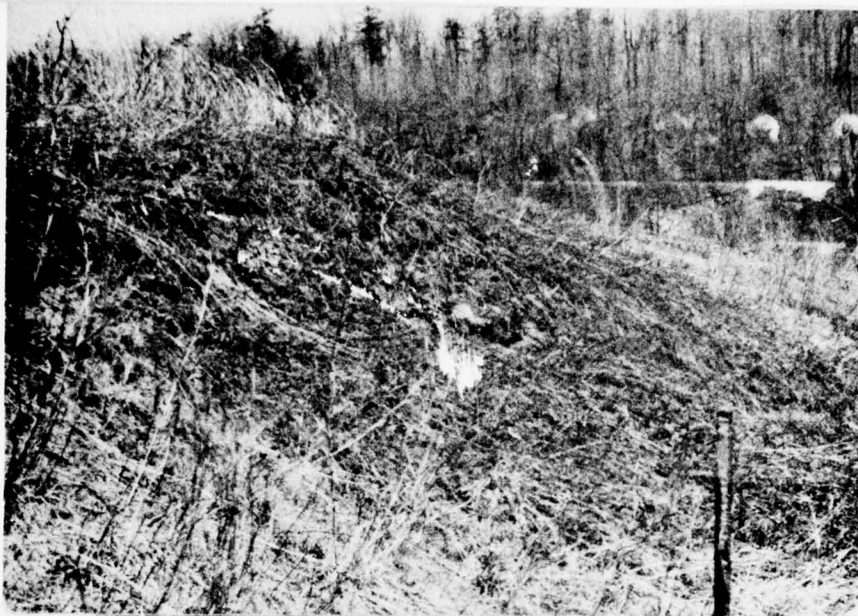
The upstream and downstream slopes have some growth of small brush, which should be controlled. The inspection observed a slide scar on the downstream slope approximately 265 feet east of the east spillway wall, with the head scarp about 28 feet from the centerline of the top of the embankment. The slide appears to be shallow in nature with a 2 foot± drop at the head and a toe of typical heave about 43 feet down slope. A parabolic curve with the peak at the head of the slide scar and a horizontal distance of 50 feet± at the toe of the slide area would approximate the plan view shape of the distressed area. Seepage was noted as emerging from the slope at the toe of the slide. This seepage is reflected at a wet spot on the berm directly below the slide. Two other isolated seepage areas were also noted on the embankment slope and are located approximately on the sketches accompanying the visual checklist in Appendix A. Additional persistent seepage was observed in the area surrounding the outlet structure just below the valve chamber. This area is also noted on the plan in Appendix A.

Of particular concern is the slide observed in the embankment as described in Paragraph 3.1.b. In the event of a high pool level a continuing of this existing slide would likely occur with the possibility of deeper, progressive slides occurring at this location which would present a hazardous condition. Also of concern are the two other areas of seepage at about the same elevation of the dam as shown in Appendix A. Under a higher pool level there is a possibility of a slide occurring at these locations. The reason for the seepage occurring at this level of the dam is not known but could be due to the upper portion of the embankment being constructed of the more pervious, cohesionless fill (sandy silt). Although there is no supporting evidence, inadequate construction procedures could have resulted in the fill having a less than the desired density. Of lesser concern is the seepage at the toe of the dam near the valve chamber and wet area between the spillway wall and natural ridge. However, both conditions could worsen with time, as could the condition of loose rock that has fallen into the spillway channel.

Slide
Downstream Slope

1. The owner should investigate the cause of the slide and seepage on the downstream embankment slope and make necessary improvements.
2. The owner should investigate the cause and seriousness of seepage at other locations on the embankment and take necessary action to improve the condition.
3. The owner should investigate means for improving the toe drain near the valve chamber and outlet structure and implement improvements as necessary.

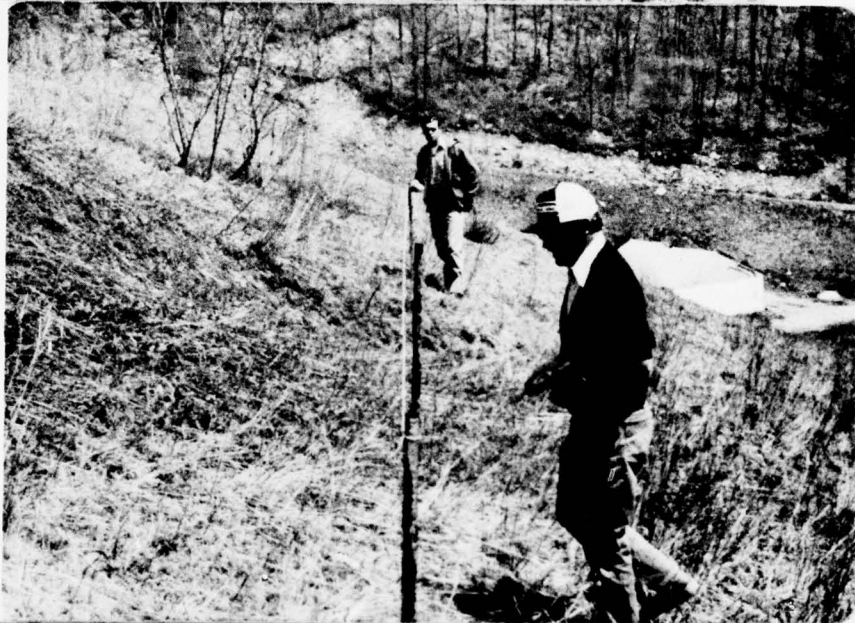
alignment between the stakes. Because of the passage of time since the stakes were installed, they are loose and are not considered reliable references for evaluating the actual behavior of the slide area.

Stakes In
Slide

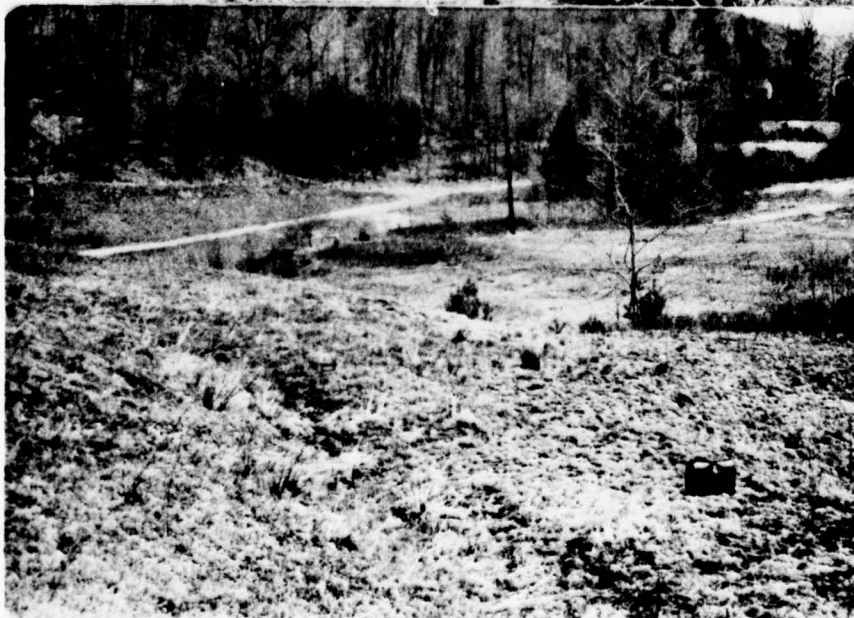
Wet Berm
