Green Lick Dam (NDI PA-219), Ohio River
Basin, Green Lick Run, Fayette County,
Pennsylvania. Phase I Inspection Report.

PHASE I REPORT

Green Lick Dam

27 April 1978 (visual inspection)

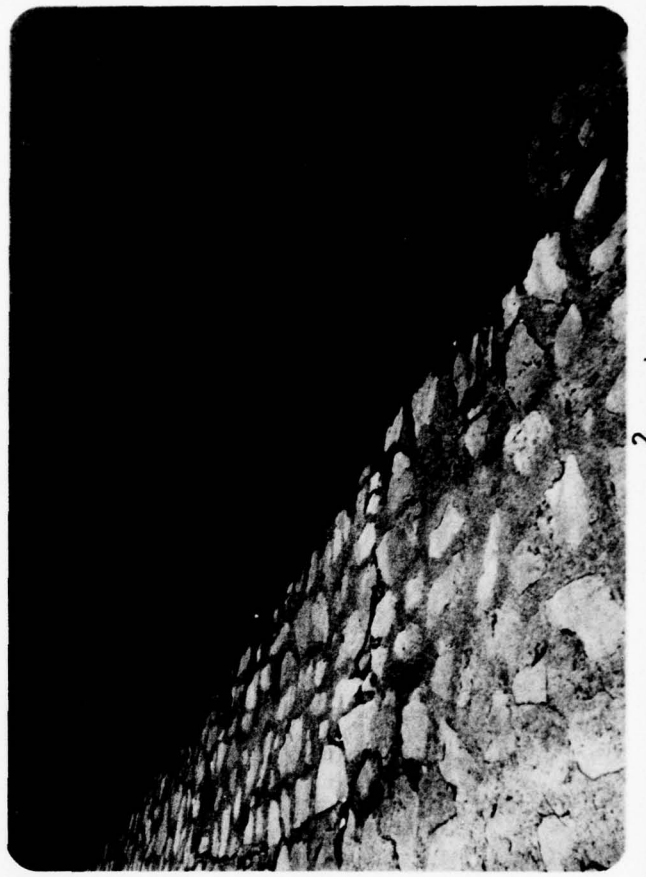
The upstream surface has been covered with a mortared masonry face and cutoff wall, probably to reduce seepage through the embankment. Field inspection, however, showed the surface to contain at least one longitudinal crack two to three feet above the present water level and a regular pattern of vertical cracks spaced at 25 to 35-foot centers across the face. Thus, the facing is ineffective as a seepage barrier.

PHOTOGRAPH 2 Close-up view of the upstream face of Green
Lick Dam. Note the masonry construction.

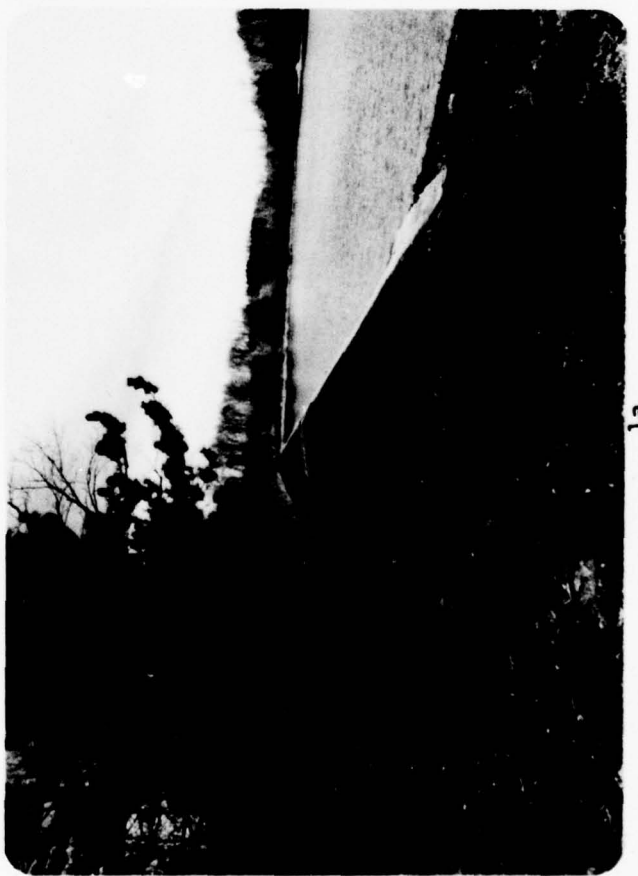
PHOTOGRAPHS 1, View looking across the top of the Green
1a Lick Dam embankment as it appeared in 1926
(1) and as it appears today (1a). The
upstream portion of the embankment is covered
with a masonry face which extends below the
water level.

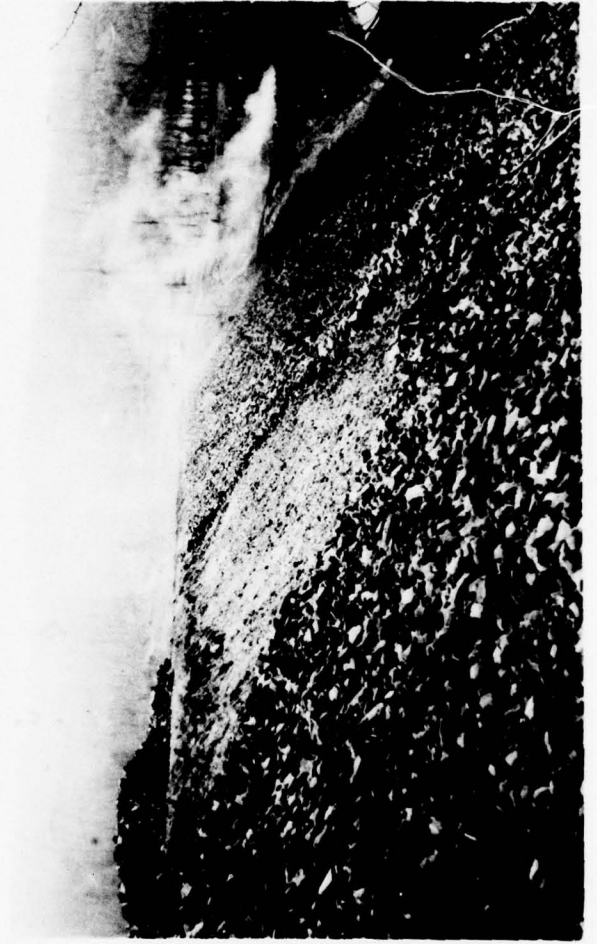
PHOTOGRAPHS 3, View looking across the downstream face of
3a the Green Lick Dam from the right abutment.
The gate house can be seen at the bottom of
the embankment. Photograph 3a is a similar
view of the embankment taken in 1920, showing
sloughing of the riprap face.

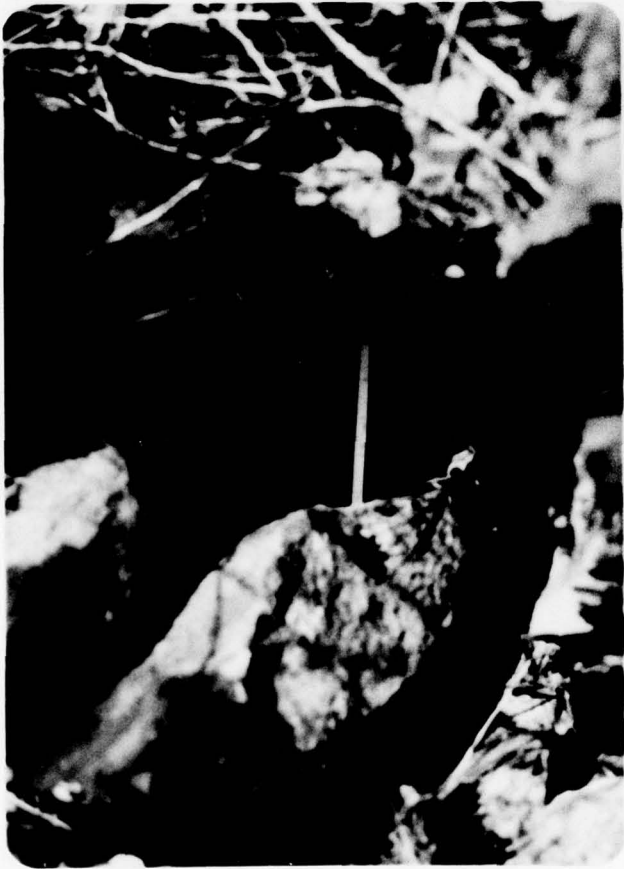
PHOTOGRAPH 6 Close-up view of another cavity in the downstream face of the Green Lick Dam embankment. We estimated the flow to be between five and ten gallons per minute at this point.

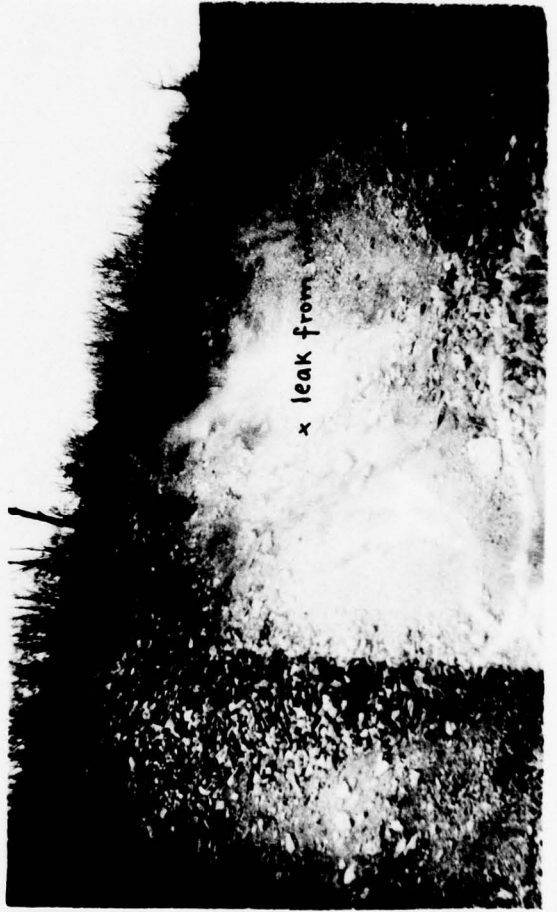
PHOTOGRAPHS 7, View of a large area of seepage on the right abutment of the Green Lick embankment. At the time of inspection, the seepage at this point was estimated to be between five and ten gallons per minute. The spillway is immediately behind this area of seepage. Photograph 7a shows seepage issuing from the same area as it appeared in 1914.

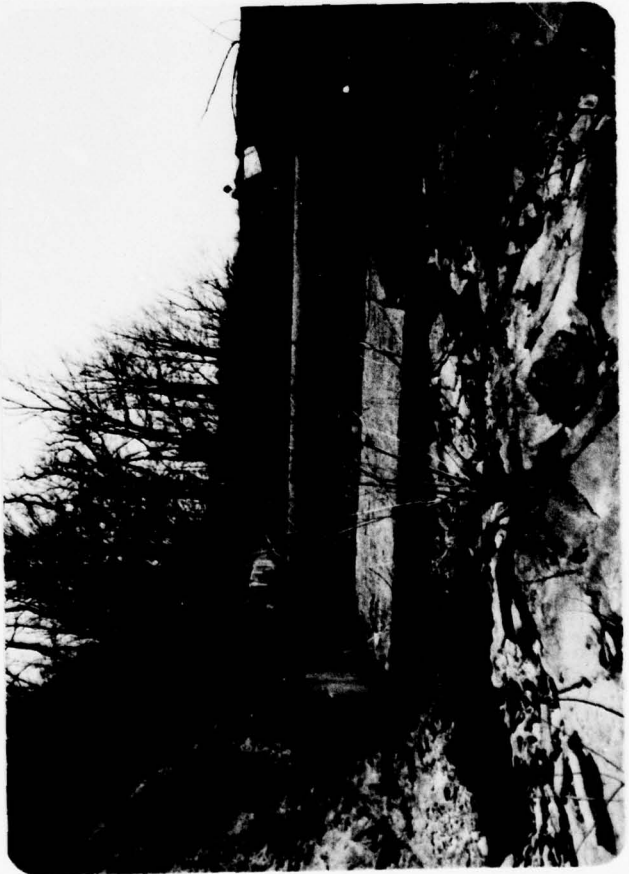
PHOTOGRAPH 9 View looking upstream at the Green Lick Dam
spillway taken from the natural rock channel
located immediately downstream of the spill-
way.

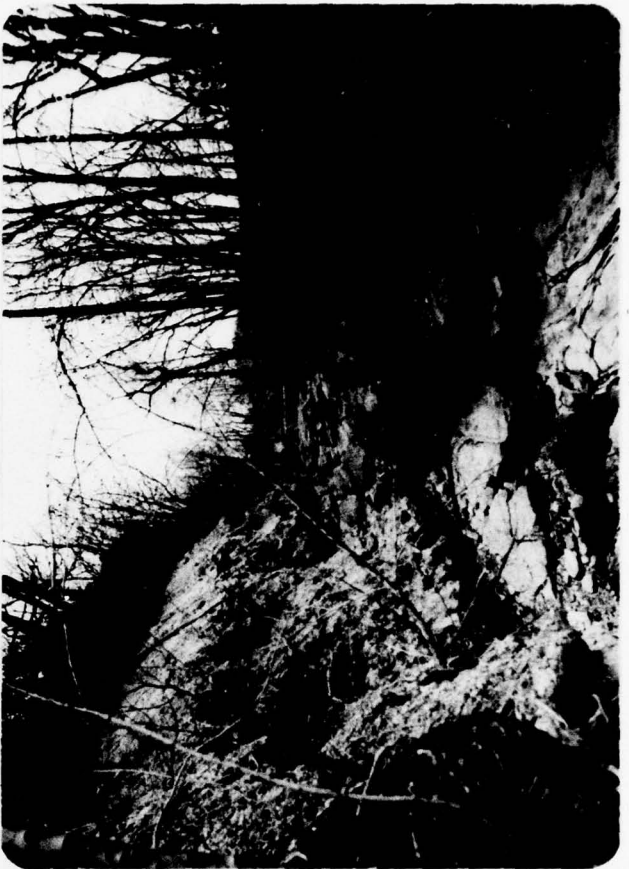
PHOTOGRAPH 10 View looking upstream from the natural rock
channel. The concrete portion of the spillway
can be seen in the background of the photo-
graph.

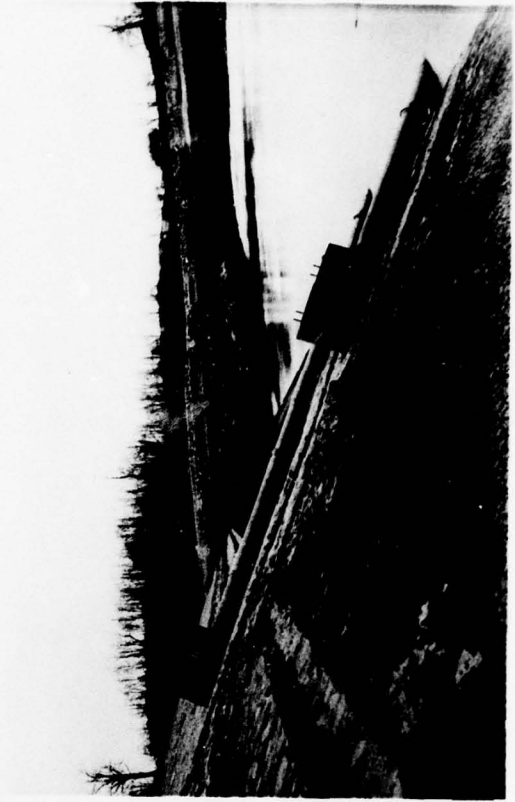
PHOTOGRAPH 13 View of the inlet ends of the 20-inch (foreground) and 16-inch (background) supply pipes as they appeared in 1926. Note the vertical steel trash racks on the inlet boxes.

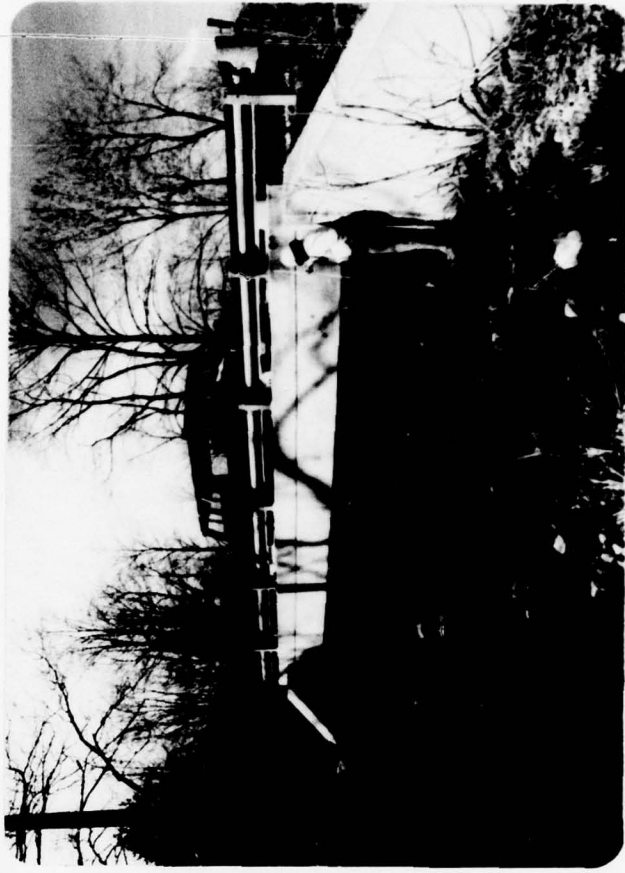
PHOTOGRAPH 17 View of a bridge over Latta Creek located approximately 3,000 feet downstream of the dam.

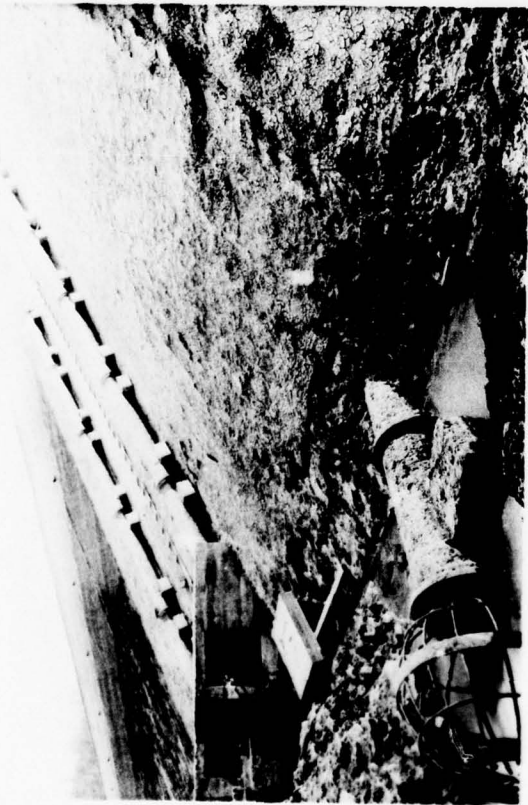
PHOTOGRAPH 14 View of the inlet end of the 24-inch blow-off pipe as it appeared in 1926.
