TWO MILE RUN DAM
NDI No. Pa. - 254

⑥
**PHASE I INSPECTION REPORT
NATIONAL DAM INSPECTION PROGRAM.**

Two Mile Run Dam (NDI PA-254), Ohio River Basin, Two Mile Run, Venango County, Pennsylvania. Phase I Inspection Report.

PREPARED BY
GAI CONSULTANTS, INC.
570 BEATTY ROAD
MONROEVILLE, PENNSYLVANIA 15146

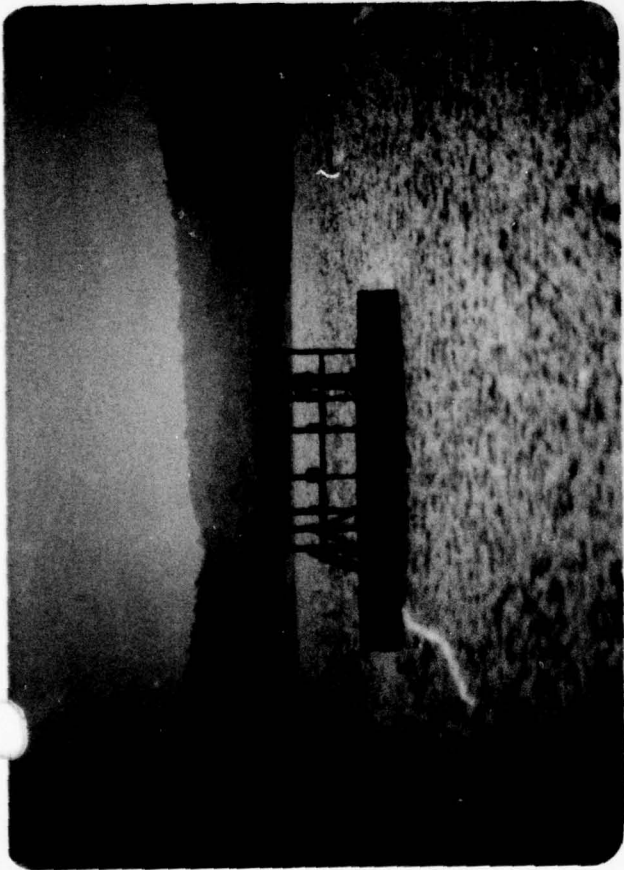
- PHOTOGRAPH 5 Telephoto View of the outlet structure at Two Mile Run Dam. See photo 1 for reference.
- PHOTOGRAPH 6 View of the discharge end of the outlet structure at Two Mile Run Dam. Considerable seepage was observed coming through the left outlet channel bank, shown on the right side of the photograph.
- PHOTOGRAPH 7 View of seepage discharging through the right abutment just downstream of the dam.
- PHOTOGRAPH 8 View looking downstream from the crest of the embankment showing the Two Mile Run Valley.
- a
