TAR RUN DAM
NDS ID NO. PA-00692
DER ID NO. 54-124

SCHUYLKILL COUNTY MUNICIPAL AUTHORITY

**PHASE I INSPECTION REPORT
NATIONAL DAM INSPECTION PROGRAM**

AUGUST 1978

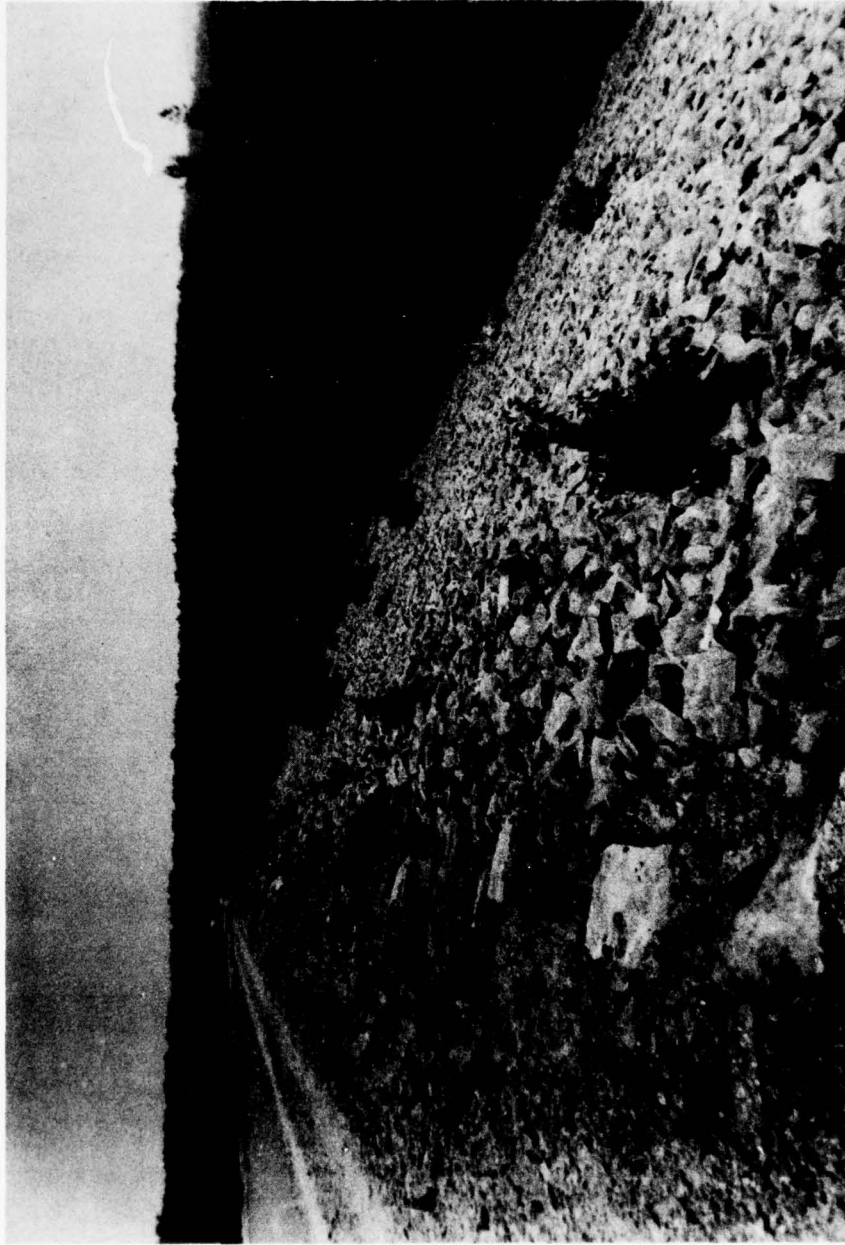
Downstream Slope of Embankment from Spillway.

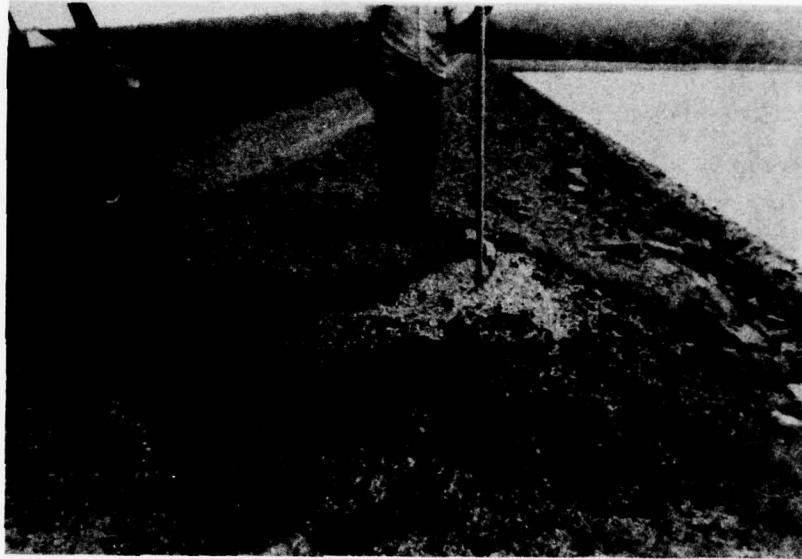
The concrete at the top of the control structure is severely deteriorated. It crumbled at the slightest touch. The reinforcing was completely exposed. Apparently an attempt had been made to protect this concrete. Asphalt covered most of the top of this structure (Photograph C). The asphalt covered the edges of the manhole cover and the cover could not be removed. Operation of the 20-inch diameter valve in the control structure was, therefore, not observed. Apparently, the 20-inch valve is used as an upstream closure facility.

The conditions observed at the top of the control structure are of some concern. The asphalt does not allow the manhole cover to be removed, thereby making the 20-inch valve inaccessible. The reason for the concrete deterioration is unknown. It could have been caused by a poor concrete mix. There is concern for the condition of the concrete in the entire structure.

C. Top of Control Structure
Upstream of Core Wall.

(3) Remove the asphalt from the top of the control structure and inspect the structure for evidence of concrete deterioration. Ensure that the 20-inch valve in the control structure is operational.

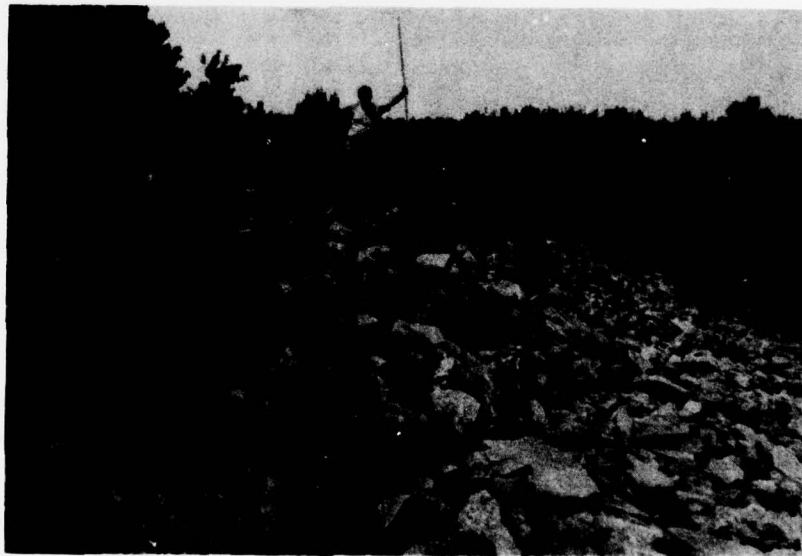
The riprap on the downstream slope is very loose with many uneven areas. It slid underfoot when an inspector walked on it. The uneven areas appear to be slides.

The bulges on the riprap on the downstream slope were thought to be surface sliding of the loose riprap, with no sliding of the embankment beneath. The sliding could, however, be an indication of more serious problems.

D. Riprap on Downstream Slope of Embankment.

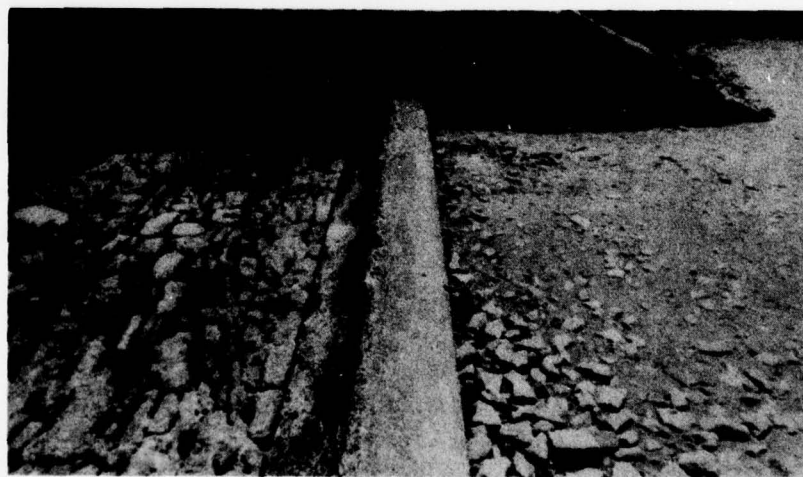
c. Appurtenant Structures. The spillway weir has a crest length of 40 feet, and it was apparently constructed as a single monolith (Photographs E and F). Four shrinkage cracks extend through the weir. The upstream side of the weir, near the crest, has spalled to a depth of 2 inches. The downstream side of the weir has spalled to a greater extent, one area being spalled along a 12-foot length to a depth of 4 inches. In the spillway approach walls, the mortar is completely deteriorated below spillway crest level. The mortar is also deteriorated where the weir joins the walls.

b. Appurtenant Structures. The shrinkage cracks in the spillway weir were probably caused by the excessive monolith length. The spalling is probably caused by exposure to flowing water or honeycombing of the concrete during construction. Neither of these conditions are sufficiently serious to present an immediate hazard. The deterioration of the mortar in the approach walls was probably caused by exposure to fluctuating pool levels and freezing-thawing cycles. The deteriorated mortar may prevent the wall from acting as a watertight structure.

F. Concrete Spillway Weir and Masonry Apron.

(3) Repair spalling concrete on spillway weir.

(4) Monitor shrinkage cracking of concrete at spillway weir and surface cracking at outlet works headwall. If changes are noted, take appropriate action.

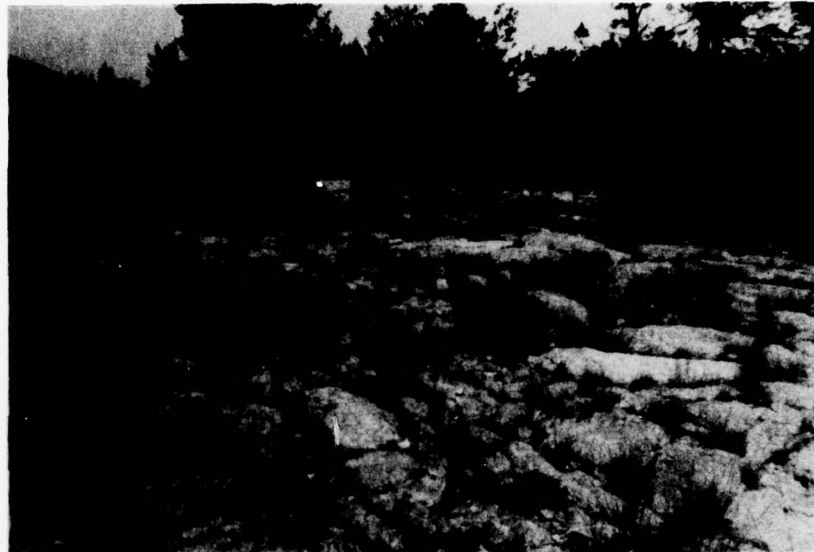
A small amount of grass is growing in the dry masonry apron downstream of the weir (Photograph H). One 3-foot square of masonry is missing. The downstream end of the apron is eroded and undermined. Downstream of the spillway training walls, the walls along the apron are 1.4-feet high (Photograph G).

The vegetation in the masonry apron is sufficiently small to be of no concern at present. The missing masonry may allow high spillway discharges to unravel the remaining masonry. The low spillway walls immediately beyond the toe of embankment are of some concern, as flow over the wall on the left would flow down the embankment, creating an erosion hazard. This condition is evaluated further in Section 5.

G. Spillway Outlet Channel Training Wall
and Masonry Apron.

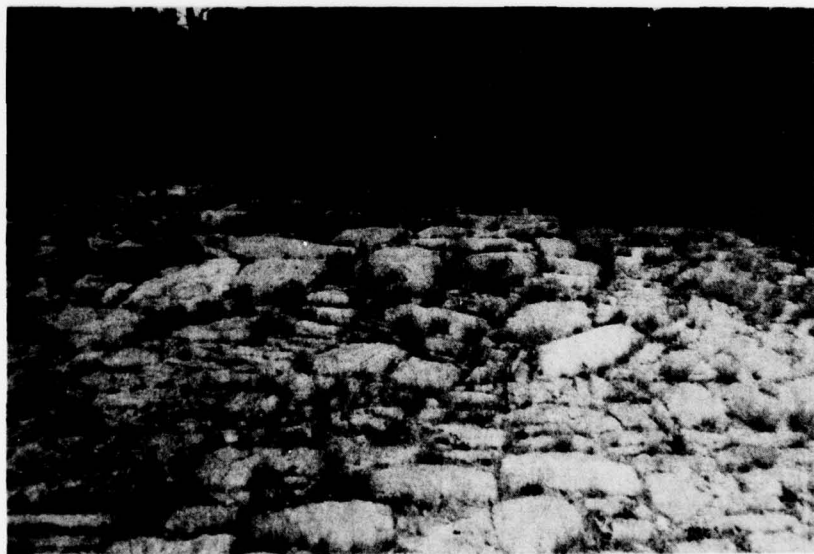
H. Spillway Outlet Channel — Looking Downstream.

(7) Replace missing stones in spillway apron.

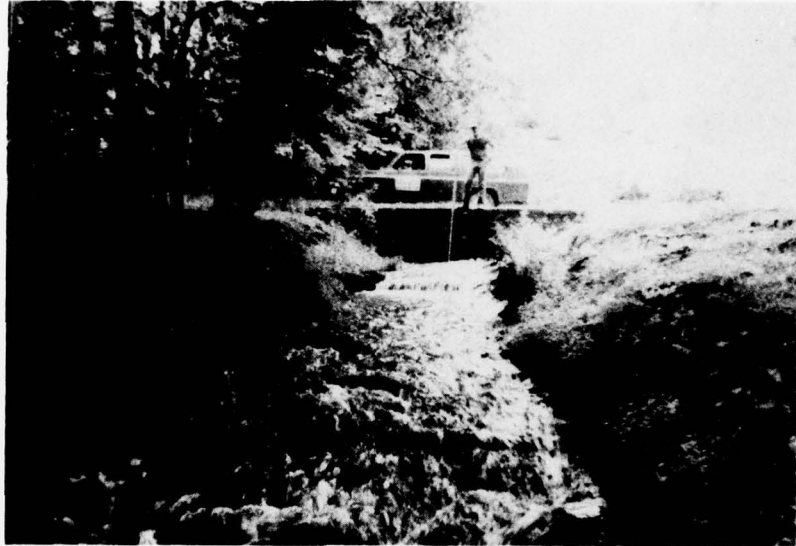
The concrete headwall had a few surface cracks. The banks of the outlet works channel downstream of the headwall and masonry apron are not well defined. The root system of trees adjacent to the channel were exposed. A large seepage area was observed 20-feet right of the outlet works channel, about 100 feet downstream from the valve house. The seepage area had clear water flowing at about 40 gpm. The seepage area appeared lower than the outlet works channel.

Cracking at the headwall is not sufficiently severe to be of concern at present. The seepage observed to the right of the outlet works channel was probably coming from the water in the channel.

K. Outlet Works Headwall and Channel.

(8) Undertake a study to determine if flows in the outlet works channel are the source of the seepage observed near the channel. If these flows are not the source of seepage, the study should be continued to determine the source and to determine what remedial measures might be necessary.

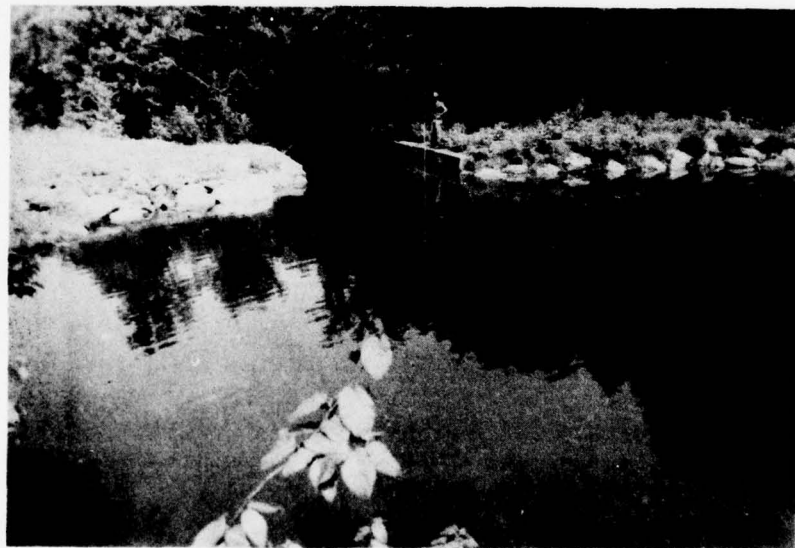
e. Downstream Conditions. Tar Run Dam is 2.8 miles northwest of St. Clair, Pennsylvania, as shown on Plate 1. Flows from Tar Run Dam proceed downstream about 0.6 mile to a small dam (Photograph L). Although part of the Owner's system,

L. Small Dam Between Tar Run Dam
and Tar Run Intake Dam.

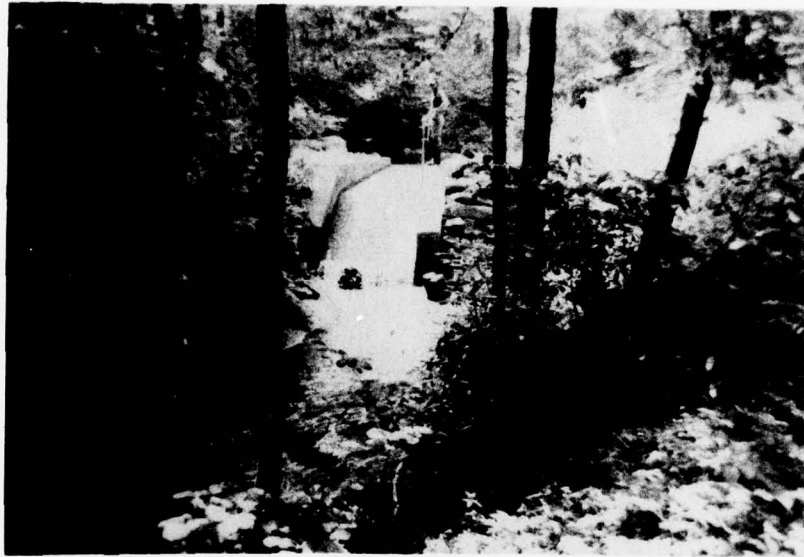
the dam is not in use at present. The water then flows 0.2 mile to Tar Run Intake Dam (Photograph M). Both these dams are sufficiently small that their failure would not add a significant amount of water to the stream. However, they would provide no significant mitigating effects to flood flows originating upstream. Tar Run then flows 0.2 mile to its confluence with Mill Creek, after passing under Pennsylvania Route 61. Mill Creek then flows 1.3 miles to its confluence with Wolf Creek. Mill Creek then proceeds downstream 1.3 miles to St. Clair. Mill Creek in the above reach generally parallels Pennsylvania Route 61 and crosses under railroad tracks a number of times. The road and railroad crossings for both Tar Run and Mill Creek are either bridges or culverts under low embankments, neither of which would provide significant mitigating effects to flood flows.

N. Tar Run Intake Dam, Downstream of
Tar Run Dam.
