NESBITT DAM

NDS ID NO. PA-00449

PHASE I INSPECTION REPORT  
NATIONAL DAM INSPECTION PROGRAM

JULY 1978

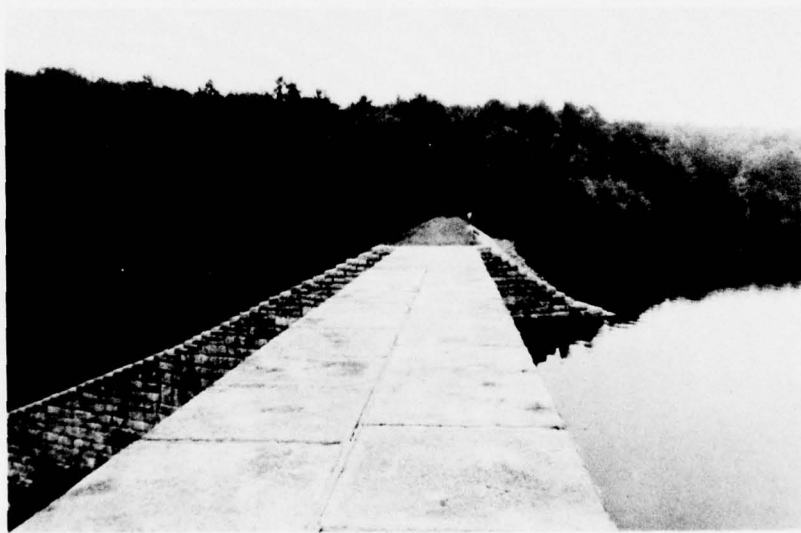
B. View Towards Right Abutment.  
Nonoverflow Section, Retaining Wall, and Embankment.

The left end of the embankment and core wall terminate at a masonry gravity retaining wall which extends both upstream and downstream of the dam axis (Photographs B and C and Plate 2). Both the upstream and downstream sections of the wall make about a 70-degree angle with the dam axis such that the upstream and downstream ends are closer to the right abutment. The tops of both sections are stepped. The back, or earthfill, face of the wall is stepped on an average of 3V on 1H. The front face of the wall has a continuous batter of 12V on 1H. The wall is founded on rock, except at its downstream end.

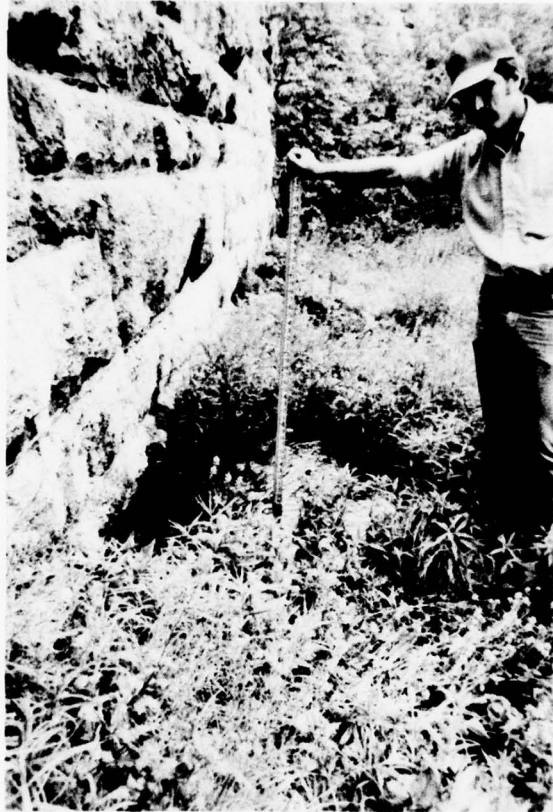
E. Wet Spot Near Downstream  
Toe of Retaining Wall

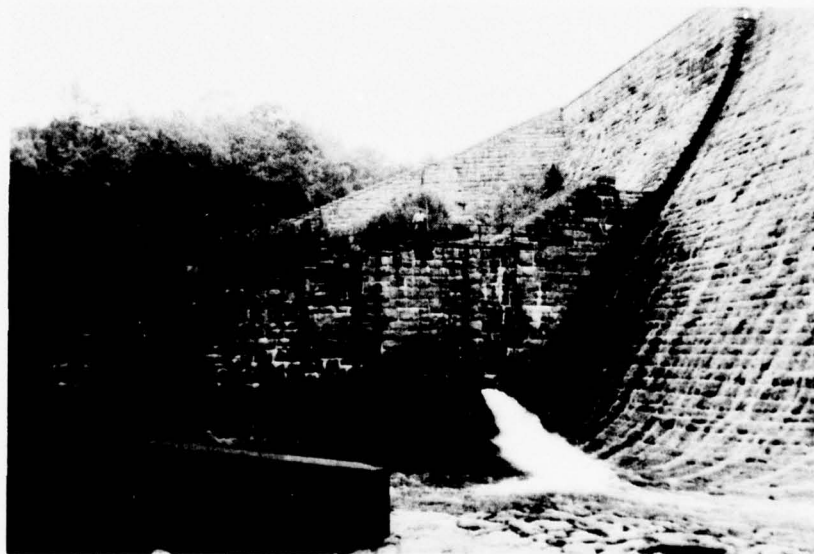
F. Spillway Training Wall  
and Outlet Pipes

(5) The spillway training wall contains the outlet works. The wall was in generally good condition. One pane of frosted glass was missing from the skylight at the outlet works control structure. The operation of the outlet works valves was observed. The 10-inch valve connected to the 14-inch diameter pipe was operated easily by two men from its partially open position to its fully open position. No problems were observed with this line except a leaking valve packing. The Owner attempted to operate the four 30-inch valves. Four valve operators equipped with lever bars attempted to turn each valve. Although some of the valve stems rotated slightly, the valves could not be opened. The Owner became concerned that, if the valves were opened, they could not be closed again. This would have seriously affected the Owner's distribution system. The caretaker could not recall the 30-inch valves being operated since they were installed in 1945.

(5) Repair leaking valve packing.

(7) Replace missing pane of glass in outlet works skylight.

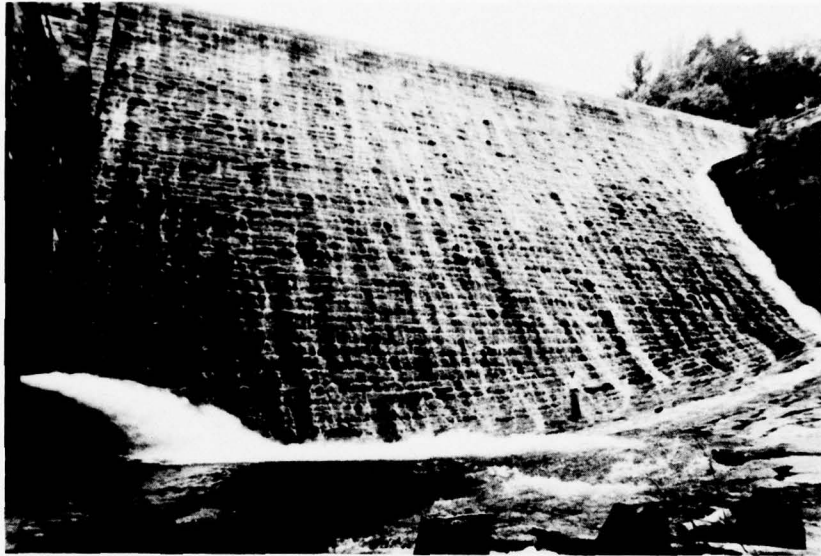
I. Downstream Face of Spillway  
and Spillway Apron

(1) The spillway was in good condition. The masonry in some of the joints near the exposed toe had eroded slightly.

(1) The eroded mortar in the spillway joints is caused by long-term exposure to flowing water. It presents no hazard at present.

(6) Visually monitor mortar for further signs of erosion. Severely eroded mortar should be repaired.

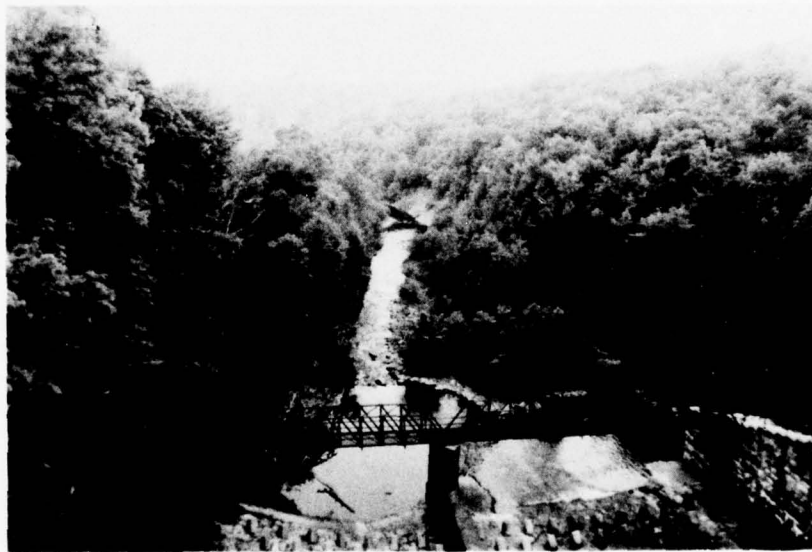
L. View of Downstream Channel  
from Spillway

f. Downstream Conditions. The right abutment hillside immediately downstream of the dam has iron pipes used as surveying monuments. These pipes are used to monitor movement in the hillside. About 100 feet downstream of the spillway apron, the channel narrows suddenly to about 30 percent of its upstream width. The right side of the channel is filled and overgrown (Photograph L). Clear seepage of about 25 gpm was observed in a swampy area 45 feet downstream of the end of the retaining wall. This swampy area was at approximately the same elevation as the wet area near the retaining wall. A small stream flowed from this area. The hillside below the swampy area was generally wet with many small seeps observed.
