WOLF CREEK DAM

NDS ID NO. PA-00664

PHASE I INSPECTION REPORT
NATIONAL DAM INSPECTION PROGRAM

AUGUST 1978

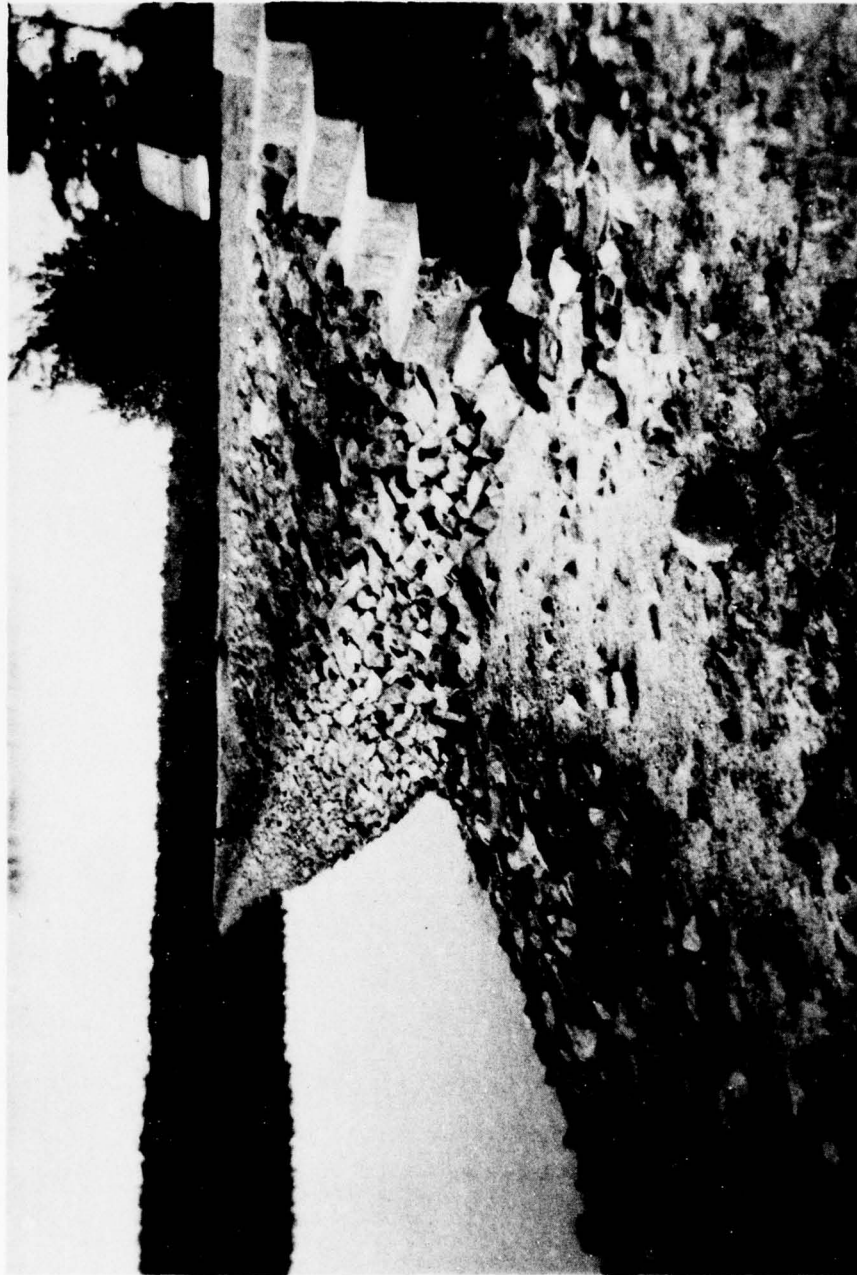
Upstream Slope of Embankment from Spillway Approach Channel

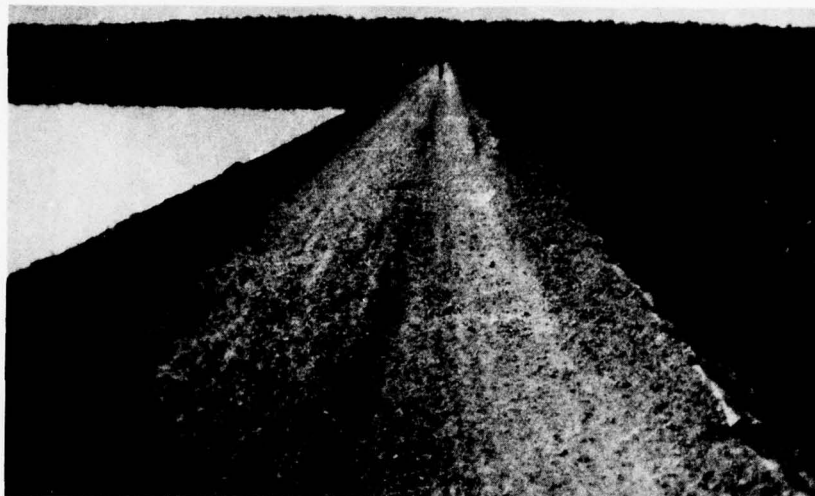
b. Embankment. As determined from a survey performed for this inspection, the entire top of dam was found to be below design top of dam elevation (Photograph A). The lowest point was 1.4 feet lower than design elevation. The material observed at the top of dam was a gravelly sand having virtually no cohesion. A significant amount of material had apparently eroded off the top, as a thin layer of material covered most of the riprap on the downstream slope and some of the riprap on the upstream slope. An erosion gully leading upstream was observed 240 feet left of the spillway. As also determined by the survey, the top of riprap elevation on the upstream slope was 1412.9, which is about 2.1 feet below existing top of dam. The top of riprap on the downstream slope was about 1.2 feet below existing top of dam. The top width of the dam varied from 10 to 14 feet, as measured for this inspection. The downstream slope was 1V on 1.5H, as determined by a survey performed for this inspection. This survey, based on one cross section, also revealed that the upstream slope above the reservoir level was 1V on 2.6H.

a. Embankment. The material observed at top of dam is readily erodable. The probability of further erosion is increased by top of riprap not being at top of dam. The decreased top width is probably caused by erosion of the material at the top. Reports of various inspections by the Commonwealth indicated that the top of dam was lower than design level. The Commonwealth inspectors believed that settlement was the cause. There may be a combination of settlement and erosion that has led to the present conditions.

A. Top of Embankment from Spillway.

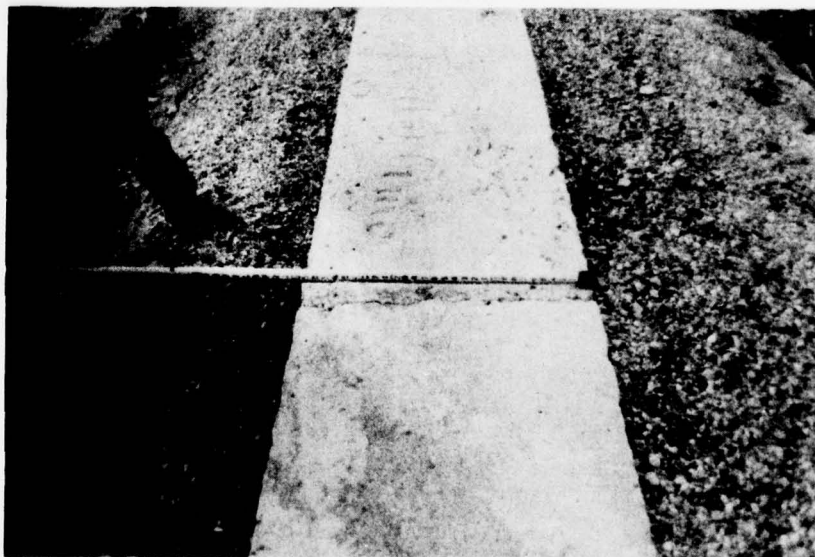
The core wall was intermittently exposed along the top of dam for a length of 450 feet between 350 and 800 feet left of the spillway. It was completely exposed for a length of 60 feet between 230 and 290 feet left of the spillway. Along this section, two cracks in the core wall were observed (Photographs B and C). One crack, 235 feet left of the spillway, was normal to the axis. The second crack, 275 feet left of the spillway, was diagonal, being angled about 60 degrees from the axis. There appeared to be a relative vertical offset of about 1/16-inch at this crack. Evidence of attempted repairs at this crack was also observed.

The cause of cracking in the core wall is unknown. The cracks may be an indication of embankment movement.

B. Crack in Exposed Section of Concrete Core Wall.

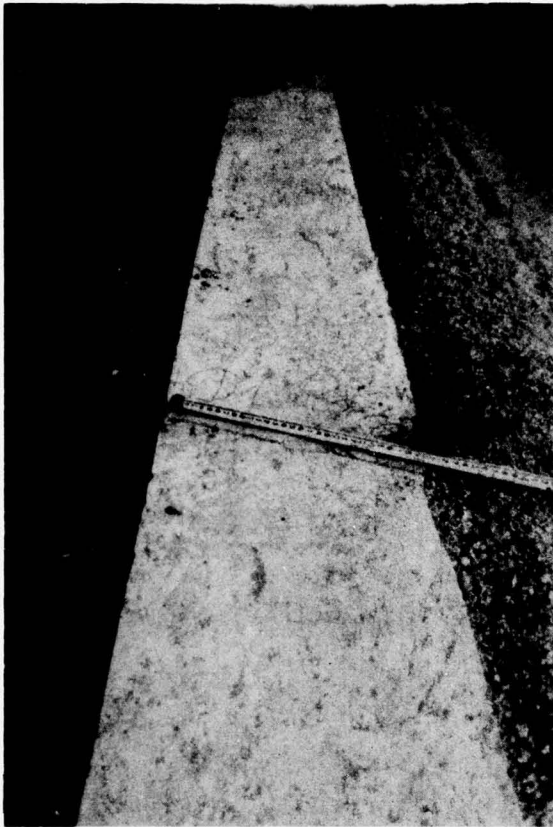
C. Crack in Exposed Section
of Concrete Core Wall.

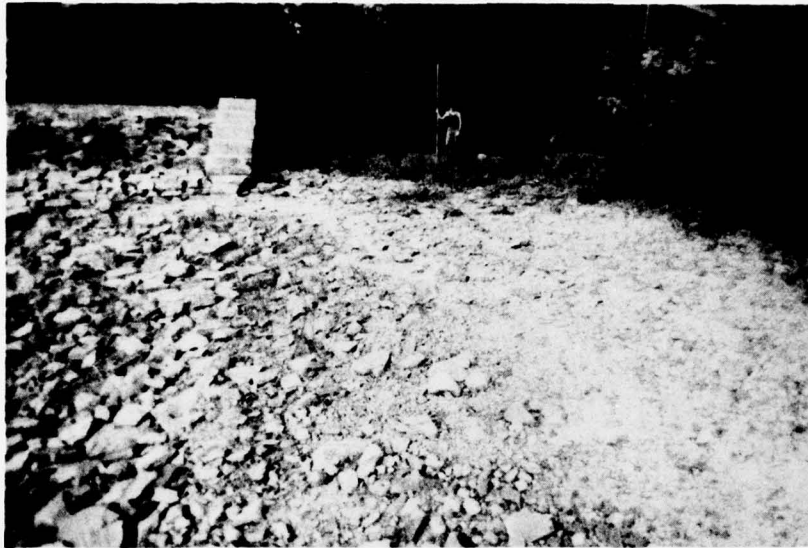
c. Appurtenant Structures. The right end of the spillway weir is indistinct where it joins the hillside (Photograph F). The right side of the approach channel has brush growing about 1 foot high (Photograph E). A survey performed for this inspection revealed that the invert elevation of the approach channel was from 0.1 to 0.7 foot higher than spillway crest elevation. Stumps up to 1.5 feet high and up to 3 inches in diameter were observed in the spillway discharge channel (Photograph H). There was some low brush growing at the left side of this channel. Where the discharge channel slope changes abruptly, to a 1V on 2H slope, severe weathering of the bedrock was observed (Photograph I). The spillway left wall has pattern cracking, especially near the upstream end. At the cracks, there was evidence of leaching, as white deposits or "efflorescence" was observed. This wall also has two larger cracks. The first crack is adjacent to the weir (Photograph G). Evidence of previous repairs was observed. The wall upstream of this crack is tilted toward the spillway. The upstream end is also slightly shifted toward the approach channel. The second crack is just downstream of the point where the wall deflects to the left. It is very fine with no apparent relative movement. The wall downstream of the crack is slightly tilted toward the spillway. Peeling was observed at the top and along the exposed toe of the wall.

E. Spillway Approach Channel — Looking Downstream.

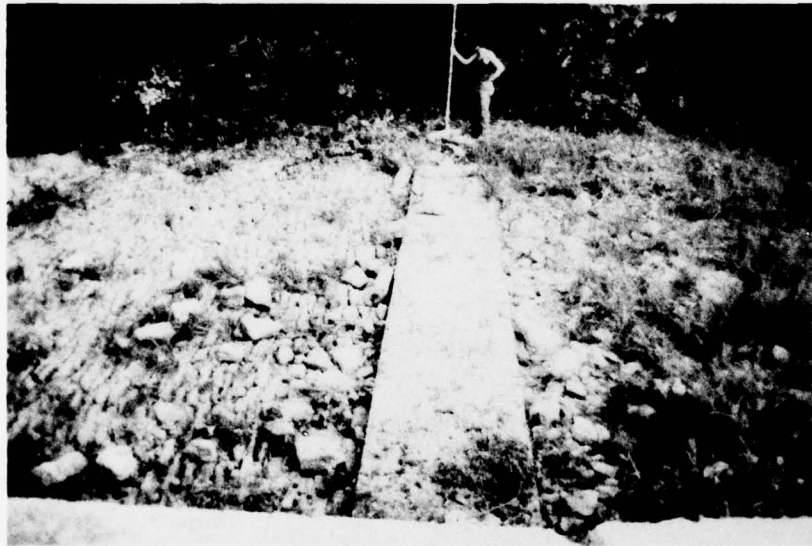
burden. The reduction in spillway crest length from 60 feet in 1918 to 35 feet on the day of inspection could be an indication that the slope on the right of the spillway may be slowly sliding toward the spillway, although no visual evidence of sliding was observed during this inspection. The conditions in the approach channel affect the hydraulics and are evaluated in Section 5. Although the growth in the discharge channel was relatively low, the size of the stumps that were observed indicate that a more frequent brush cutting schedule is warranted. The weathering of the rock in the spillway discharge channel presents no hazard at present. Further weathering may start to undermine the wall at the left of the channel.

F. Concrete Spillway Weir and Masonry Apron —
Flow from Right to Left.

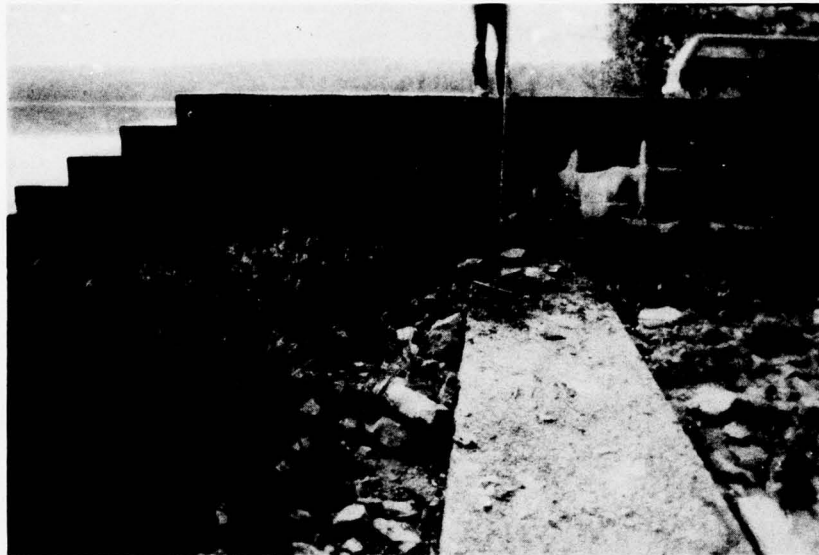
Pattern cracking is usually evidence of shrinkage on the surface of the concrete. It is usually caused by overfinishing the concrete during construction. The cracking does not appear to present a hazard at present. The crack near the spillway weir prevents the wall from acting as a watertight structure. The cause of the crack cannot be assessed with certainty because foundation conditions and structural details for this wall were not available for review. This crack was first noted in 1932 during one of the periodic inspections by the Commonwealth. The other crack observed near the point of deflection of the wall appeared similar to a shrinkage crack. If the downstream end of the wall had not been slightly tilted towards the spillway, the crack would be termed a shrinkage crack. There is a possibility that the wall was formed with the tilting section, as the form work appeared to be quite rough. The peeling observed is probably caused by long term exposure to the elements. The condition of the wall indicates that its stability is in question. It is possible that the wall would not be stable under the maximum loading condition.

G. Left Spillway Wall.

(11) Repair spillway wall.

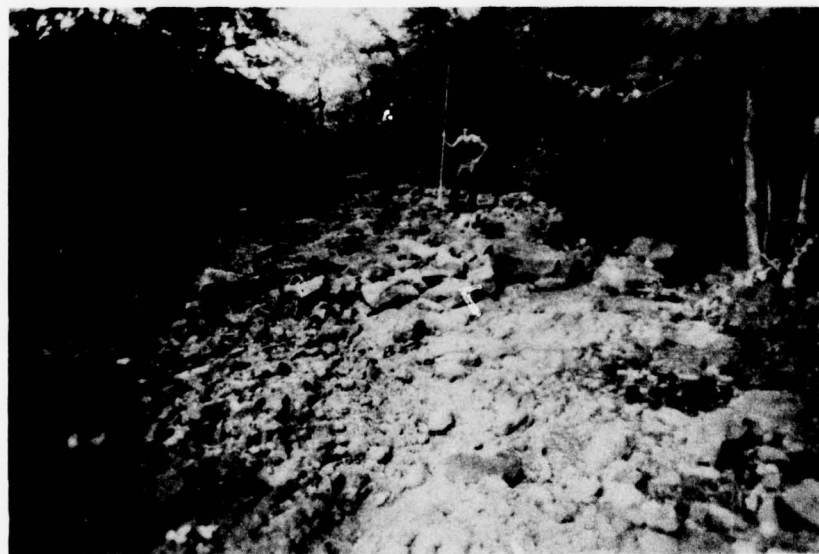
The spillway channel below the 1V on 2H drop is very poorly defined. Numerous shallow channels, blocked by substantial piles of debris, were observed.

H. Spillway Outlet Channel — Looking Downstream.

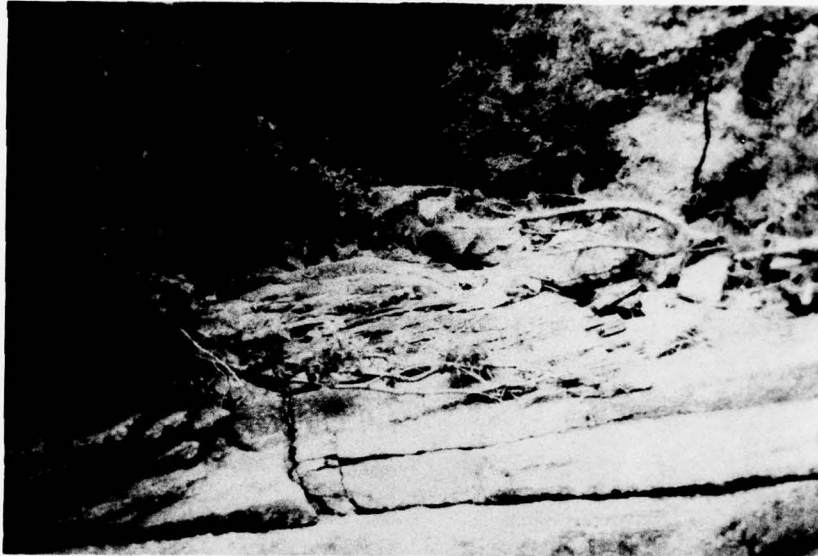
I. Spillway Outlet Channel —
Looking Downstream at 1V on 2H Section.

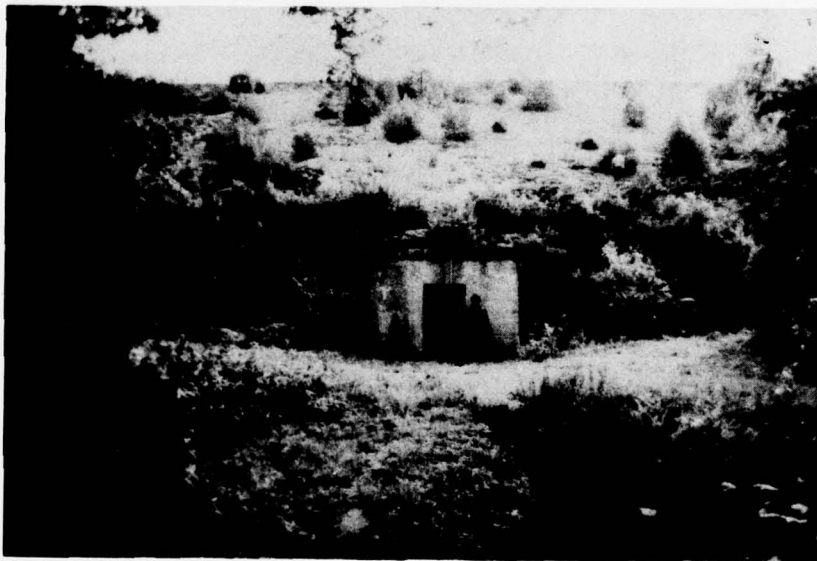
The outfall for the outlet works pipes is about 70 feet downstream of the valve house (Photograph J). The tops of both pipes are exposed for about 20 feet from the outfall (Photograph K). The bell end of these pipes is on the downstream end of each section of pipe. The 16-inch diameter pipe was discharging on the day of the inspection. The pipe joints were observed to leak severely.

J. Valve House at Toe of Downstream Slope of Embankment.

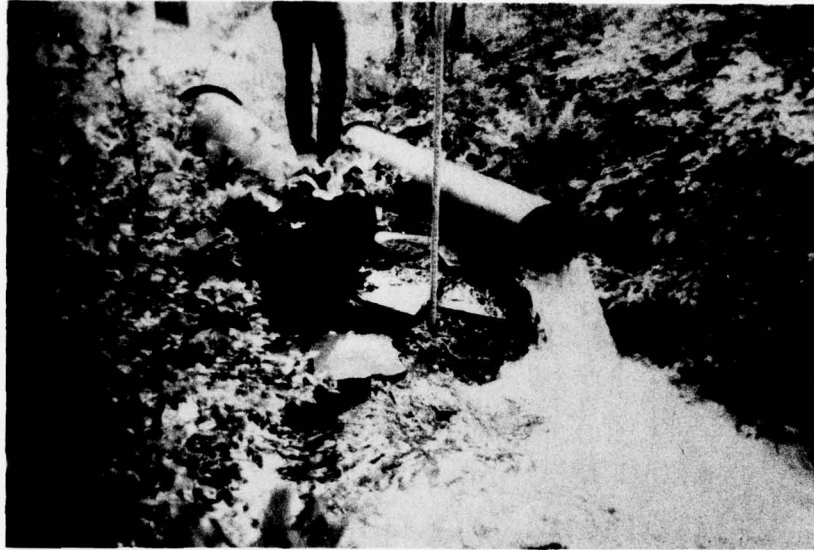
It is normal construction practice to lay pipe with the bell end upstream. The leakage observed at the joints indicates that poor joint construction practices were utilized. If the joints leak upstream of the exposed length of pipe, this could be contributing to the observed seepage. As one of these pipes extends under pressure through the embankment, there is concern for its integrity, even though it is encased in concrete. The growth

K. Outlet Works Outfall.

- (4) Provide closure facilities for the outlet works pipes upstream of the concrete core wall for periodic inspection and for use in the event the pipe should leak severely, thereby endangering the embankment.

(5) Repair leaking pipe joints.

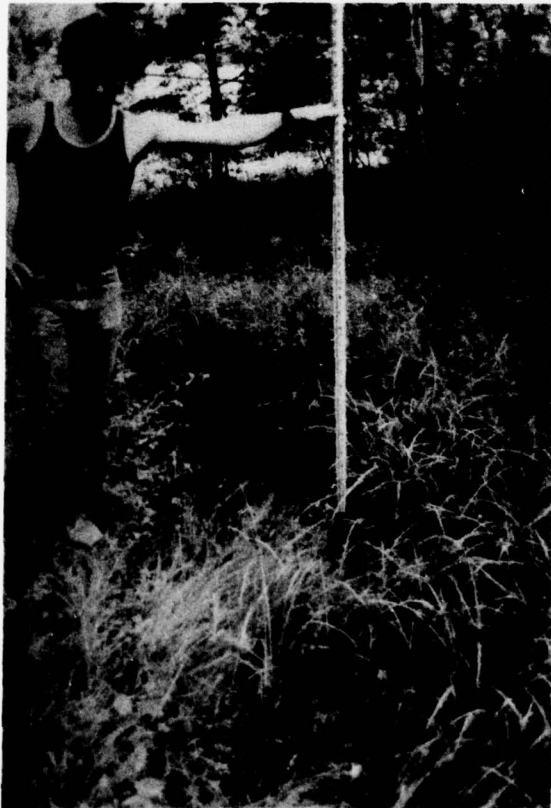
L. Wet Area to Left of
Valve House.

- (7) Install ten or more observation wells, or other instrumentation, downstream of the axis of the dam. Two wells, or other instrumentation, should be located in the vicinity of the wet area right of the valve house. Two others should be located near the wet area left of the valve house. Another two should be in the embankment near the cracks in the core wall. The other four should be at appropriate locations to determine the general water level in
