**LARCHMONT WATER COMPANY  
DAM NO 2**

**WESTCHESTER COUNTY  
NEW YORK**

**INVENTORY NO 112**

**PHASE I INSPECTION REPORT  
NATIONAL DAM SAFETY PROGRAM**

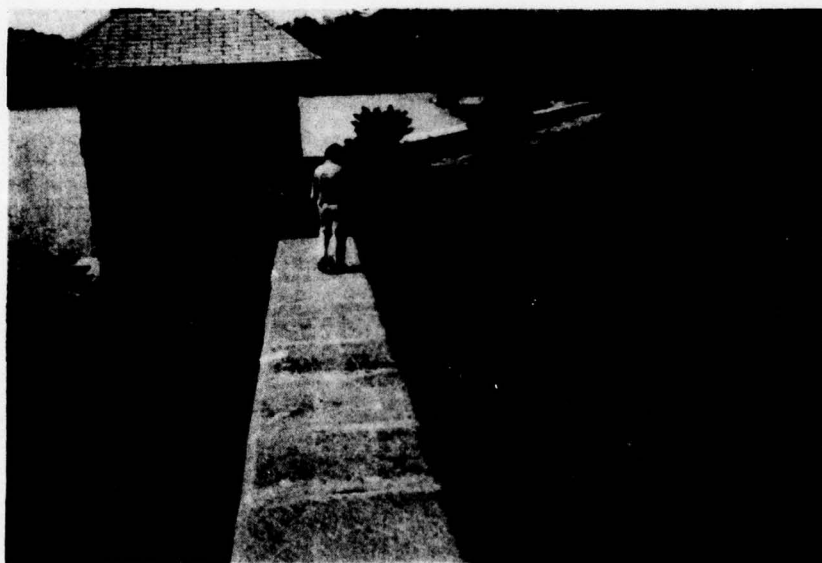
2. Closeup of spillway with concrete cap and masonry ogee section.

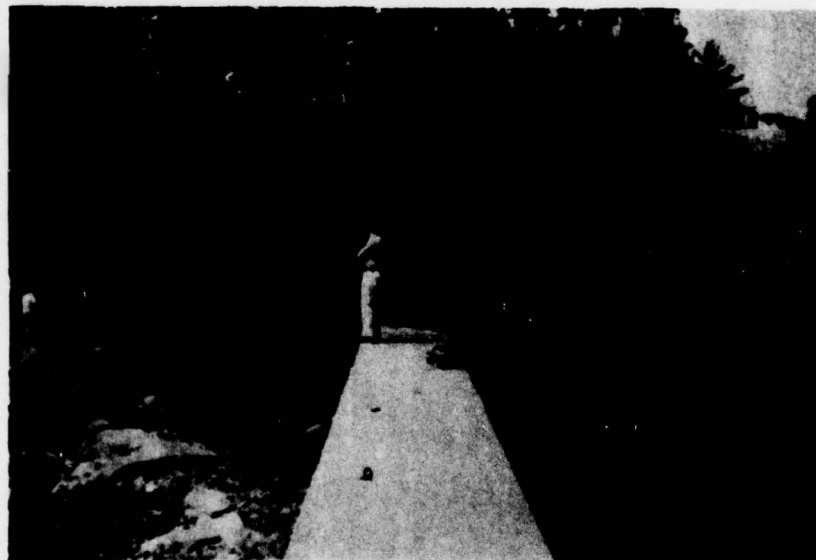
6. Closeup of east abutment.

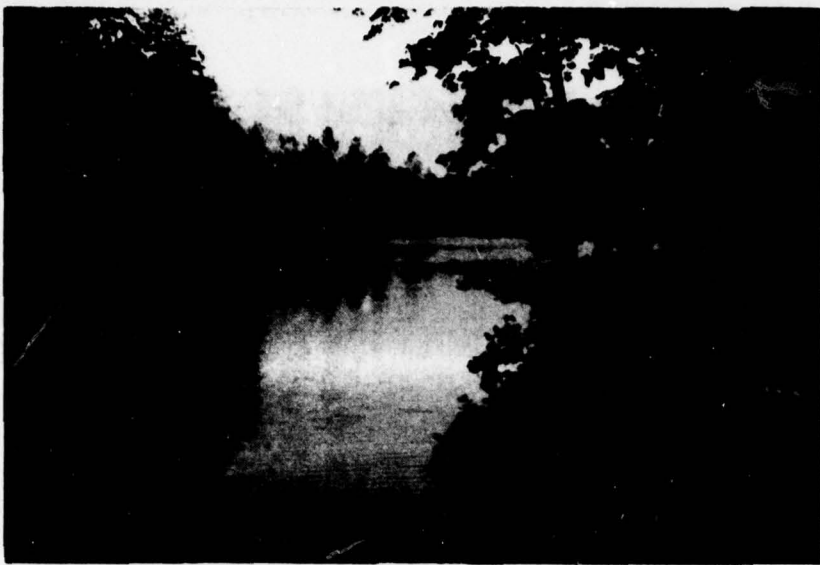
9. View of downstream area below spillway.

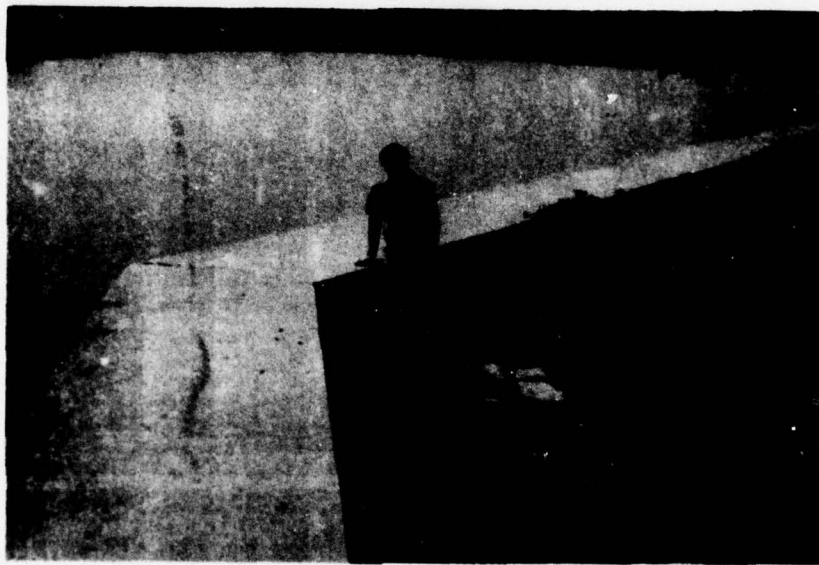
10. Closeup of top of dam showing concrete section on left modification and masonry section on right. Section in between filled with rock. This section has been vandalized, leaving a 2.0-foot hole.

A limited depth of rubble in the dam core between the upstream masonry facing and rock faced downstream slope in the vicinity adjacent to the spillway's southerly headwall has been removed, presumably by vandals. The condition has not yet had any significant structural effect.
