BLAIR GAP DAM

NDI I.D. NO: 521

PHASE I INSPECTION REPORT
NATIONAL DAM INSPECTION PROGRAM

D'APPOLONIA CONSULTING ENGINEERS
10 DUFF ROAD
PITTSBURGH, PA. 15235
JULY 1978

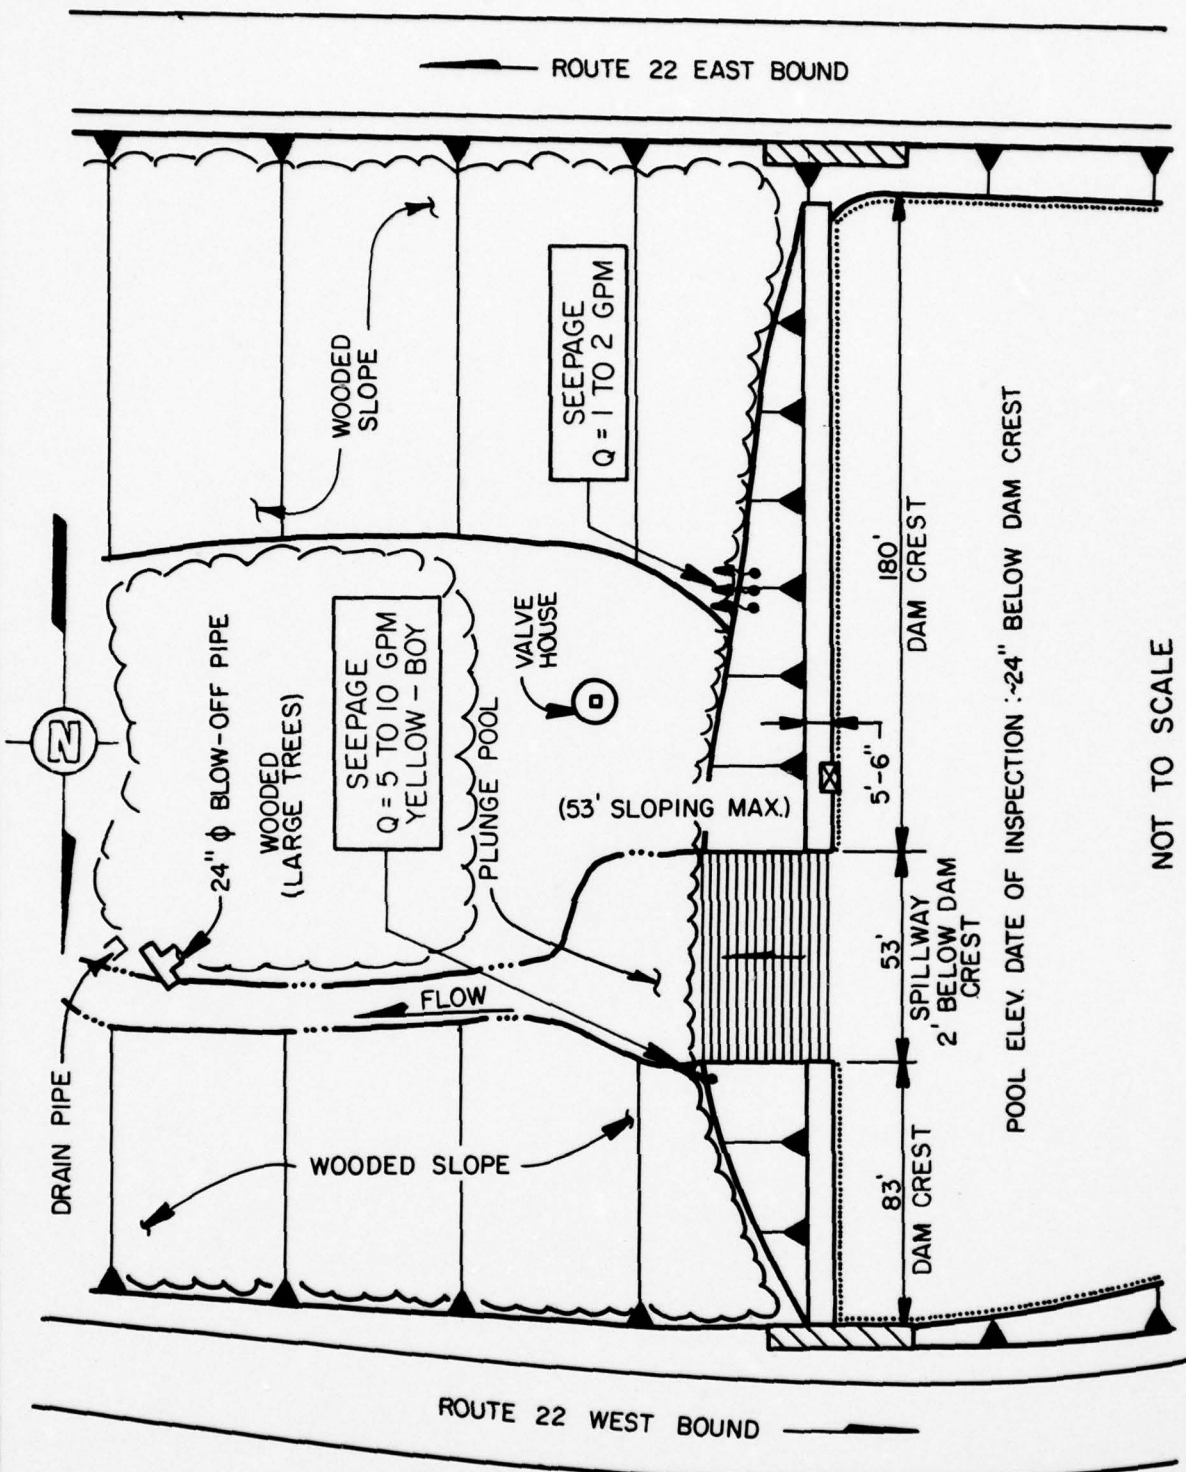
BLAIR GAP DAM NDI ID: 521
 GENERAL PLAN
 FIELD INSPECTION NOTES
 FIELD INSPECTION DATE: JUNE 9, 1978

VISUAL EXAMINATION OF	OBSERVATIONS	REMARKS OR RECOMMENDATIONS
ANY NOTICEABLE SEEPAGE	AT TWO LOCATIONS THROUGH THE DAM SEE PLATE 3 FOR LOCATION.	
STRUCTURE TO ABUTMENT/EMBANKMENT JUNCTIONS	NO SIGNS OF DISTRESS OR SEEPAGE.	
DRAINS	NONE FOUND.	
WATER PASSAGES		
FOUNDATION	NO SIGNS OF DISTRESS.

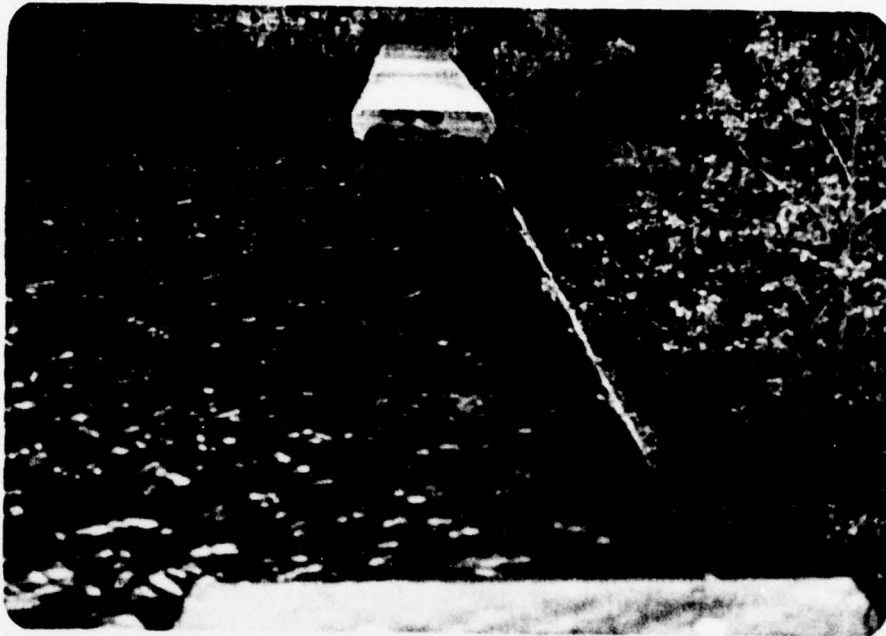
c. Appurtenant Structures. The spillway crests and plunge pools were examined for deterioration or other signs of distress and obstructions that would limit flow. No signs of apparent distress or erosion were observed. Water company personnel declined to operate the blow-off valve so its condition is not known.

Photograph No. 3
Spillway crest.

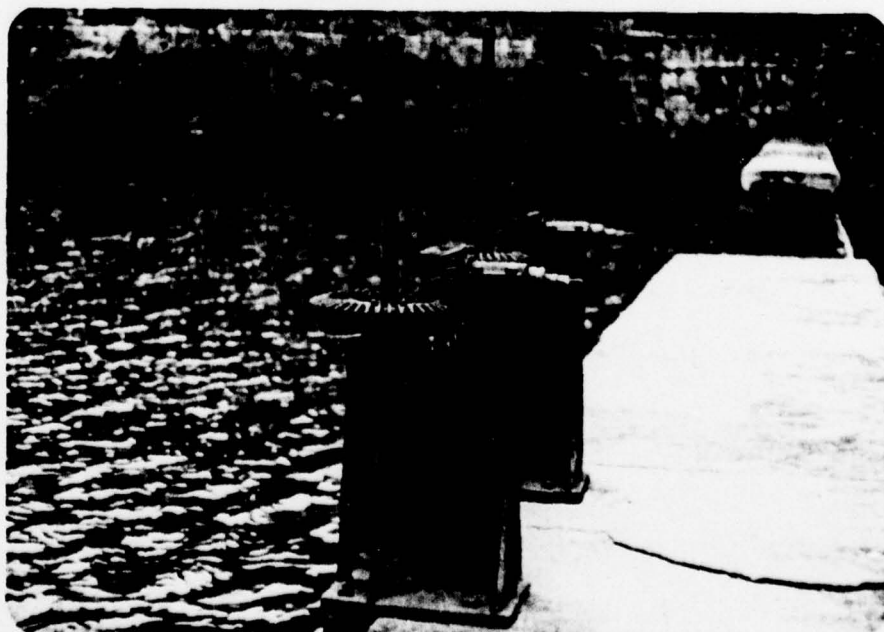
4.3 Maintenance of Operating Facilities. The water company declined to operate the blow-off valve for the dam without compensation for this service plus any damages due to operation of the valves. Therefore, the operative condition of the drawdown facilities could not be assessed. In general, the equipment appears to be in poor condition.

Photograph No. 4
Valve controls on crest.

1. It is recommended that the owner immediately evaluate the operational condition of the lake blow-off valve and perform necessary maintenance.
2. Because the dam may overtop during unusually high runoff, it is recommended that during such periods the owner should provide around-the-clock surveillance for early detection of problems, such as erosion of the abutments.
3. It is recommended that brush and trees in the toe area should be cleared over a distance of approximately 20 feet from the toe to permit adequate future inspection of the toe area.

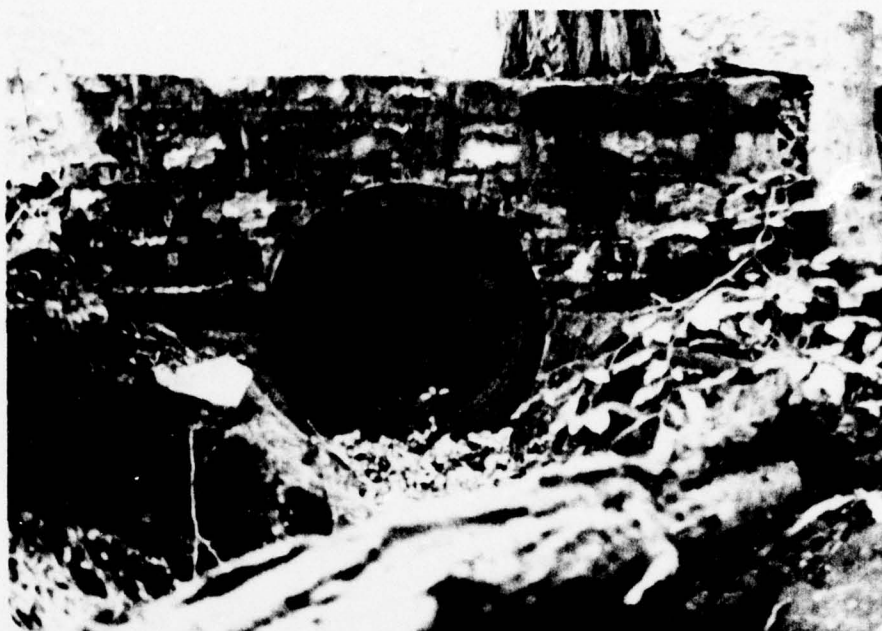
Photograph No. 5
"Blow-off" pipe.

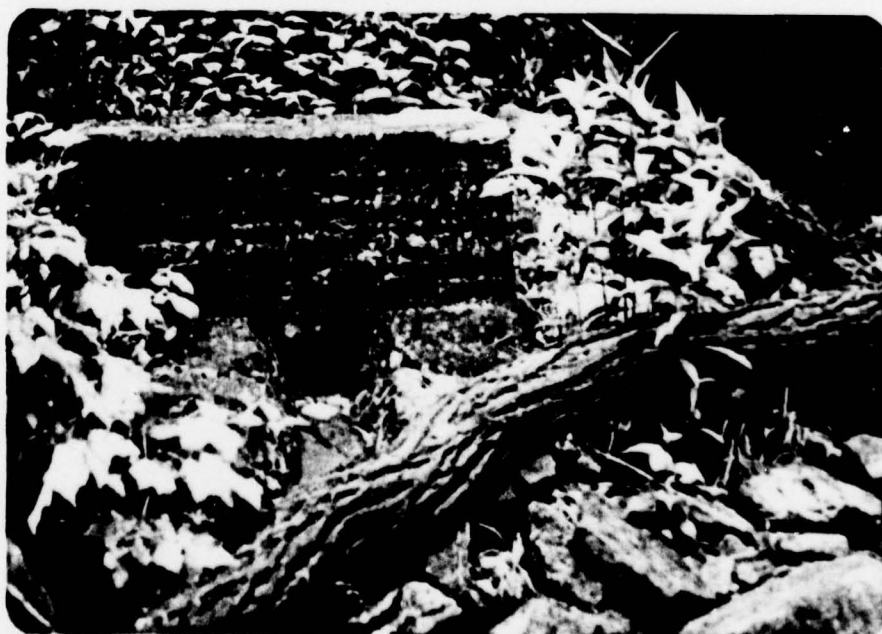
Photograph No. 6
Drainpipe adjacent to "blow-off" pipe outlet.
