BRUSH MOUNTAIN DAM

NDI I.D. NO: 539

PHASE I INSPECTION REPORT  
NATIONAL DAM INSPECTION PROGRAM

JULY 1978

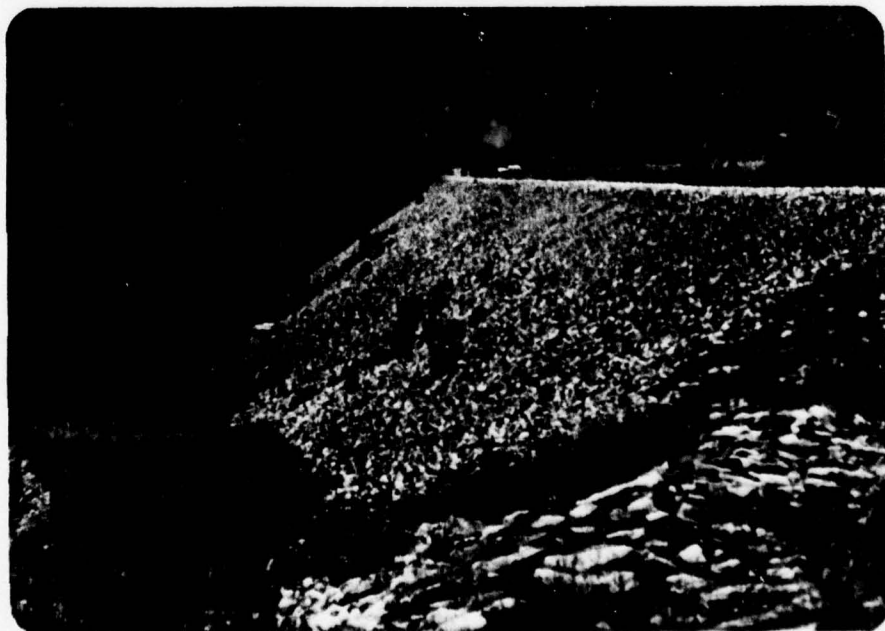
Downstream Face

3. Surficial slides in the downstream riprap were observed. These slides appeared to be causing bulges in the riprap near the toe of the dam.

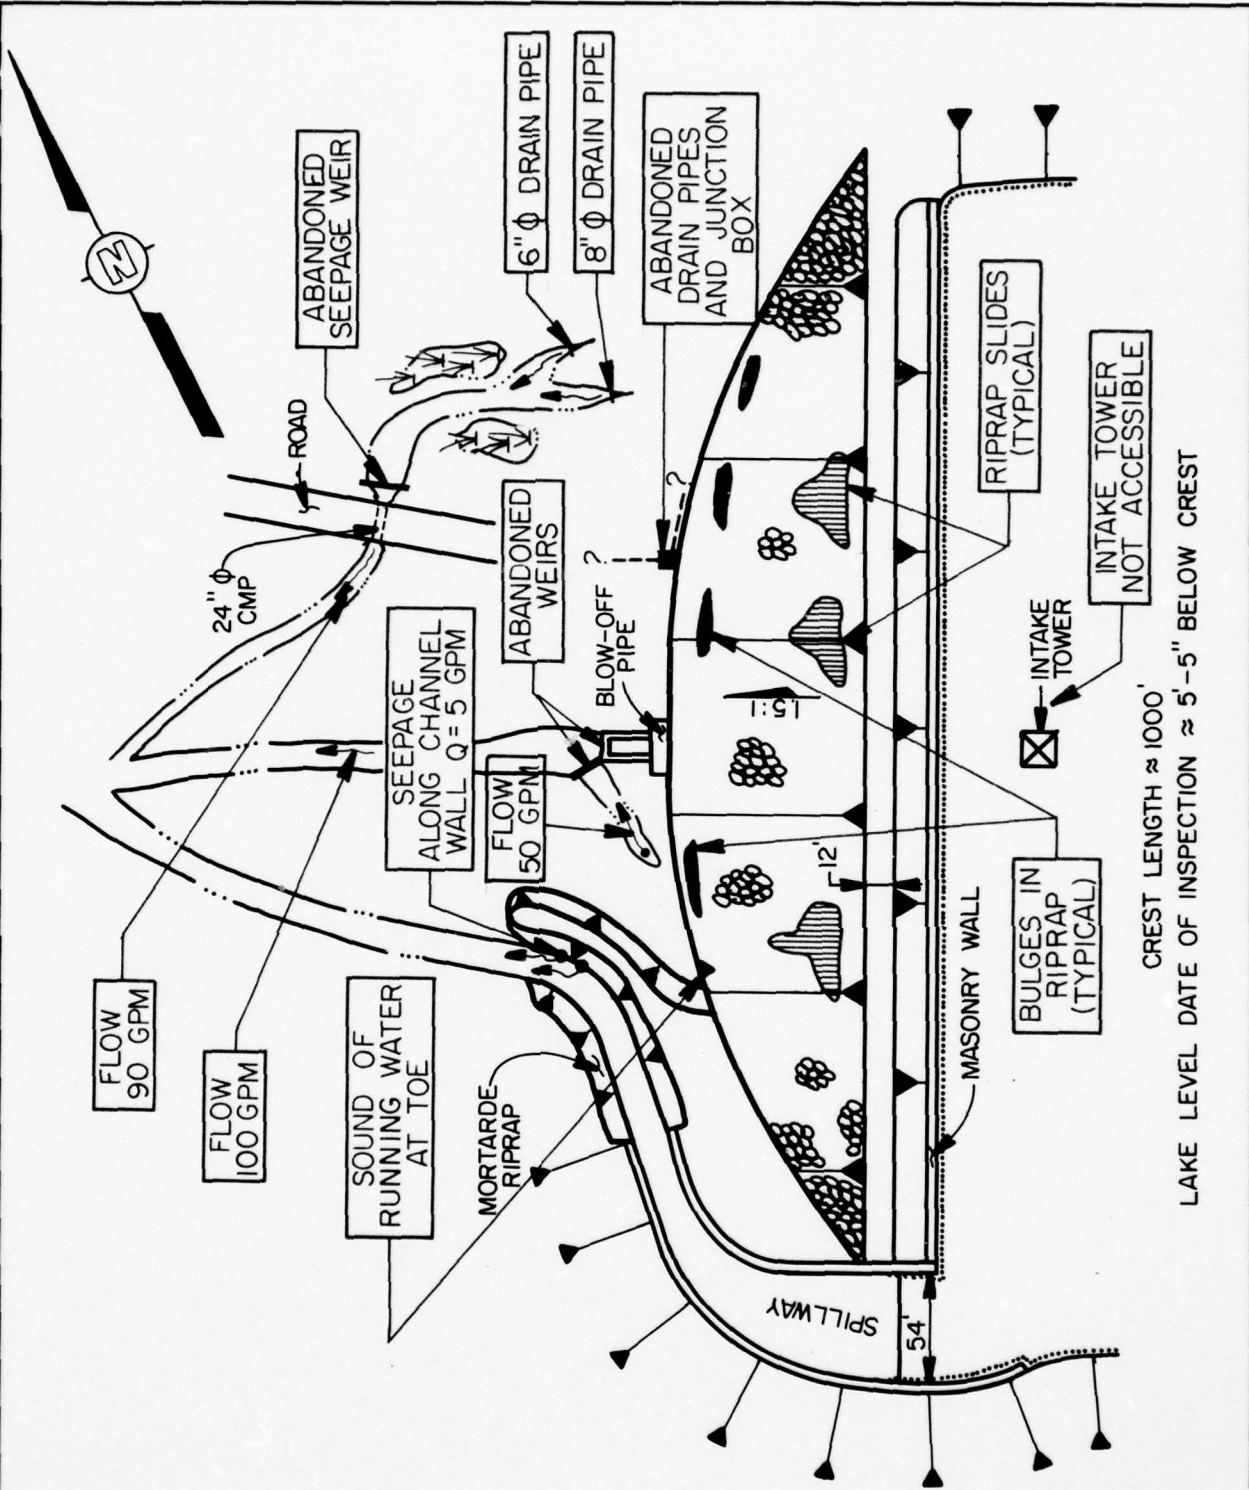
1. All seepage areas observed at the toe of the dam (Plate 6) coincided with the seepage areas that previously existed as implied by the locations of the monitoring weirs (Plate 5). Total seepage flow from the right abutment area was estimated to be 90 gallons per minute (gpm). The seepage on the left side of the outlet works discharge channel was estimated to be 50 gpm. Total flow in the outlet works discharge channel was estimated to be 100 gpm.
2. Minor seepage was observed in the spillway discharge channel and the seepage quantity was estimated to be 5 gpm.

VISUAL EXAMINATION OF	OBSERVATIONS	REMARKS OR RECOMMENDATIONS
JUNCTION OF EMBANKMENT AND ABUTMENT, SPILLWAY AND DAM	NO SIGNS OF DISTRESS OR SEEPAGE.	
ANY NOTICEABLE SEEPAGE	SEVERAL SEEPS BELOW TOE SEE PLATE 6 FOR LOCATION.	
STAFF GAGE AND RECORDER	NONE FOUND.	
DRAINS	SEEPAGE COLLECTION SYSTEM. SEE PLATE 5

VISUAL EXAMINATION OF	OBSERVATIONS	REMARKS OR RECOMMENDATIONS
MONUMENTATION/SURVEYS	NONE FOUND	
OBSERVATION WELLS	NONE FOUND.	
WEIRS	THREE SEEPAGE WEIRS AT LOCATIONS SHOWN IN PLATE. 6 WEIRS ARE <u>NOT</u> FUNCTIONAL.	
PIEZOMETERS	NONE FOUND.	
OTHER	NONE.

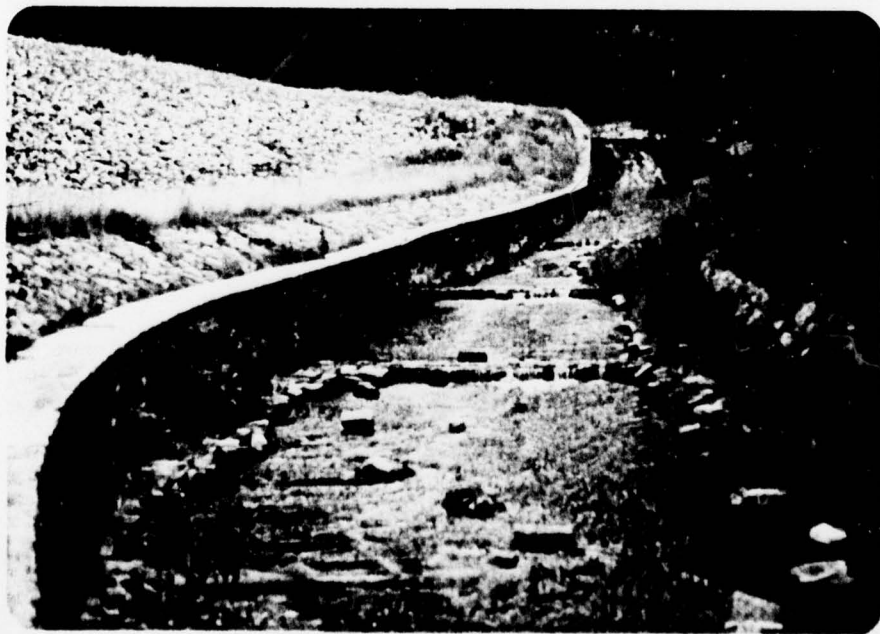
Photograph No. 2  
Spillway discharge channel.

The spillway structures were examined for deterioration or other signs of distress and obstructions that would limit flow. It was observed that most of the grouted riprap channel floor pavement that was constructed in 1936 in the spillway channel below Elevation 1693 has been eroded away; however, this has not affected the overall performance of the channel. The remaining parts of the spillway are considered to be in good condition.

VISUAL EXAMINATION OF	OBSERVATIONS	REMARKS OR RECOMMENDATIONS
CONCRETE WEIR	BROAD CRESTED WEIR - GOOD CONDITION	
APPROACH CHANNEL	SHALLOW - NO SIGNIFICANT OBSTRUCTIONS TO FLOW.	
DISCHARGE CHANNEL	RECTANGULAR CHANNEL. MASONRY LINING IN THE LOWER HALF IS ERODED.	
BRIDGE AND PIERS	NONE.

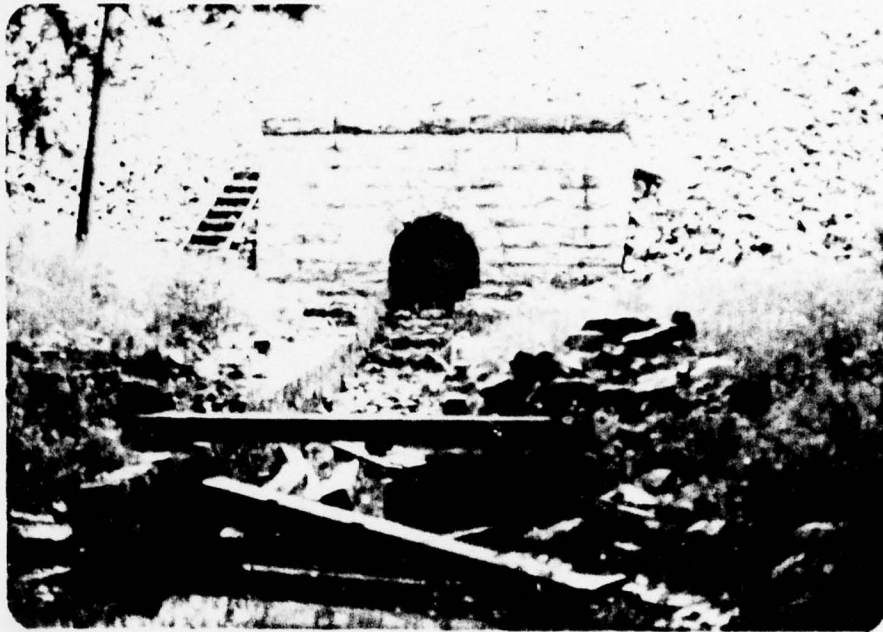
Photograph No. 3  
Outlet works.

The downstream end of the outlet pipe was examined and was found to be in fair condition.

1. The owner should initiate additional hydrology and hydraulic studies to more accurately ascertain the spillway capacity and to determine the nature and extent of remedial measures required to increase the spillway capacity.
2. It is recommended that the owner immediately evaluate the operational condition of the outlet works and perform necessary maintenance.
3. Since the intake tower and diversion tunnel were inaccessible, the condition of these structures could not be assessed. Therefore, the owner should evaluate the structural integrity of these structures on a periodic basis.
