PEACE VALLEY DAM
BUCKS COUNTY, PENNSYLVANIA
NATIONAL I.D. NO. PA 00790

PHASE I INSPECTION REPORT
NATIONAL DAM INSPECTION PROGRAM.
Peace Valley Dam (ID PA-00790), Delaware
River Basin, North Branch Neshaminy Creek,
Bucks County, Pennsylvania. Phase I
Inspection Report.

WOODWARD-CLYDE CONSULTANTS
5120 Butler Pike
Plymouth Meeting, Pennsylvania 19462

PHASE I INSPECTION REPORT
NATIONAL DAM INSPECTION PROGRAM
PEACE VALLEY DAM
NATIONAL ID # PA 00790
DER ID #9-169

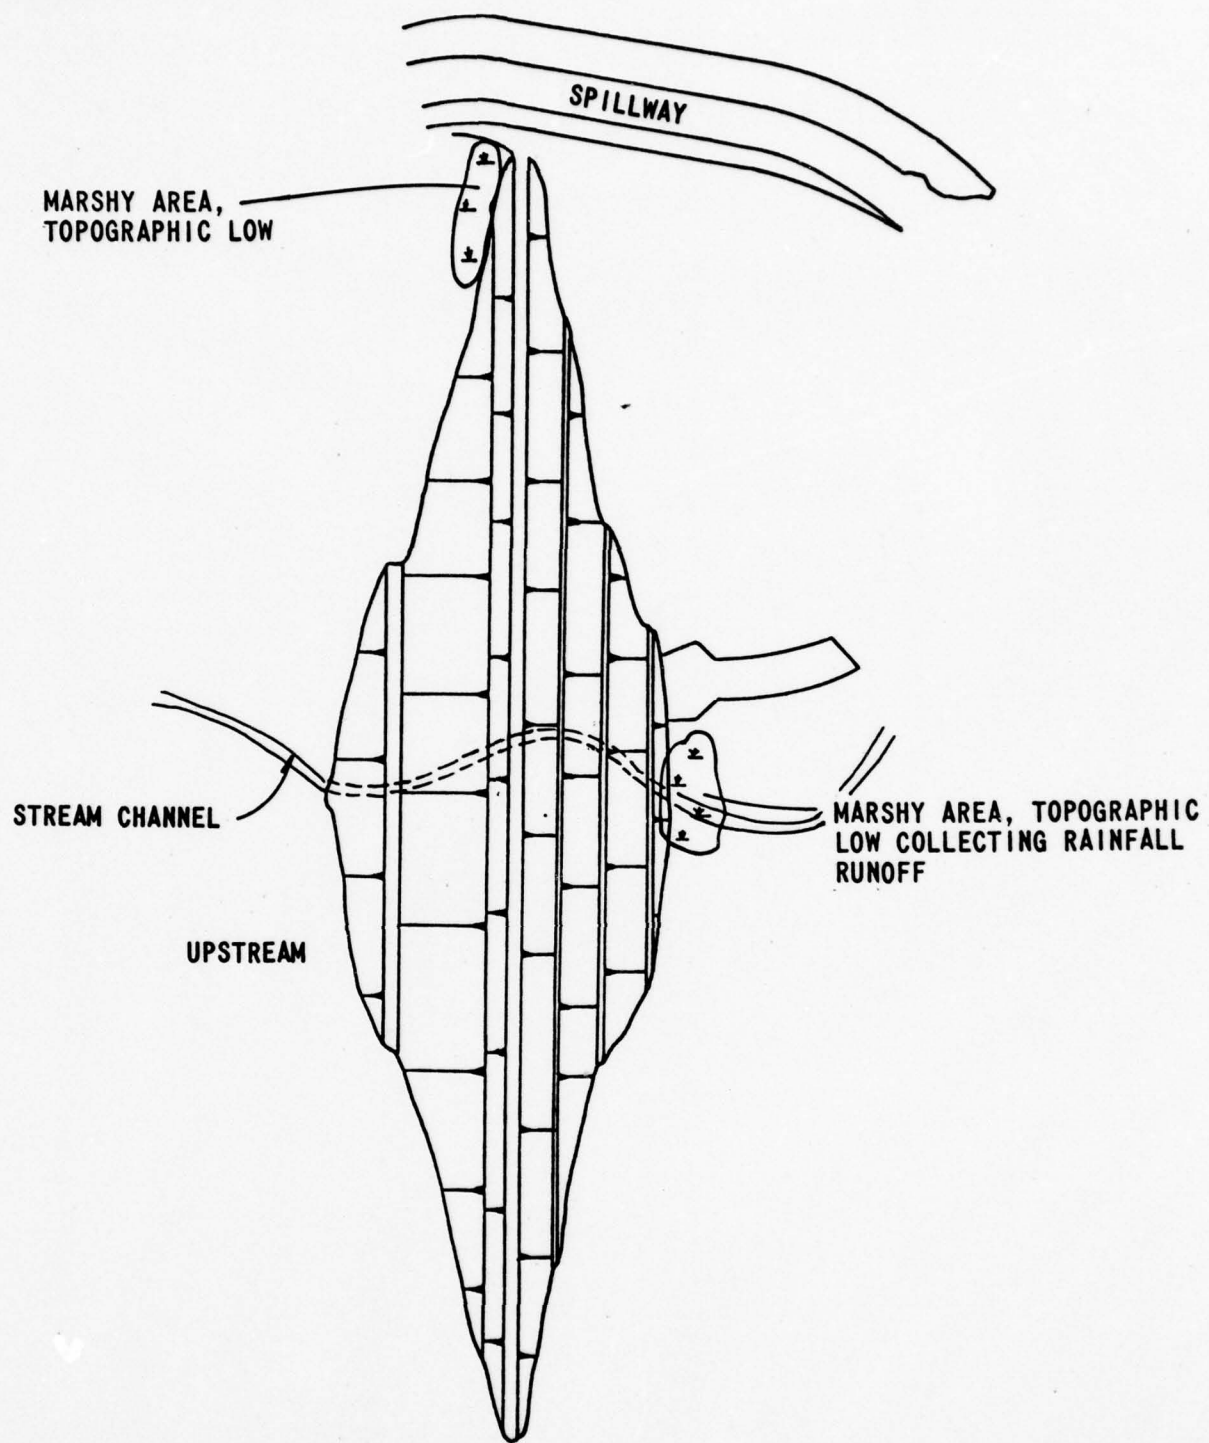
SEEPAGE LOCATION PLAN
PEACE VALLEY DAM

A small marshy area was noted downstream right of the Saint Anthony Falls (SAF) stilling basin. This area

corresponds to the location of the original streambed. There was no evidence of seepage emanating from the toe or through the surrounding natural ground. It appears that this area is a natural topographic low which does not readily drain. A second marshy area was noted on the upstream side near the left abutment which is also a natural topographic low that accumulates water.

a. Facilities. It is recommended that the area of standing water in the vicinity of the old stream channel be regraded and drained into the creek downstream. Subsequently, this area should be cleared and inspected for seepage. If seepage is observed, the flow rate should be monitored and the turbidity checked.
