INDIAN BROOK RESERVOIR  
WESTCHESTER COUNTY  
NEW YORK  
INVENTORY NO 44

PHASE I INSPECTION REPORT  
NATIONAL DAM SAFETY PROGRAM.

Name of Dam Indian Brook Reservoir NY44

State Located New York  
County Located Westchester  
Stream Indian Brook River  
Date of Inspection July 26, 1978

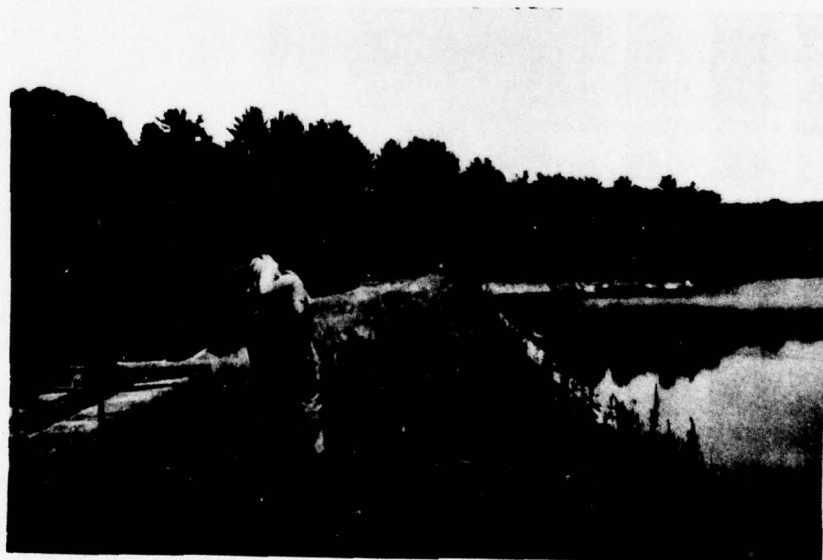
4. View looking north across top of dam.

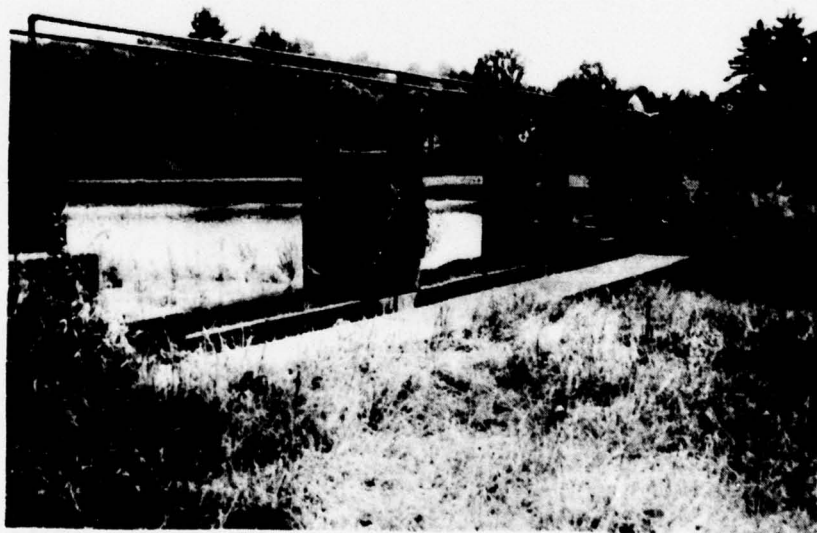
6. View across spillway at top of dam.
