COLLIERSVILLE DAM

OTSEGO COUNTY, NEW YORK
INVENTORY NO. 685

PHASE I INSPECTION REPORT
NATIONAL DAM SAFETY PROGRAM

JULY 26, 1978

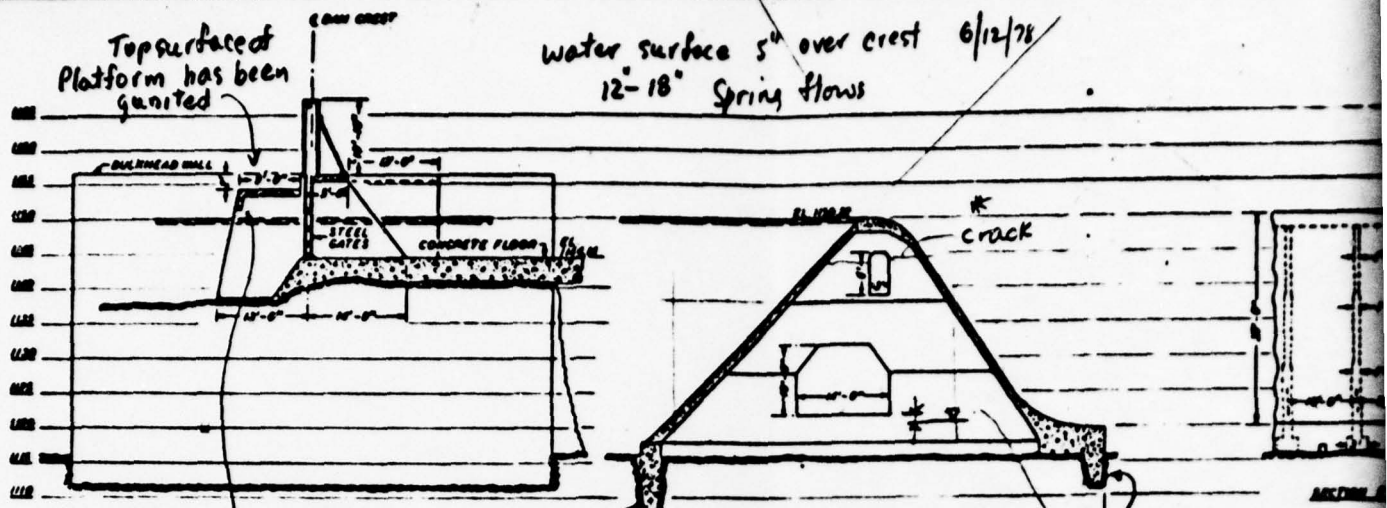
high water does contact bottom of ups lip - some erosion has resulted

* gages monitor up and down motion of cracks since March 28, 1952

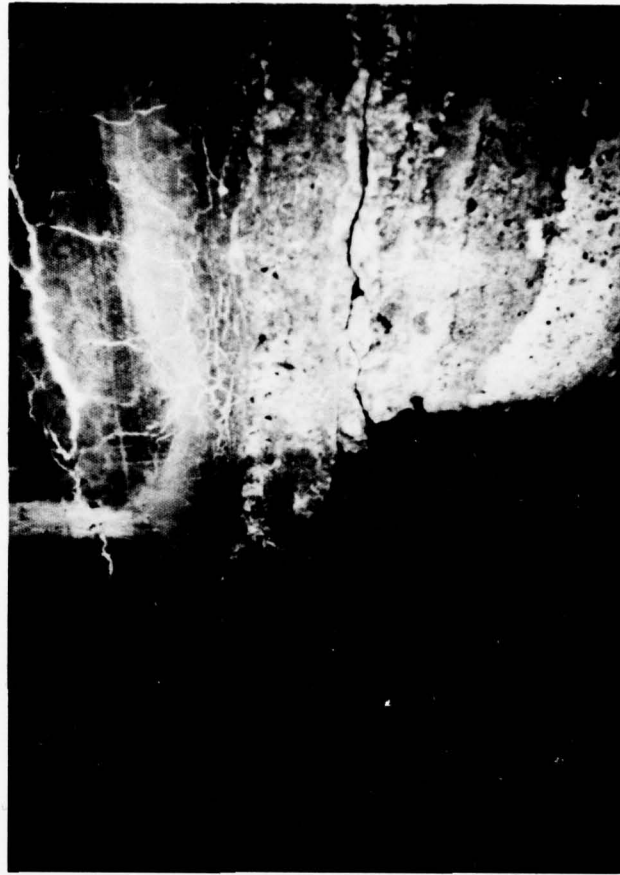
The inspection indicated bottom leakage on the left side of Gate No. 2, the second from the west. Significant leakage also was observed around the Gate No. 4 guide immediately adjacent to the dam and about 3.5 feet above the floor of the flume. There is a large area of spalled concrete adjacent to the leak. From this spalled area, a bulge in the wall which ranges from 6 to 12 inches in width extends horizontally for several feet.

The west wall of Gate Bay No. 4 had a crack 3-feet long on its downstream face about 4 1/2 feet from the floor which also continued around the downstream end. There is some spalling of the concrete on the faces of the piers of Gate Bays Nos. 2 and 3. In Gate Bay No. 1, the west wall, adjacent to the road, has some relatively long irregular cracks near the top. There is also a bulging of the upper wall a few feet downstream of the gate.

DOWNSTREAM VIEW OF NO. 4 GATE SLOT AREA
SHOWING DAMAGED WALL ADJACENT TO ABUTMENT

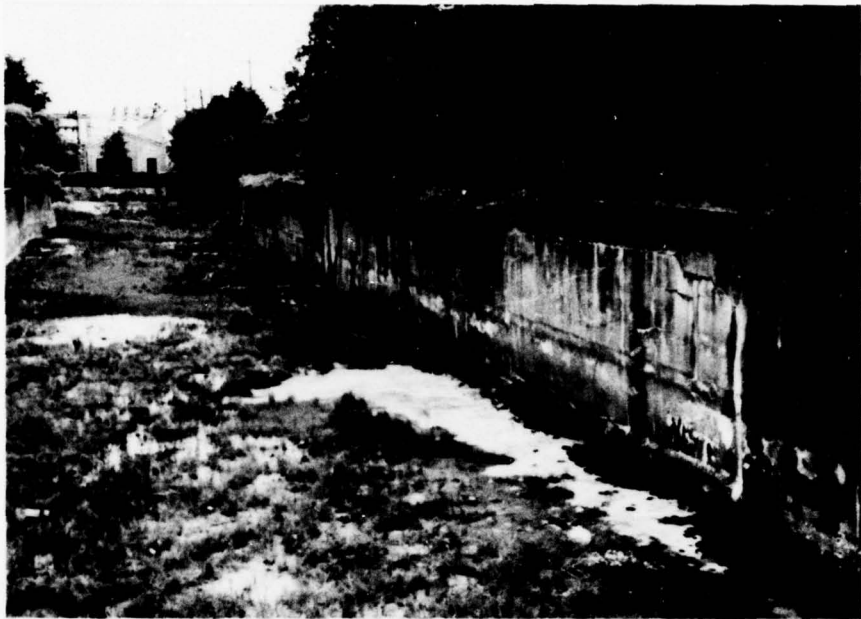
In general the condition of the headrace flume is poor. There is evidence of extensive gunite repairs to the concrete flume which was reconstructed following the collapse of the original flume. The gunite itself can now be observed to be cracked and pulling away from the concrete wall as much as 12 to 18 inches at several locations. At one location, where a highway culvert discharges water down to the flume, it appears that freezing and thawing of water in an initial crack in the gunite forced the gunite farther away from the wall to which it was applied. This condition was noted in a previous inspection report. The downstream wall of the flume near the powerhouse also shows signs of deterioration in the form of cracks, bulging and spalling of the concrete wall. In addition the buttresses stiffening the downstream wall exhibit signs of deterioration in the form of spalled surfaces, surface cracks and some areas with exposed aggregate. The ice spillway at the downstream end of the flume has been removed and the opening in the wall has been closed.

HEAD RACE VIEWED FROM HEAD GATE PLATFORM,
SHOWING IRREGULARITIES IN RIGHT WALL

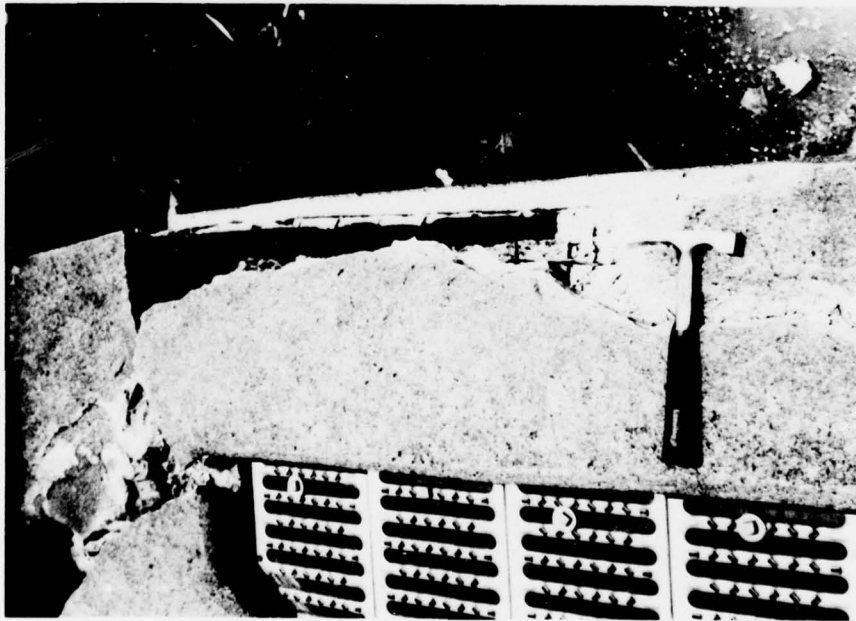
CRACK AND SEPARATION OF GUNITE SURFACE AT
JUNCTION OF RIGHT END OF DAM AND LEFT WALL
OF HEAD RACE

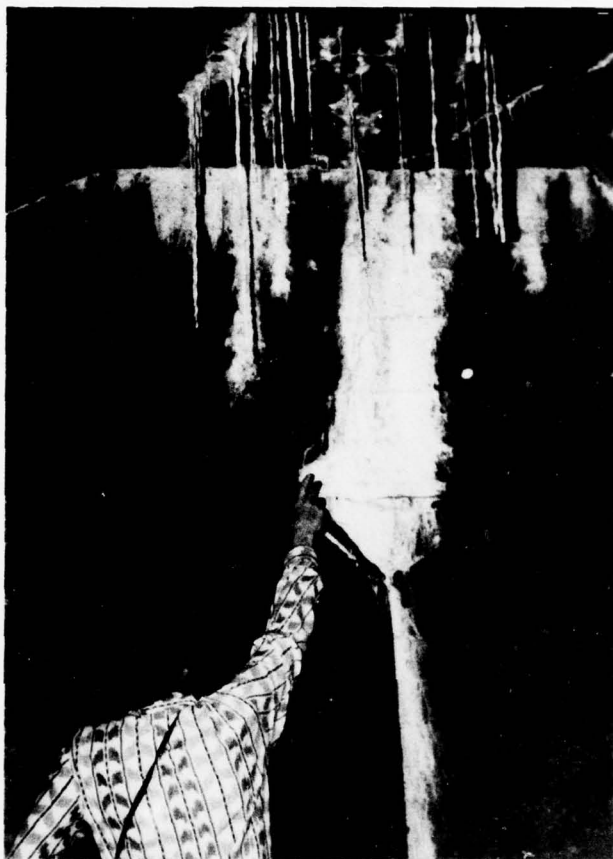
There is evidence of leakage in almost all bays. The wooden walkway between the buttresses was wet throughout and a buildup of mineral deposits was encountered at several locations. A flow of water was observed at the deteriorated portion of the left abutment wall mentioned above and another small stream of water was observed passing through the upstream face slab in Bay 9. Flow in this bay increased significantly when the head on the dam increased due to the rain previously mentioned. The cracks in Bays 4, 8, 12, 18 and 19, which are referred to above, show seepage in the form of dampness. Seepage also was observed to occur at the juncture of the upstream face slab and the buttress in some bays.

WALKWAY OPENING IN BUTTRESS,
SHOWING STALACTITES AND WALL DEPOSITS

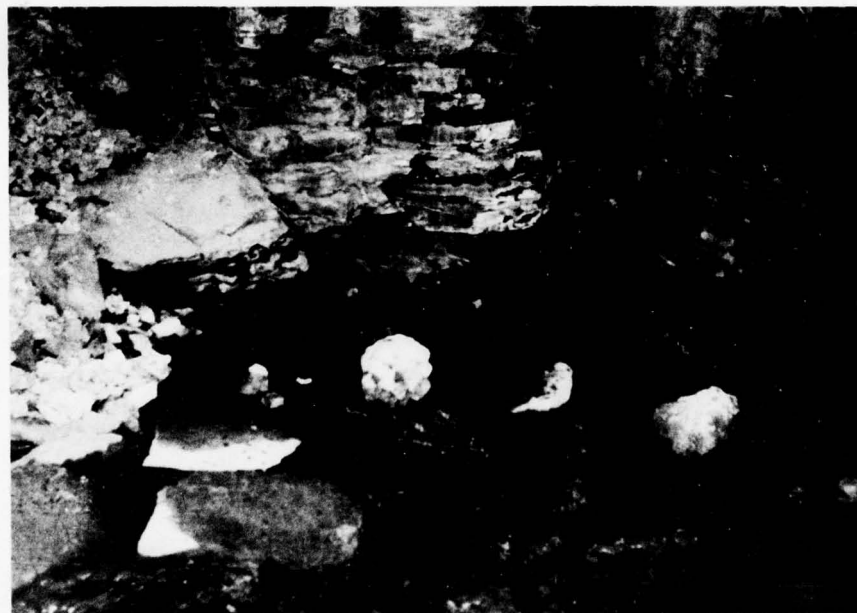
SEEPAGE AND DISCOLORATION AT LEDGE
UNDER UPSTREAM END OF HEAD RACE
