SCHUYLKILL RIVER BASIN
INDIAN RUN CREEK, SCHUYLKILL COUNTY

PENNSYLVANIA
ID NO. PA.00696

INDIAN RUN DAM

PHASE I INSPECTION REPORT NATIONAL DAM INSPECTION PROGRAM

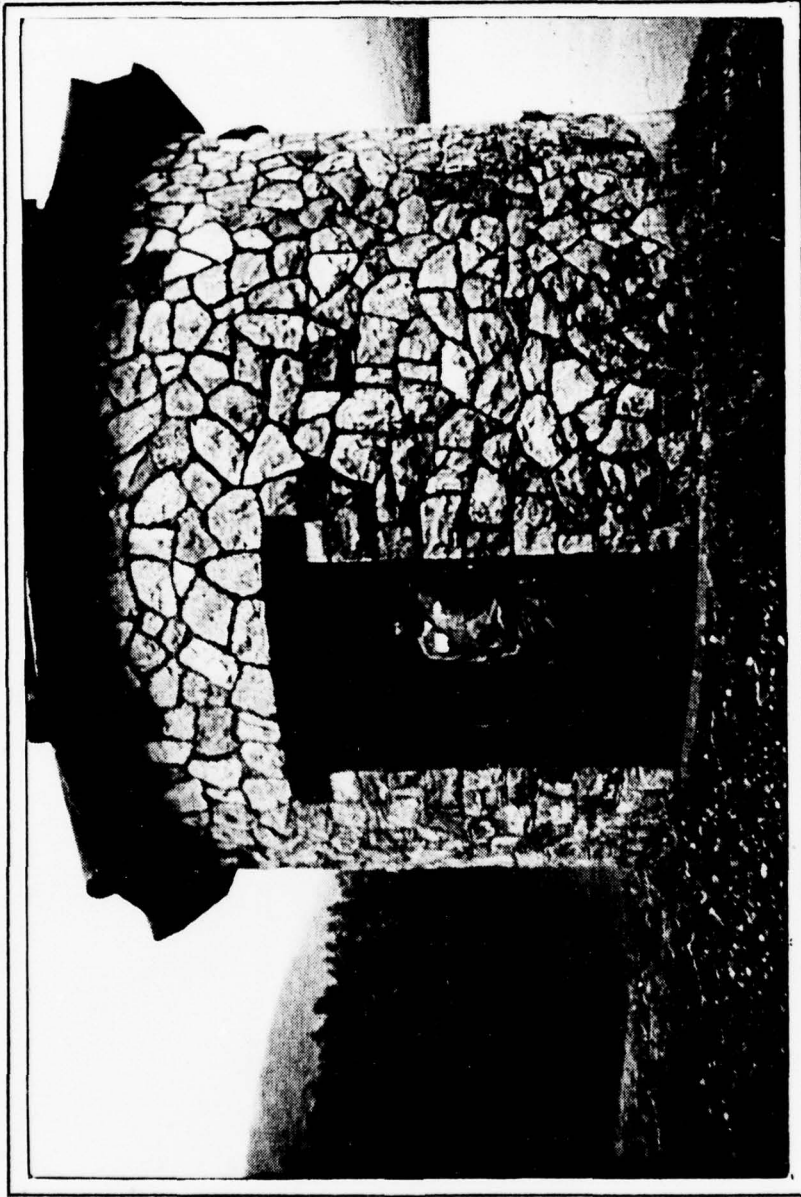
PHOTOGRAPH NO. 1

The intake tower was found to be in generally fair condition. All valves were exercised except the blow-off valve at the base of the dam. There were no plans available showing details of the valve control mechanism. Since the intake tower is a wet tower, the valves and the interior sections of the tower could not be inspected. Sections that were exposed were in fair condition. Since the 24-inch cast iron discharge pipes are buried to the pumphouse and pond, they could not be inspected, nor could the six-inch cast iron pipe located at the base of the tower be inspected or the outlet located.

INTAKE TOWER LOCATED AT TOP OF SLOPE
ON UPSTREAM SIDE.

1. The intake tower should be drained and inspected to evaluate the condition of the tower and gates;
2. All seepage downstream should be monitored periodically and checked for increasing rates and turbidity;

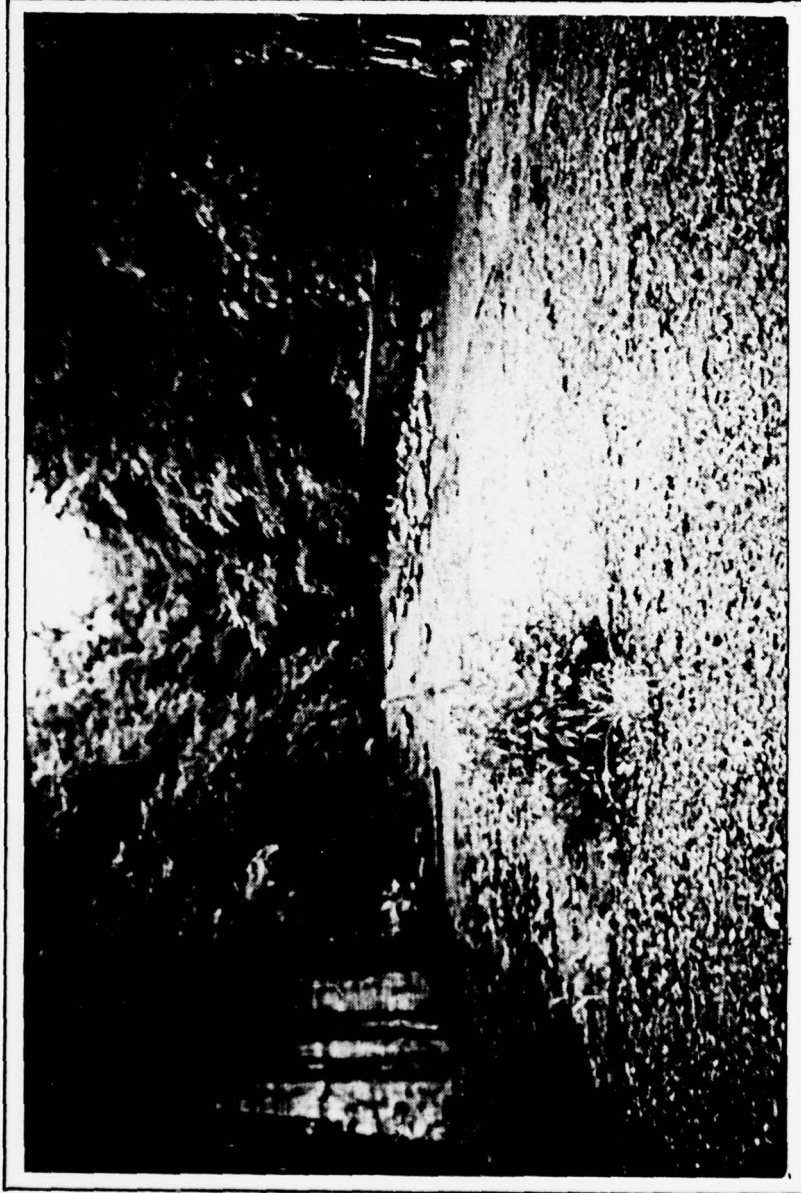
PHOTOGRAPH NO. 3

The spillway chute showed severe spalling with reinforcing steel exposed, especially at the stepped sections. Some of this reinforcement has deteriorated and is not longer functioning as designed. The spillway chute retaining walls are in somewhat better condition with less spalling and deterioration. However, there are several

VIEW LOOKING DOWNSTREAM OF PRINCIPAL
SPILLWAY FROM OVERFLOW WEIR. NOTE
SPALLING CONCRETE.

5. The spalled concrete, including the spillway crest, should be repaired;
6. The embankment should be regraded to the design elevation along the entire crest;

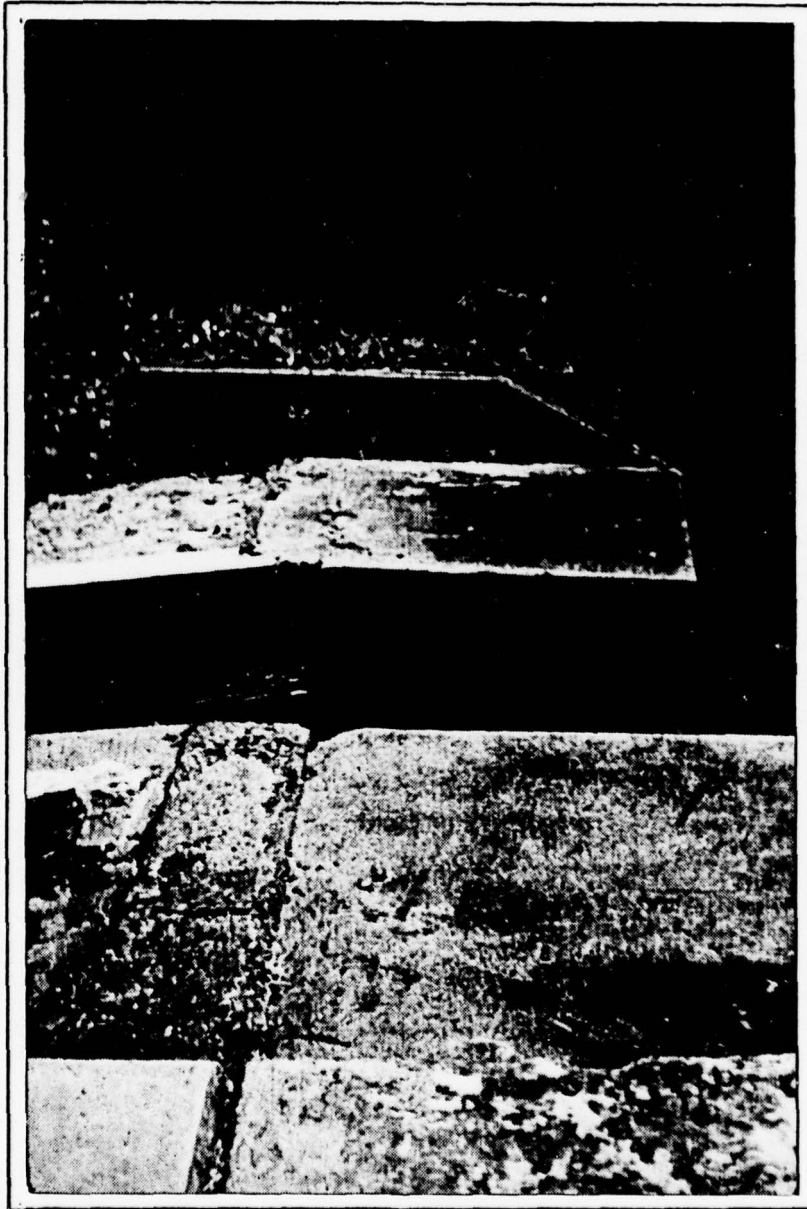
PHOTOGRAPH NO. 6

e. Downstream Channel. Water from the emergency spillway is discharged into a 3-1/2 acre reservoir immediately downstream from the dam. The water discharges over a small concrete spillway at the end of the pond. This spillway is cracked and deteriorated. Thereafter, the water flows into the natural stream channel which empties into the West Branch, approximately 2,000 feet downstream. The channel bottom between the lower reservoir and the confluence with the West Branch is rocky with stable side slopes. The flood plain downstream of the reservoir is densely wooded with many rock outcrops. The West Branch flood plain is also densely wooded.

DOWNSTREAM RESERVOIR SPILLWAY. PRIMARY SPILLWAY
CHANNEL IS SIX FEET WIDE.

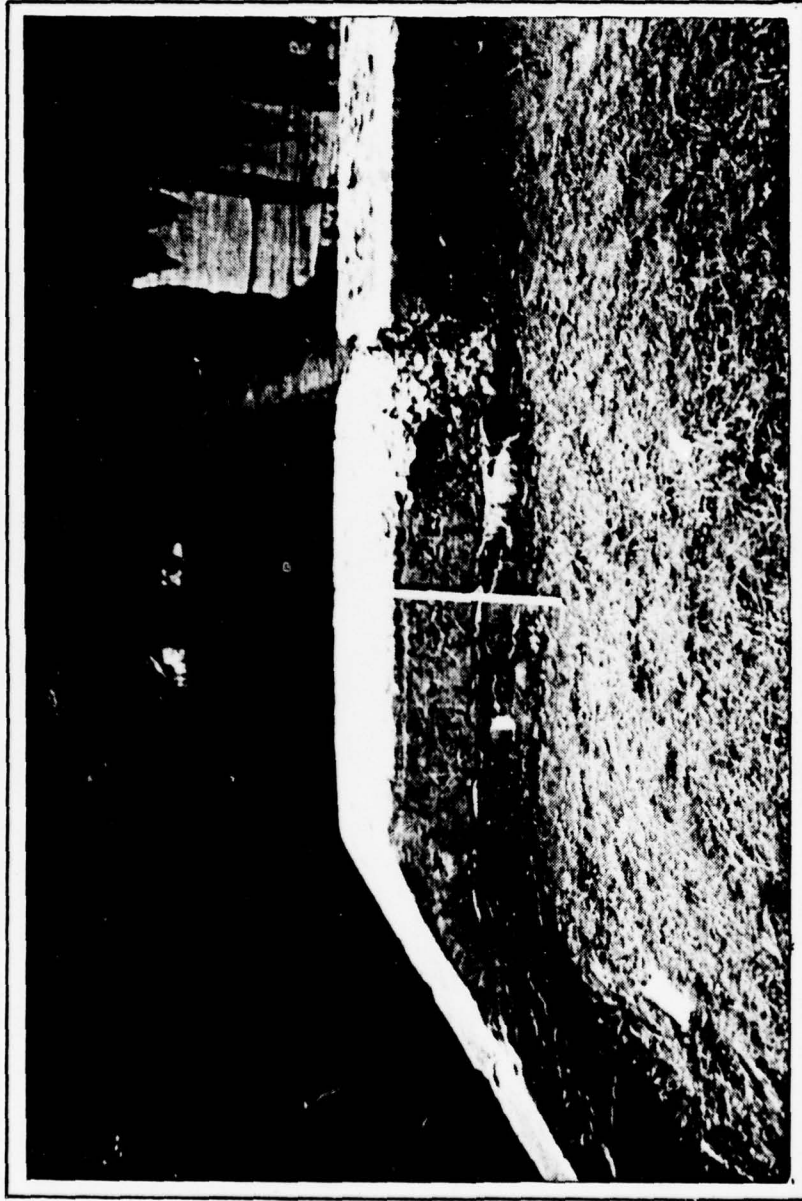
PHOTOGRAPH NO. 7

SPALLED CONCRETE OF SPILLWAY WALLS.
NOTE SETTLEMENT OF EMBANKMENT ADJACENT
TO WING WALLS.

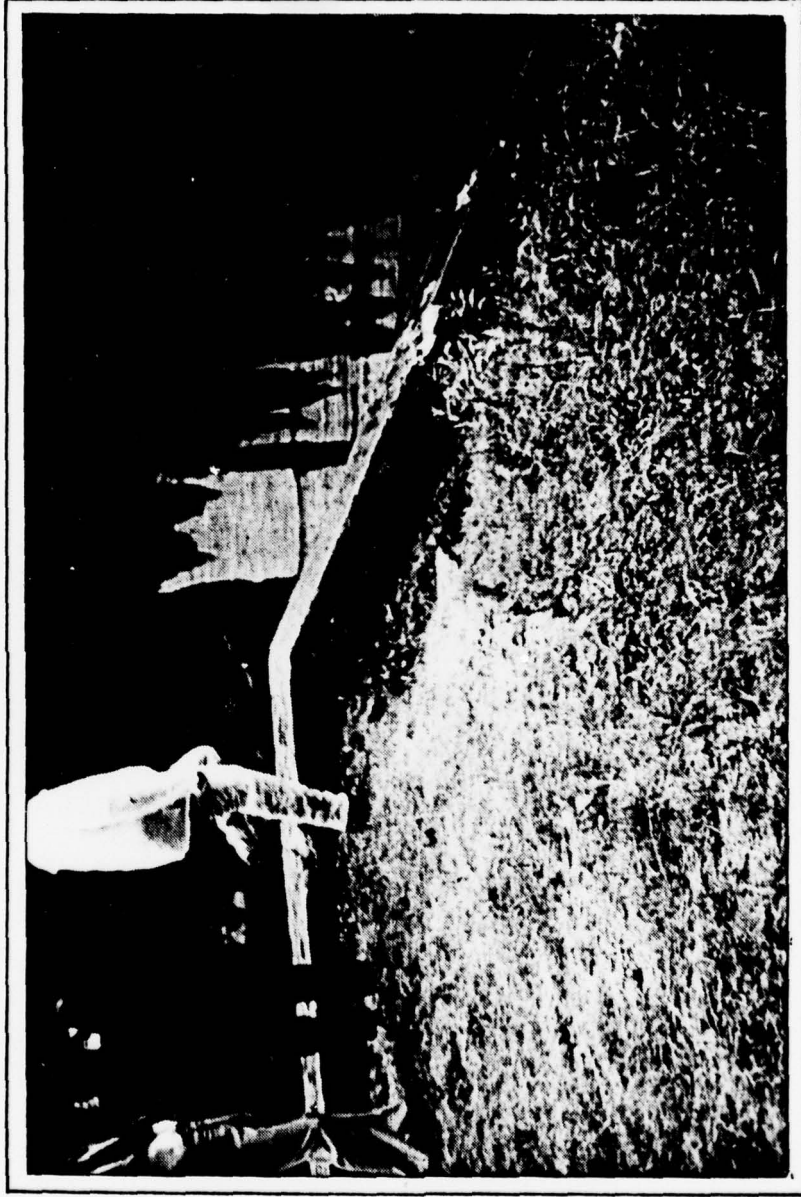
As shown on Photograph No. 8, erosion and settlement of the embankment was noted adjacent to the spillway wall. This settlement feathered out about 40 feet from the wall. This settlement has lowered the embankment crest by at least 9 inches and, correspondingly, reduces the flood storage capacity.

Some erosion was noted at the junction between the embankment and the emergency spillway. This erosion has effectively reduced the crest height of the dam by approximately one foot. The crest should be restored to the design elevation.

PRINCIPAL SPILLWAY. NOTE CONCRETE
DETERIORATION AND EROSION ADJACENT
TO WING WALLS. DESIGN CALLED FOR
FILL TO TOP OF WALLS.

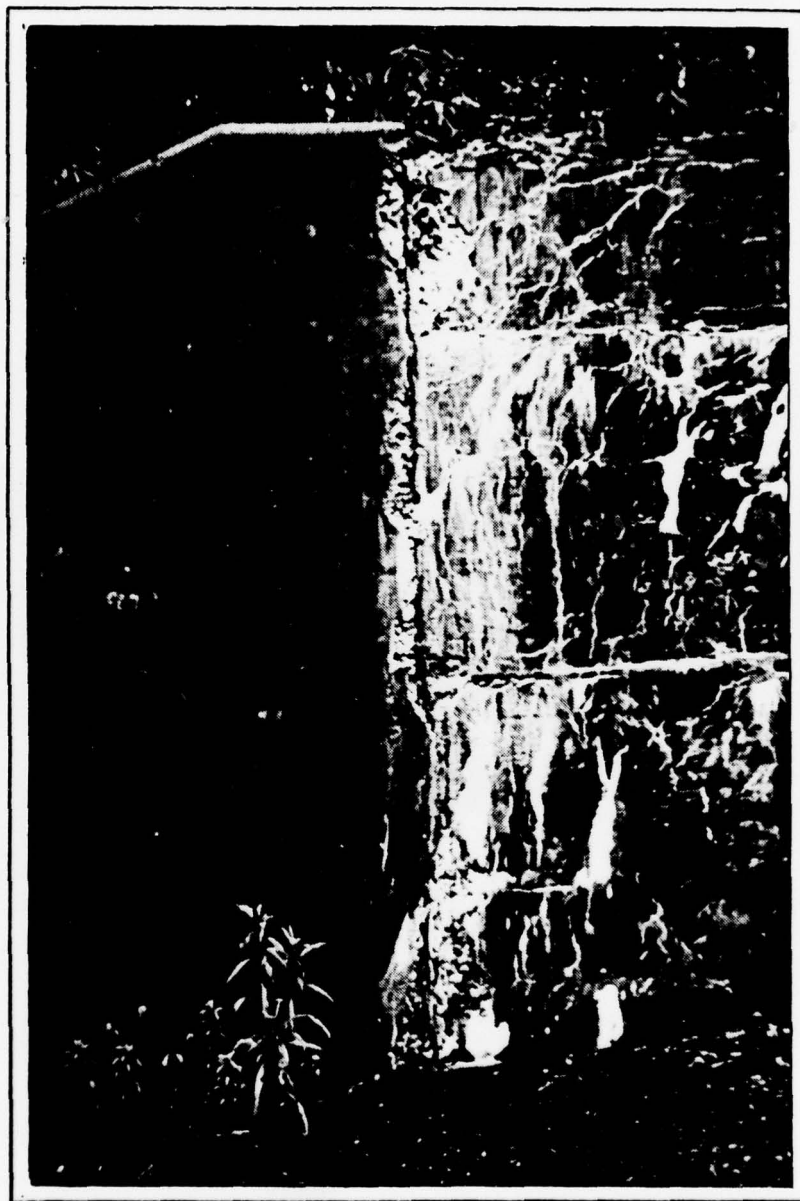
PHOTOGRAPH NO. 9

DETERIORATED RIGHT WALL
OF PRINCIPAL SPILLWAY.

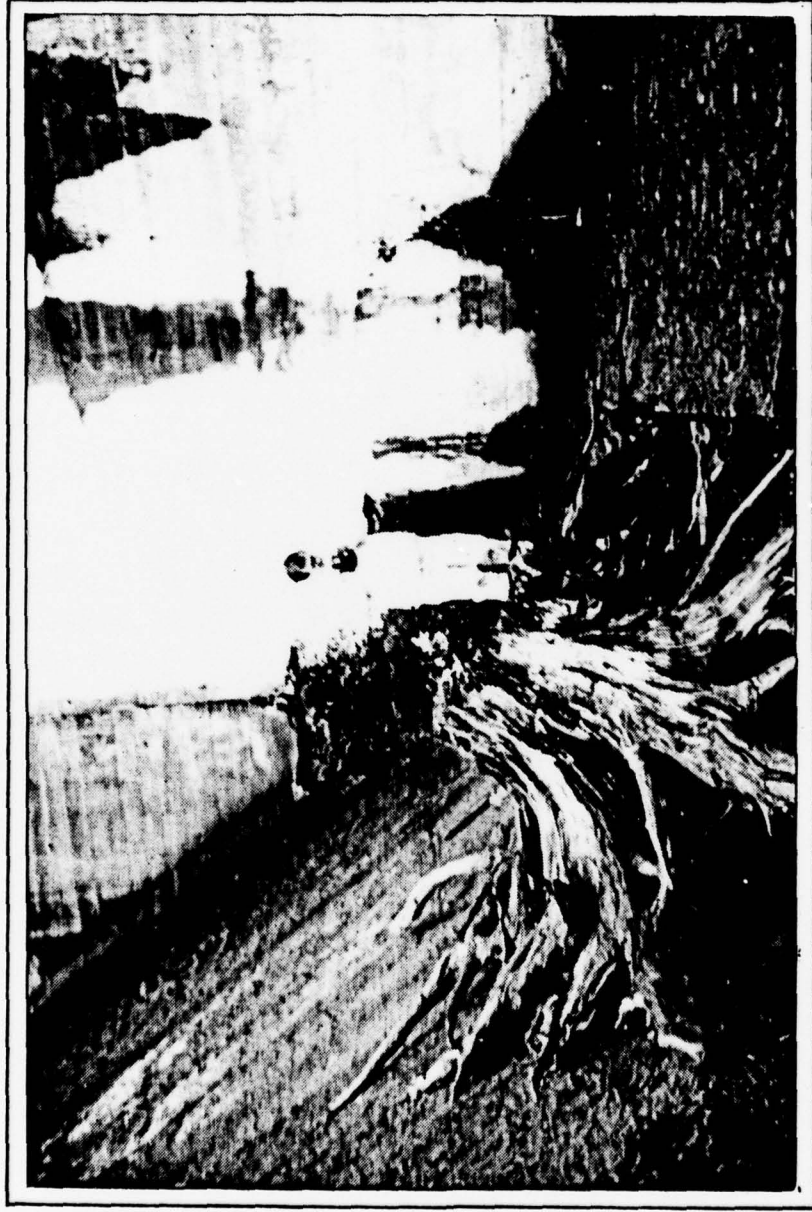
PHOTOGRAPH NO. 10

PRINCIPAL SPILLWAY. NOTE DETERIORATION ON LEFT WALL, SEEPAGE THROUGH WALL AND DEBRIS IN CHANNEL. SEEPAGE THROUGH SPILLWAY AND PORTIONS OF THE WALL FLOWS UNDER SLAB AT THE CONSTRUCTION JOINT.

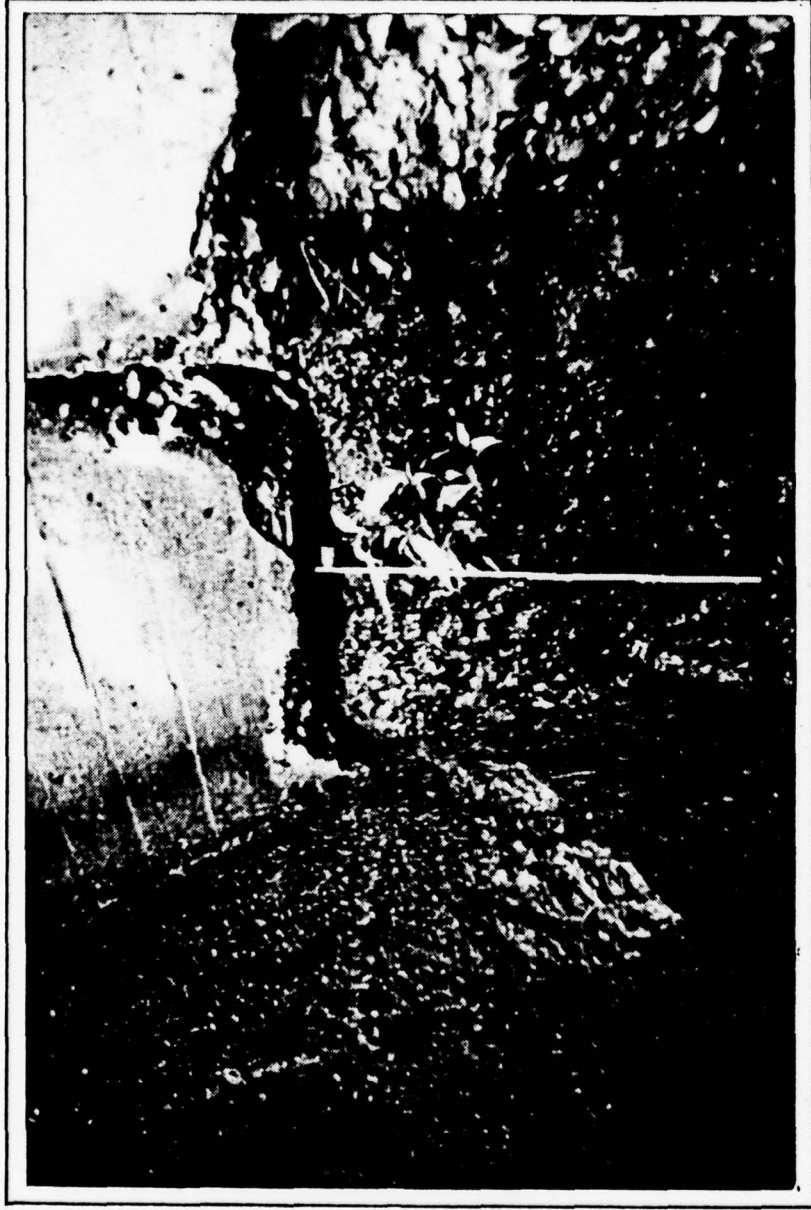
PHOTOGRAPH NO. 11

CLOSE-UP VIEW OF LEFT SPILLWAY WALL
DETERIORATION.

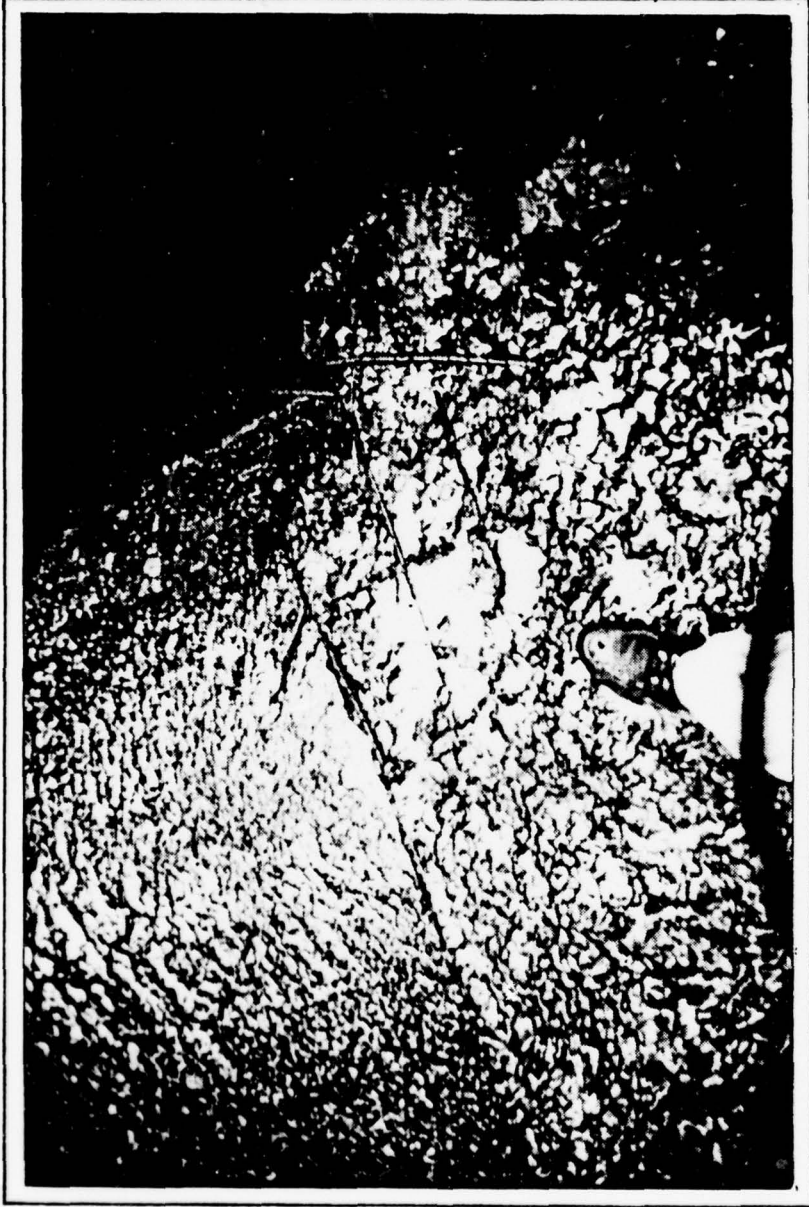
PHOTOGRAPH NO. 13

VIEW OF DETERIORATED CONCRETE ALONG
CHUTE SPILLWAY. NOTE EXPOSED AND
RUSTED REINFORCING STEEL.

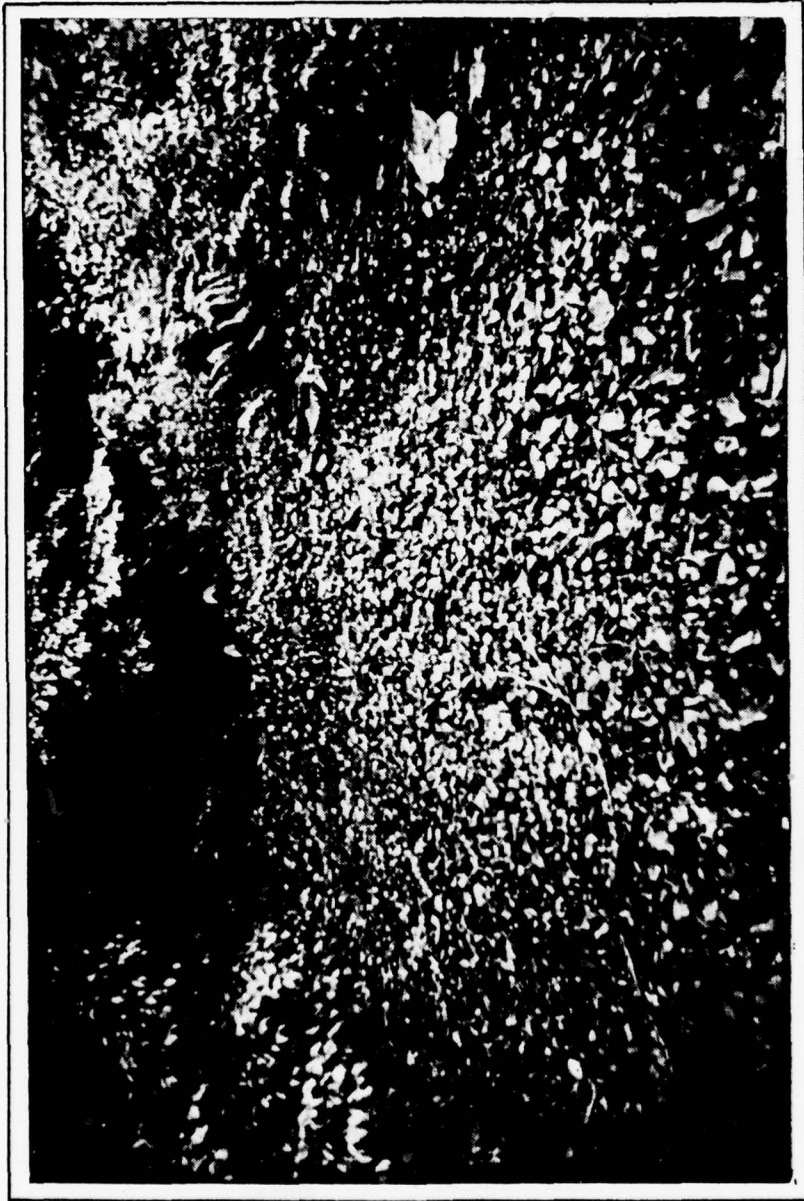
Seepage was noted along the downstream toe and along the right abutment. This seepage was cited by Department of Environmental Resources personnel during their periodic inspections. Flows have apparently never been monitored and, therefore, changes in the rate of flow were unavailable. The current Owner excavated these areas, placed gravel and installed pipes to drain the water into the small reservoir immediately downstream. The discharge was observed to be clear.

TYPICAL SEEPAGE AREA ON RIGHT SIDE OF
DAM (DOWNSTREAM SLOPE) WHICH WAS EX-
CAVATED AND REPLACED WITH GRAVEL. PIPES
LEAD FROM THE GRAVEL INTO THE LOWER
POND.

6. The wet area at the base of the dam should be regraded and drained. If seepage is observed after a reasonable period, an inverted filter or an equivalent seepage control system should be installed. Seepage and turbidity should be monitored.
