**STRAIGHT RUN DAM**

**NDI No. Pa. - 283**

**PHASE I INSPECTION REPORT  
NATIONAL DAM INSPECTION PROGRAM**

PHASE I INSPECTION REPORT  
NATIONAL DAM INSPECTION PROGRAM  
STRAIGHT RUN DAM  
NDI# PA-283, PENNDER# 32-76

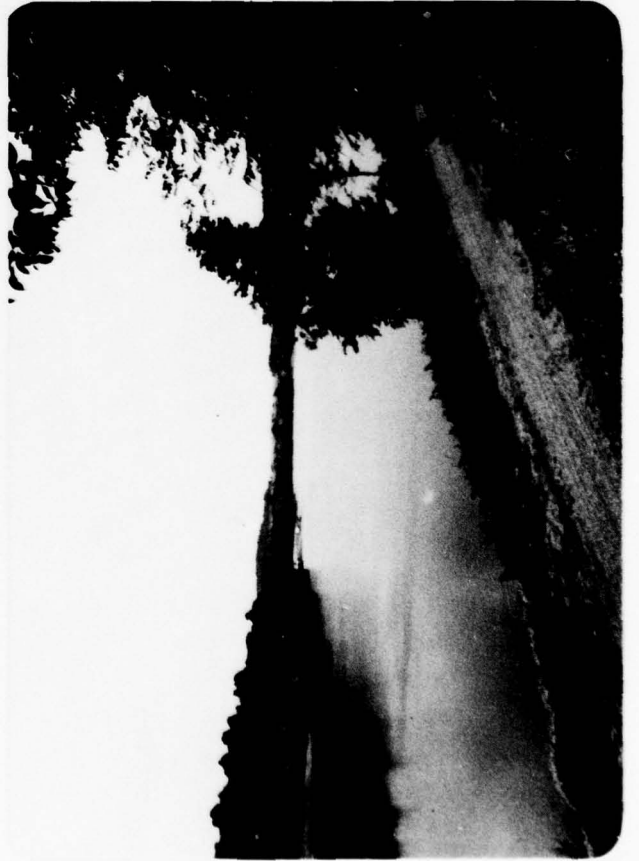
PHOTOGRAPH 3 View of the wooded, gentle to moderate slopes surrounding the reservoir.
