**NEW CROTON RESERVOIR DAM
WESTCHESTER COUNTY, NEW YORK
INVENTORY NO. 46**

**PHASE I INSPECTION REPORT
NATIONAL DAM SAFETY PROGRAM**

NEW YORK DISTRICT CORPS OF ENGINEERS

AUGUST 15, 1978

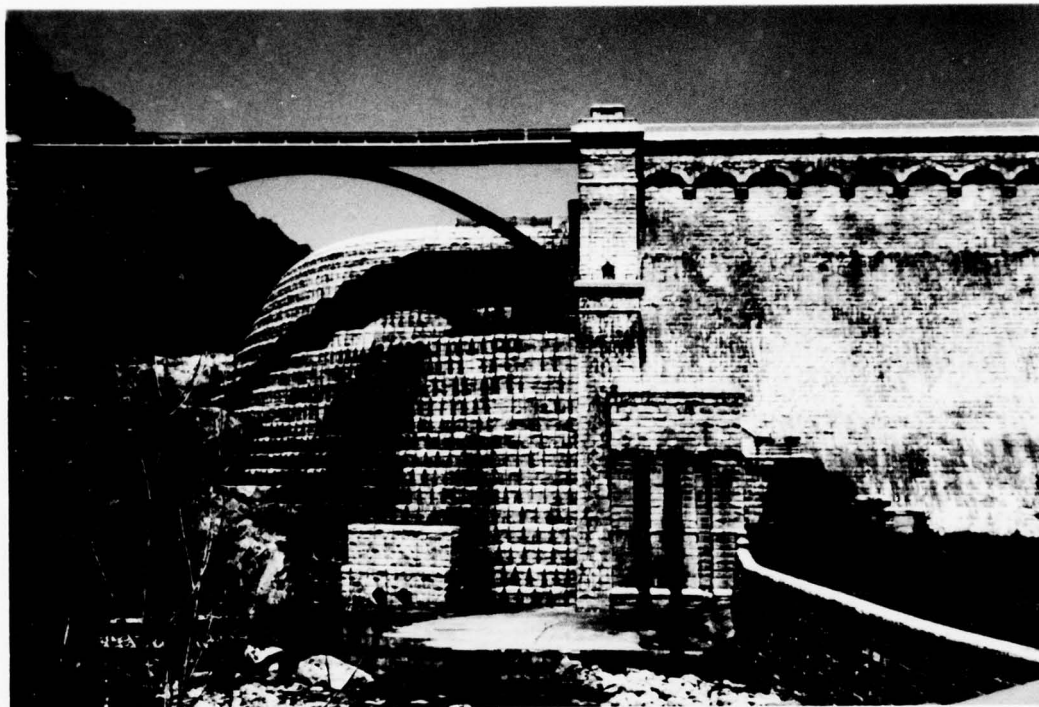
(A)* Minor seepage was observed in the morning at several locations on the downstream face. The seepage appeared to emerge from joints between facing stones. The seepage decreased considerably or disappeared in the afternoon when the face was exposed to the sun, apparently as a result of evaporation and expansion of the stones and mortar. It was reported that there is a noticeable increase in seepage on the downstream face of the dam during the cold weather of the winter months. Some calcium deposits were also observed on the face of the dam; the calcium was dissolved from the mortar and deposited by minor seeps.

(K)* The concrete apron downstream of the spillway channel and Gate House No. 2 blow-offs suffered moderate damage (cracks, eroded portions).

The seepage through the spillway and its foundation (Observations (F) and (J)) indicate a somewhat damaged condition of the structure resulting from the 1955 flood. The seepage suggests the presence of cracks and water pressures of unknown distribution inside of the structure. At freezing temperatures, seepage water may cause frost damage.

DOWNSTREAM VIEW OF SPILLWAY BRIDGE AND OUTLET STRUCTURES. THE PICTURE SHOWS SEEPAGE ON THE DOWNSTREAM FACE OF SPILLWAY, OBSERVATION (F) AND DAMAGED CONCRETE APRON, OBSERVATION (K).

a. The spillway and tailrace channels should be cleared and their surface made smoother by removing loose rocks and filling depressions with concrete. The apron downstream of the spillway should be repaired.

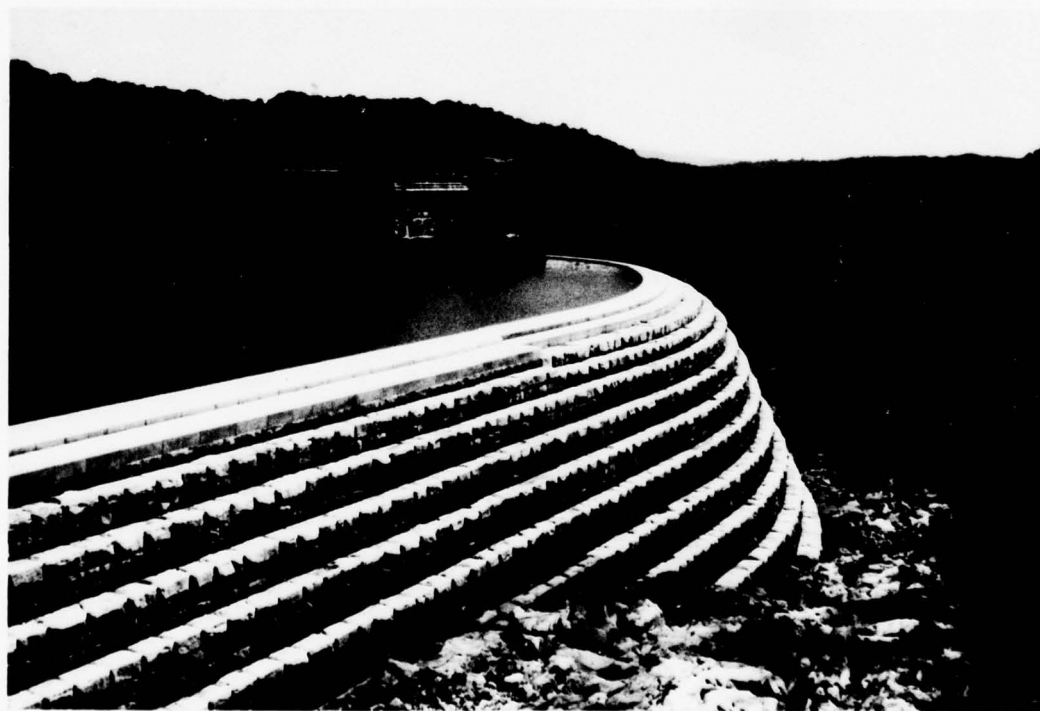
(J)* Some seepage appears to emerge at the contact of the masonry structure and its foundation along the spillway channel.

SPILLWAY AND GATE HOUSE NO. 2 (NORTH) VIEWED FROM THE SPILLWAY CHANNEL. THE WATER IN THE CHANNEL IS SEEPAGE FLOW, OBSERVATION (J).

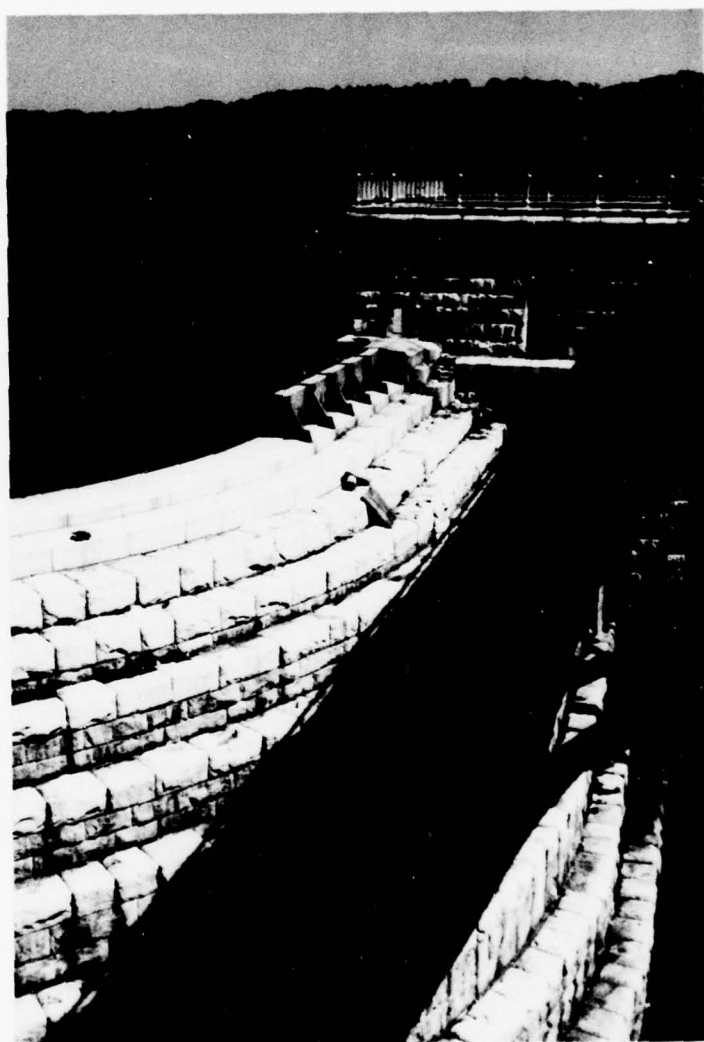
(G)* Debris and vegetation are evident on the structure at various locations, but a considerable amount of these were observed on the wide platform on El 140.

SPILLWAY AND GATE HOUSE NO. 2. THE PICTURE ILLUSTRATES THE SEGMENTS OF LEFT IN PLACE PARAPET WALL NEXT TO THE GATE HOUSE AND ALSO SHOWS SEEPAGE FLOW, SOME DEBRIS AND VEGETATION GROWTH, OBSERVATIONS (F) AND (G).

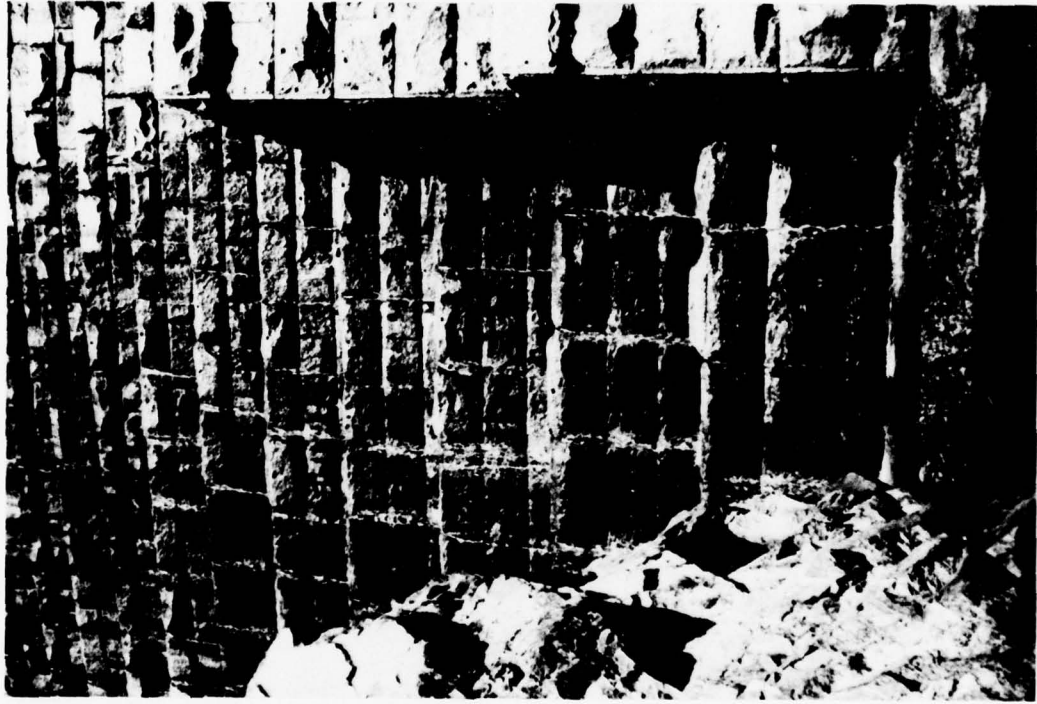
SEEPAGE FLOW ON THE DOWNSTREAM FACE OF SPILLWAY, OBSERVATION (F)

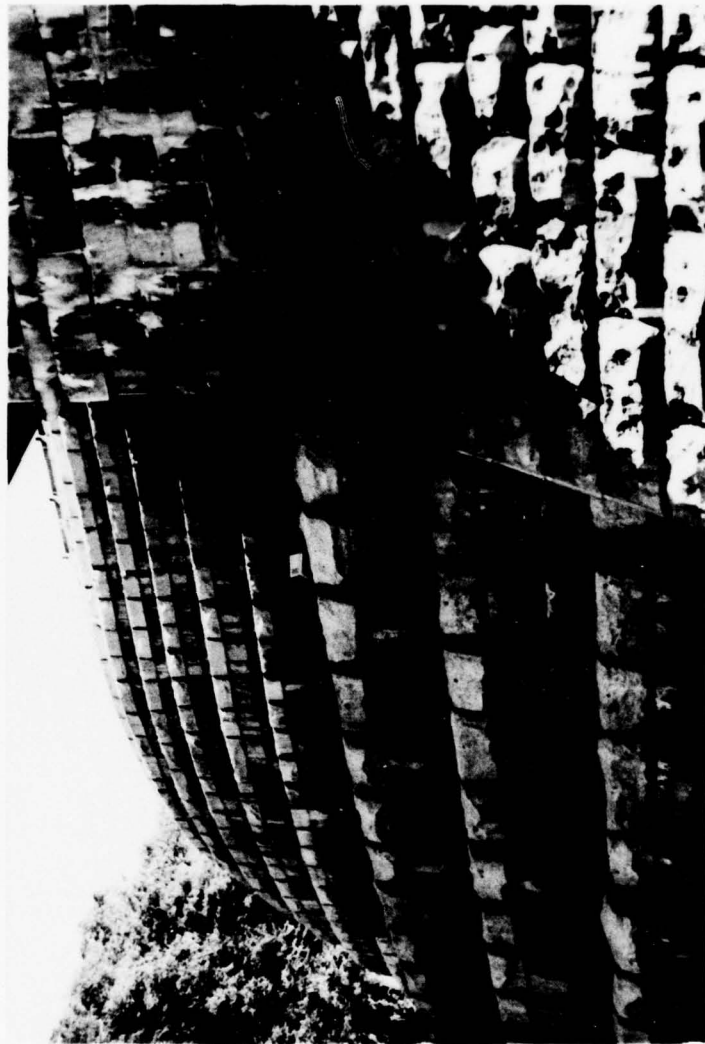
VIEW OF THE DOWNSTREAM FACE OF SPILLWAY SHOWING SEEPAGE FLOW ON THE STEPS, VEGETATION COVER AND DEBRIS ON THE EL 140 FEET PLATFORM, OBSERVATIONS (F) AND (G).

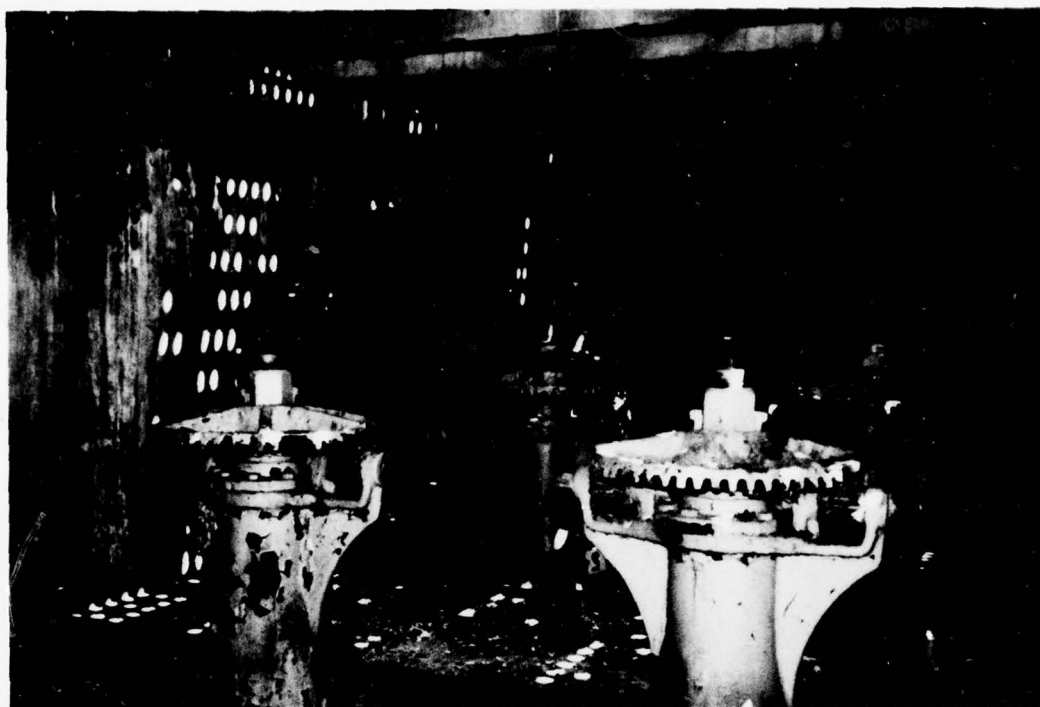
(M) Gate stand surfaces have extensive paint peeling and some rusting.

(P) Some of the roof and floor grating panels were broken and missing. The floor is strewn with debris.

GATE HOUSE NO. 1 (SOUTH) SHOWING RAISED SHIELD AT ENTRANCE TO THE OLD AQUEDUCT LEADING TO THE NEW CROTON GATE HOUSE; MISSING FLOOR PANELS, AND CONDITION OF GATE OPERATING STANDS, OBSERVATIONS (M) AND (P).

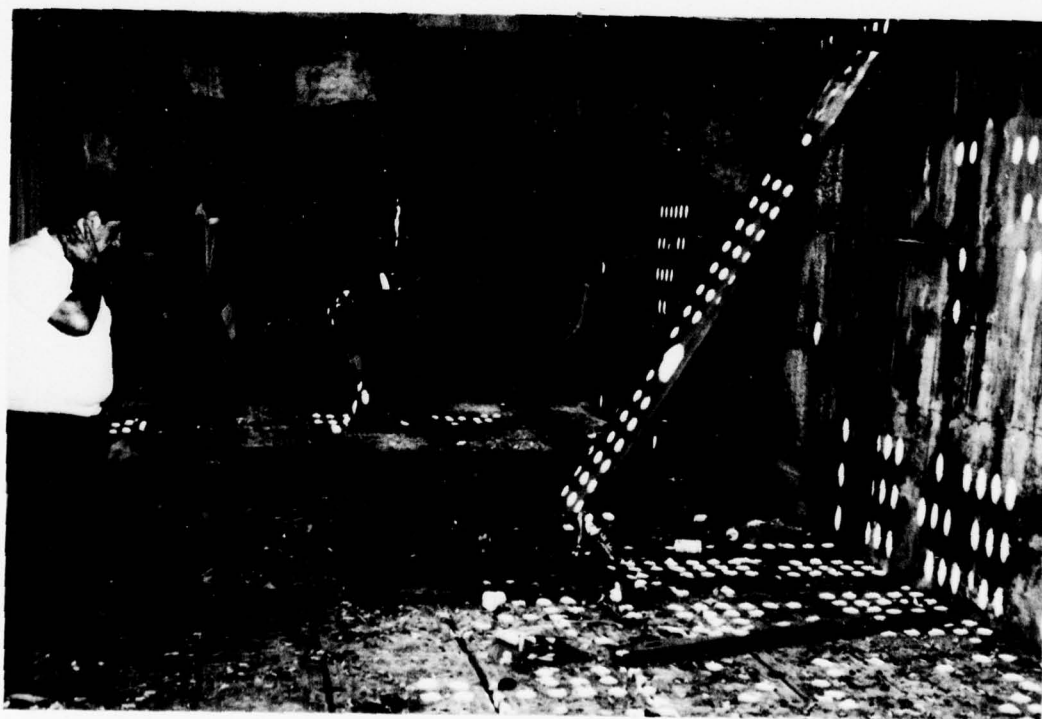
(Q)* The sluice gate of the north blow-off pipe was open and hung with the operating stand removed. The balance valve was closed and said to be operable but leaking.

GATE HOUSE NO. 2 (NORTH) SHOWING DISMANTLED OPERATING STAND OF INTAKE SLUICE GATE, AND OPERATING STAND OF BALANCE VALVE FOR NORTH BLOWOFF PIPE, OBSERVATION (Q).

b. The gates and valves of the three blow-offs in Gate House No. 2 should be repaired or replaced. These facilities are essential for lowering the reservoir. In connection with the repair of the low level outlet facilities the relocation of the left tailrace retaining wall may be considered. Reportedly, this wall is subject to damage when the south blow-off is operated.
