DELAWARE RIVER BASIN
ARIEL CREEK, WAYNE COUNTY

PENNSYLVANIA
ID NO. PA.00166

ROAMING WOODS LAKE DAM

PHASE I INSPECTION REPORT
NATIONAL DAM INSPECTION PROGRAM

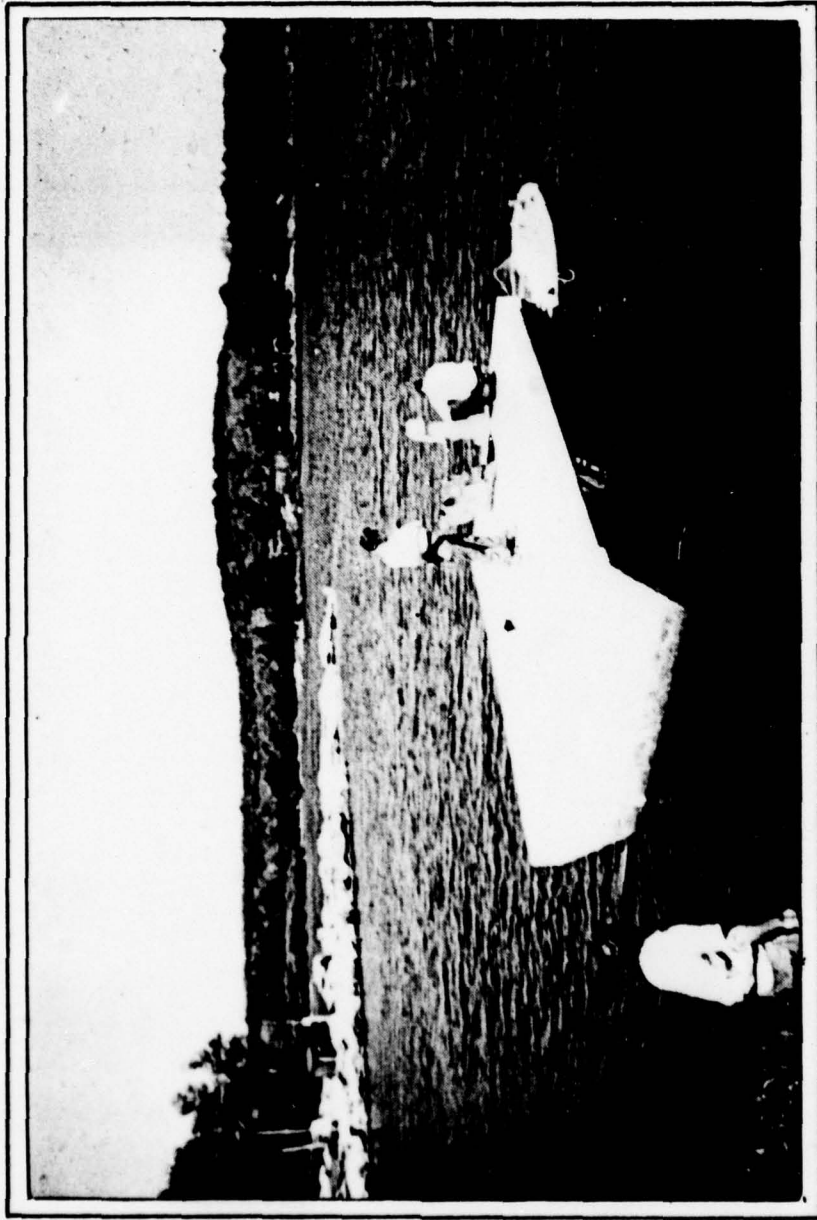
PHOTOGRAPH NO. 1

VIEW OF PRINCIPAL INTAKE STRUCTURE.
NOTE WEIR AND POND DRAIN VALVE.

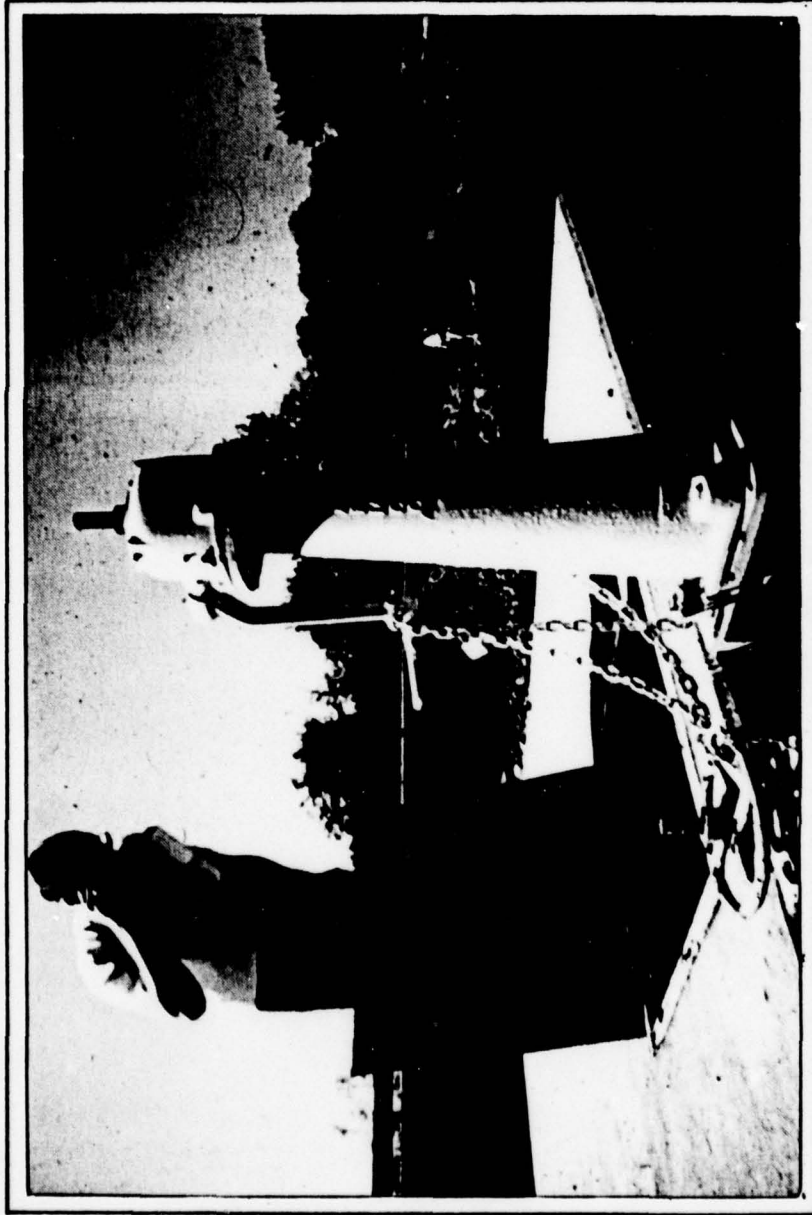
PHOTOGRAPH NO. 2

Data located in DER files indicates that the eight inch pipe was designated for use to maintain minimum flow. However, this valve was closed. During the inspection, water was found to be flowing through leaks in the pond drain valve. This flow was estimated to meet or exceed minimum flow requirements. During the winter, the reservoir is lowered three to five feet so that the water level is below the dock facilities. Since this structure was built, the emergency spillway has never experienced flow. There are no other known operational requirements for this dam and reservoir.

VIEW OF POND DRAIN VALVE.

It is believed that current operating procedures are a realistic means of operating the relatively simple control facilities of Roaming Woods Lake Dam. Although the eight-inch valve is not being used to maintain minimum flow, normal leakage of the pond drain gate appears to be satisfying this flow. During the lifetime of this facility sediment may eventually block the pond drain system. If minimum flow requirements are to be continued through the pond drain, it is recommended that 1) the gate be exercised at least yearly to maintain an open channel to the drain and 2) the valve be calibrated to assure that minimum flow is maintained.

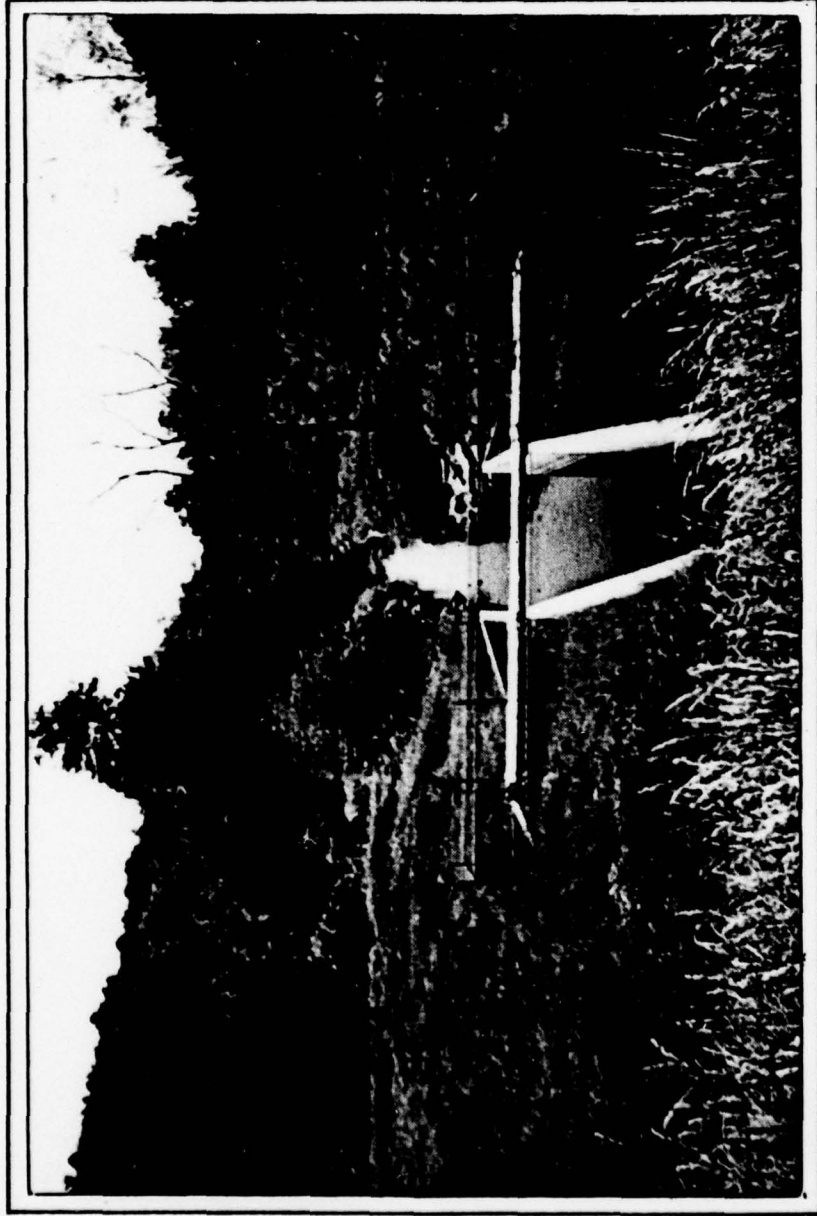
PHOTOGRAPH NO. 3

VIEW FROM DAM CREST LOOKING TOWARDS
STILLING BASIN. WATER PIPES CROSS
THE BASIN.

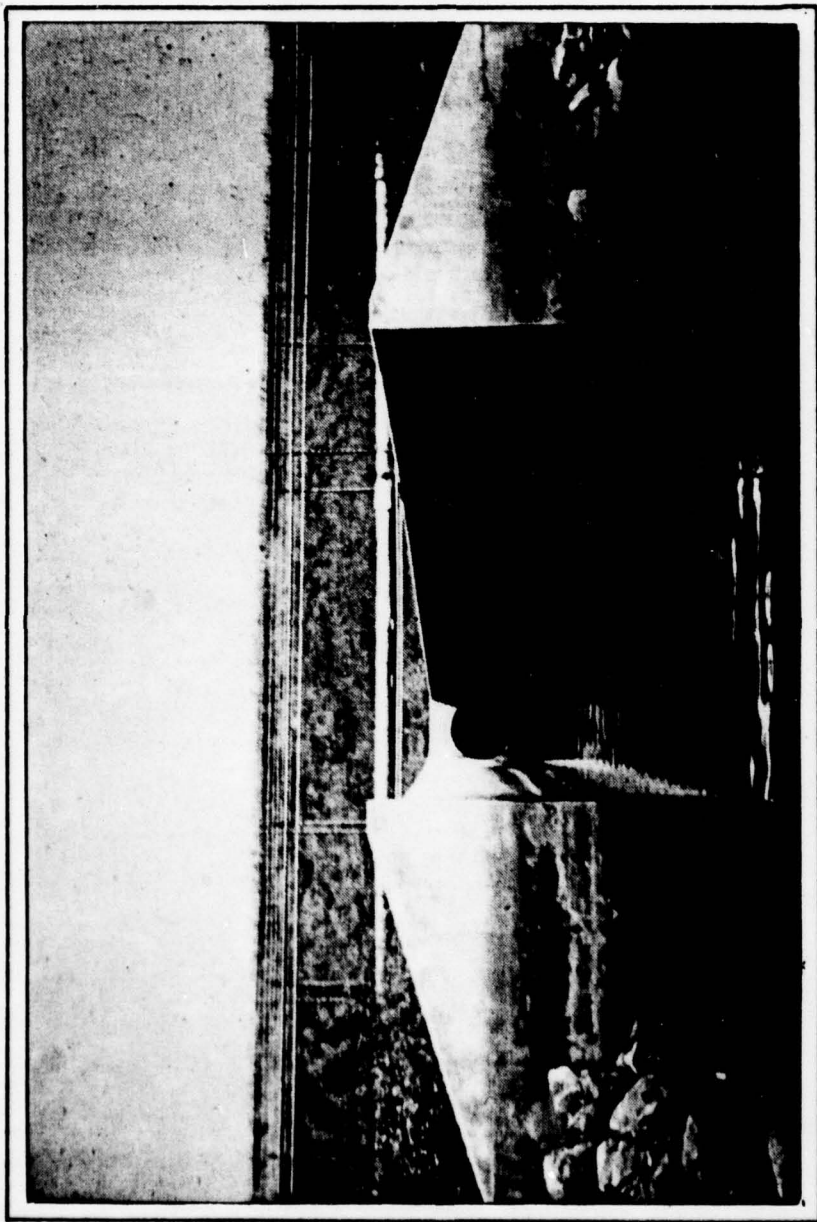
PHOTOGRAPH NO. 4

VIEW LOOKING UPSTREAM INTO STILLING
BASIN. NOTE HIGH WATER MARKS ON
THE WING WALLS.

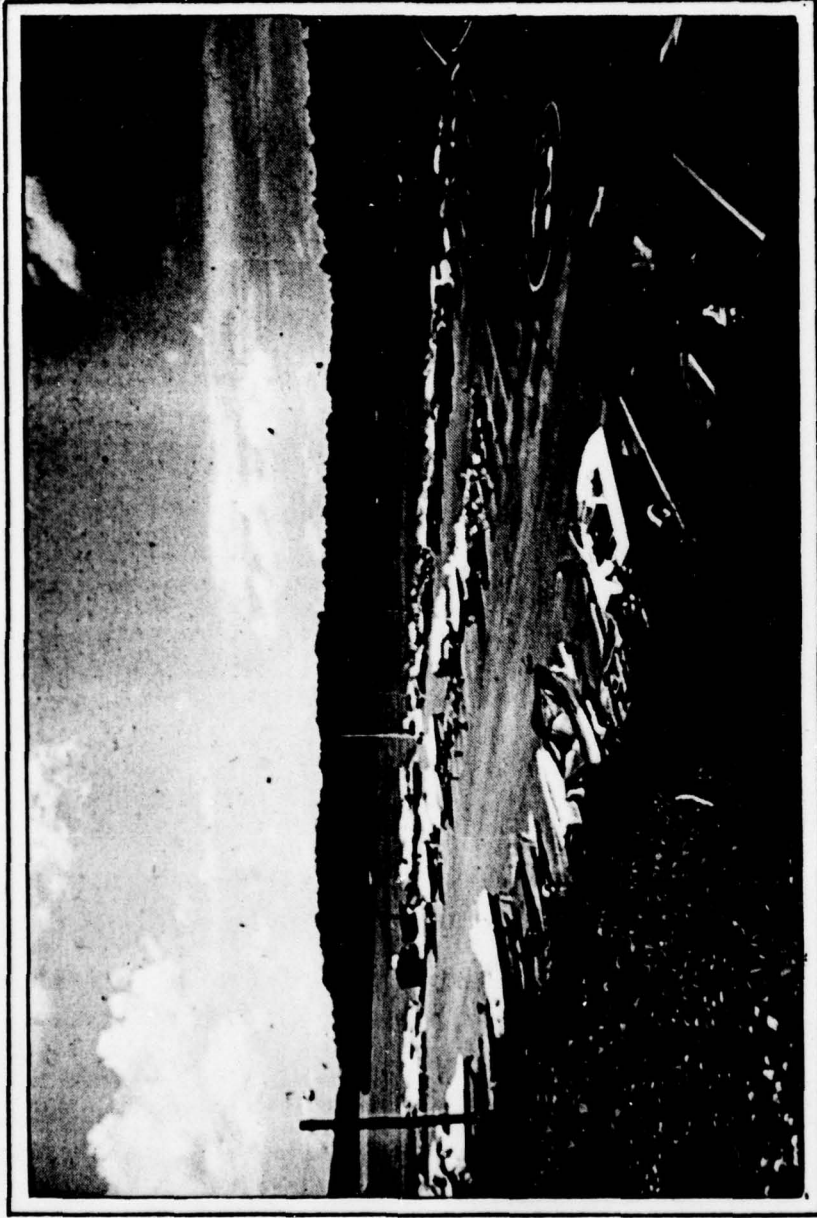
PHOTOGRAPH NO. 5

c. Visual Observations. Detailed visual observations concerning the reservoir, spillways, and downstream channel are contained in Appendix B. It should be noted that the approach channel to the emergency spillway is paved and is being used as a marina, parking lot and storage area for canoes, boats, and boat trailers. Also located in this area are two sheds used by the marina personnel. The lakeward sides of the marina are lined with large decorative boulders with tops that are approximately at or below the elevation of the emergency spillway. It is considered likely that flow through the emergency spillway will be slightly, but insignificantly, reduced because

VIEW OF EMERGENCY APPROACH CHANNEL.
NOTE BOATS AND OTHER OBSTRUCTIONS
IN PARKING AREA.

1. In view of the obstructions in the approach channel, it is recommended that the emergency spillway be re-assessed. It is not recommended that the channel be used to store boats, trailers or serve as a parking lot.
2. The riprap discontinuity along the water's edge should be re-evaluated by a qualified engineer and rehabilitated in accordance with the engineer's recommendations.
3. It is recommended that the Owner contact a professional engineer and obtain a procedure for operating the two gates in the intake riser. Specifically, clarification should be obtained on when and how to use the eight-inch valve and how to operate the pond drain valve to satisfy minimum flow requirements.

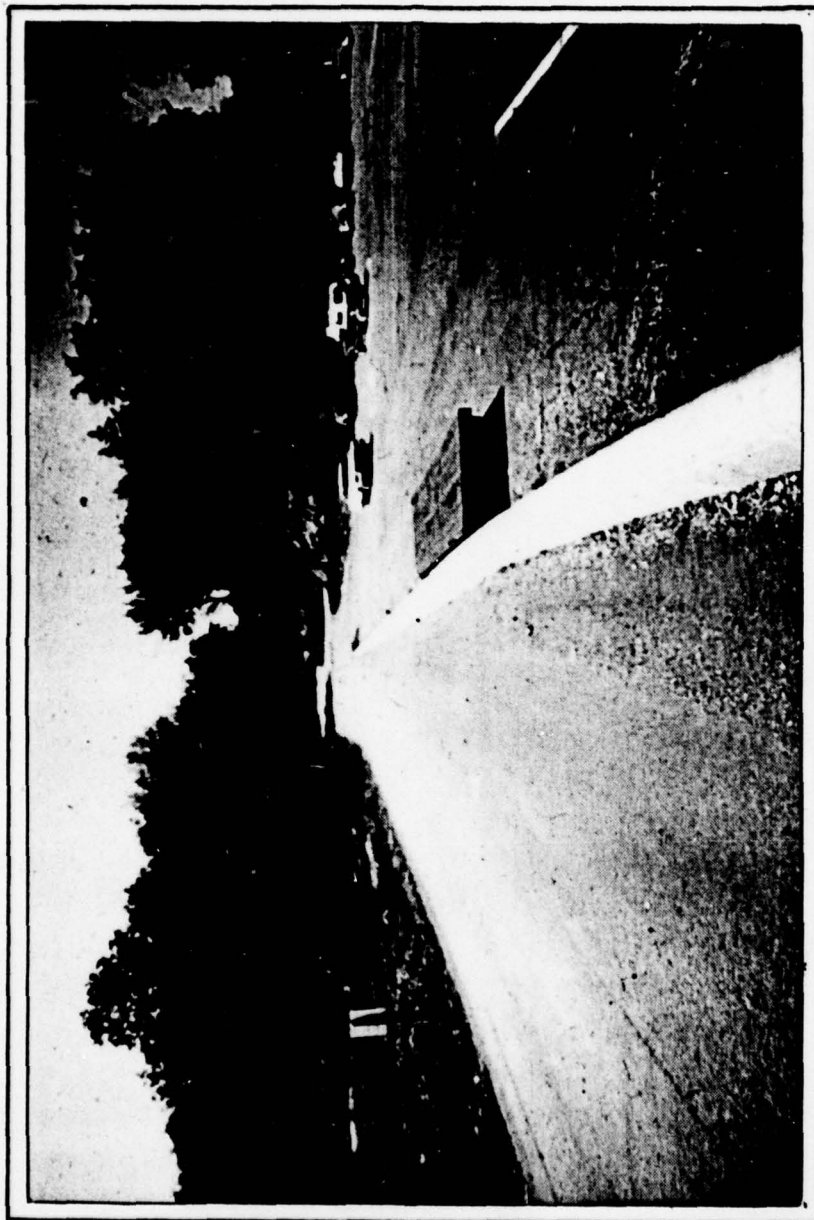
PHOTOGRAPH NO. 6

The emergency spillway was inspected and found to be in good condition. There was only very minor spalling of the weir section which can probably be attributed to highway traffic hitting this dual purpose weir and curb structure. The approach channel was observed to be asphalt paved and used as a parking area. Details of the approach channel are described in Appendix B and in Section 2.1, paragraph b. The discharge channel downstream was inspected and the riprap appears to be in good condition. A concrete retaining wall is located along the left abutment of the spillway which is conjugal with the right abutment of this dam. This concrete retaining wall was constructed to prevent erosion of the dam in the event of the passing of a storm over the emergency spillway. Some standing water was observed at the base of the emergency spillway, between the toe of the spillway and the discharge channel. This appears to be a natural topographic low and not associated with under seepage through the spillway or under the dam.

VIEW OF EMERGENCY SPILLWAY CONTROL
SECTION LOOKING TOWARDS RIGHT ABUT-
MENT.

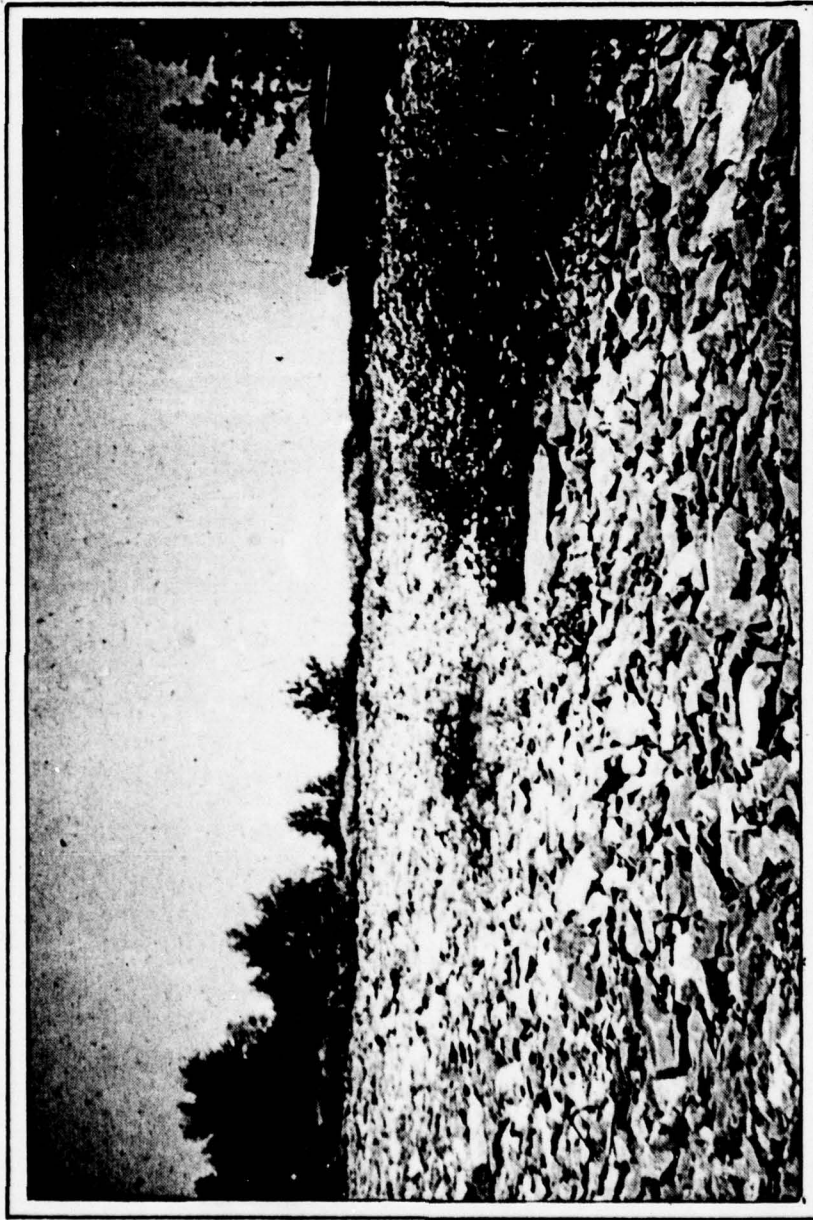
PHOTOGRAPH NO. 8

RIPRAP PAVING OF EMERGENCY SPILLWAY
DOWNSTREAM OF THE CREST (LOOKING
UPSTREAM) .

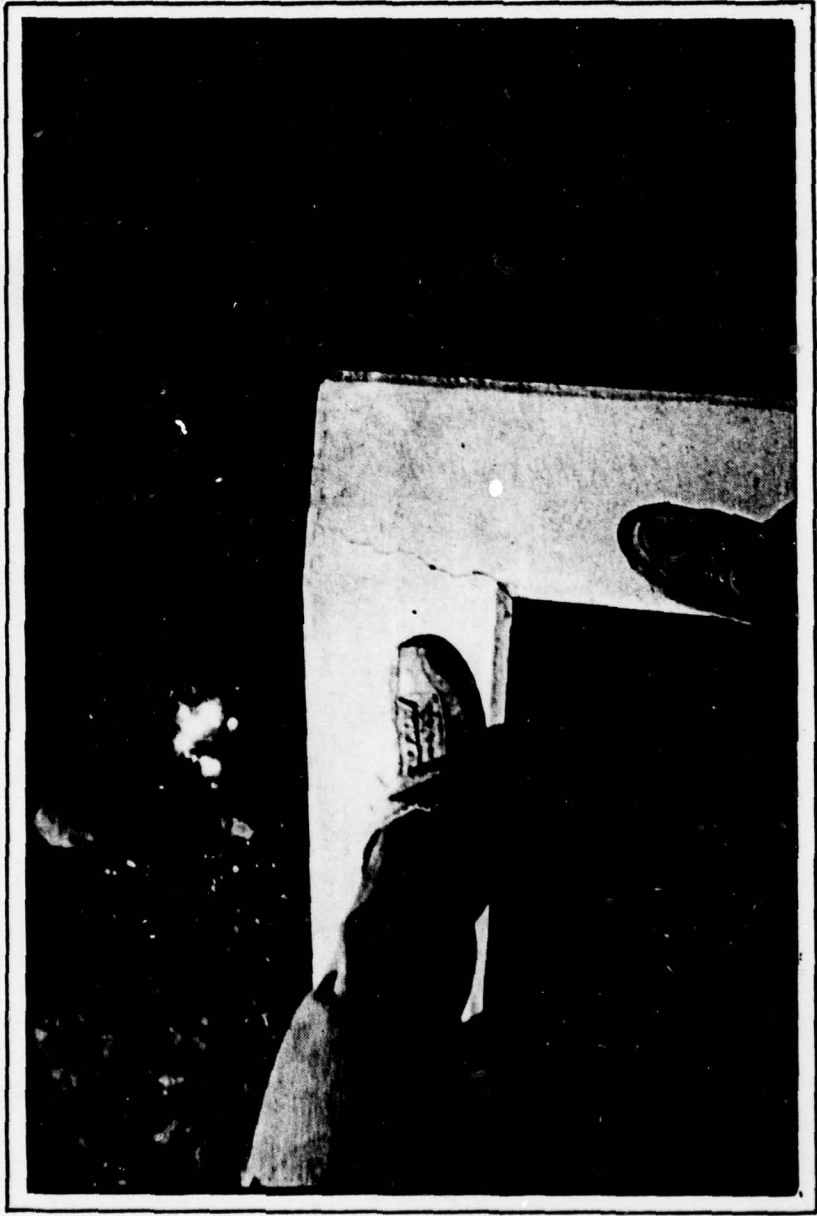
PHOTOGRAPH NO. 10

walls. One minor tension crack was observed along the left wing wall. This crack is described in Appendix B, Sheet 6 of 11 and shown on Photograph No. 10.

MINOR CRACKING OF LEFT WING WALL.

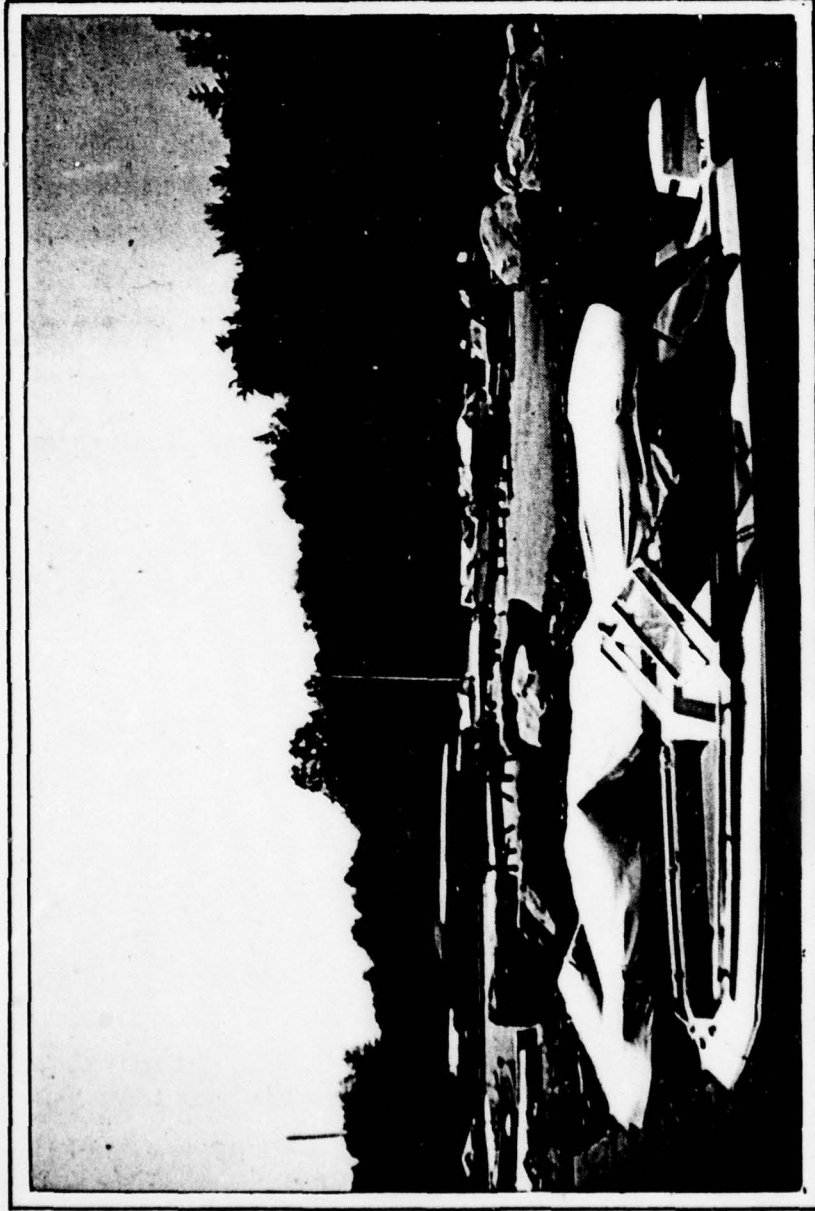
PHOTOGRAPH NO. 11

VIEW OF OBSTRUCTIONS IN THE EMER-
GENCY SPILLWAY.

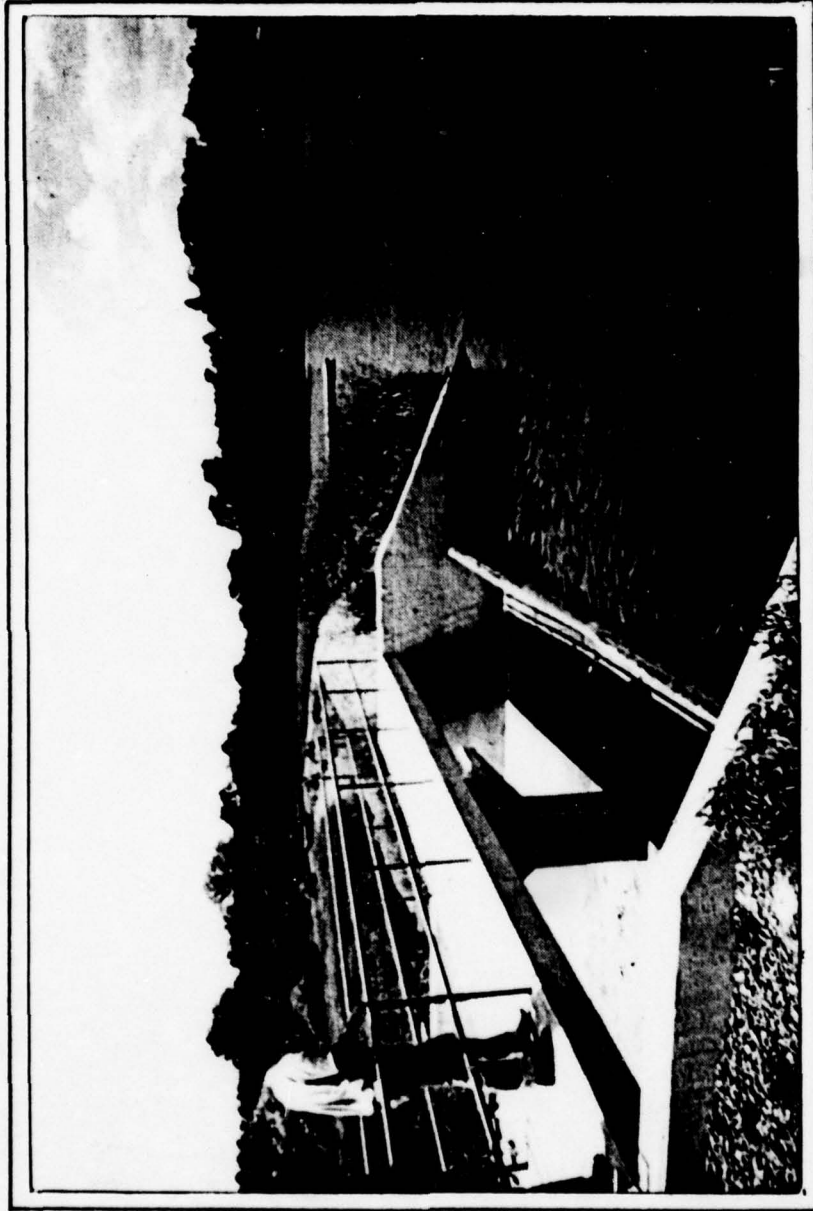
PHOTOGRAPH NO. 14

OVERVIEW OF BROOKS LAKE DAM AND
SPILLWAY.
