BEAR GAP NO. 2

PHASE I INSPECTION REPORT

Bear Gap Number 2 (NDS PA-816),
Susquehanna River Basin, Northumberland
and Columbia Counties, Commonwealth of
Pennsylvania. Phase I Inspection Report.

BERGER ASSOCIATES, INC.
CONSULTING ENGINEERS
HARRISBURG, PA

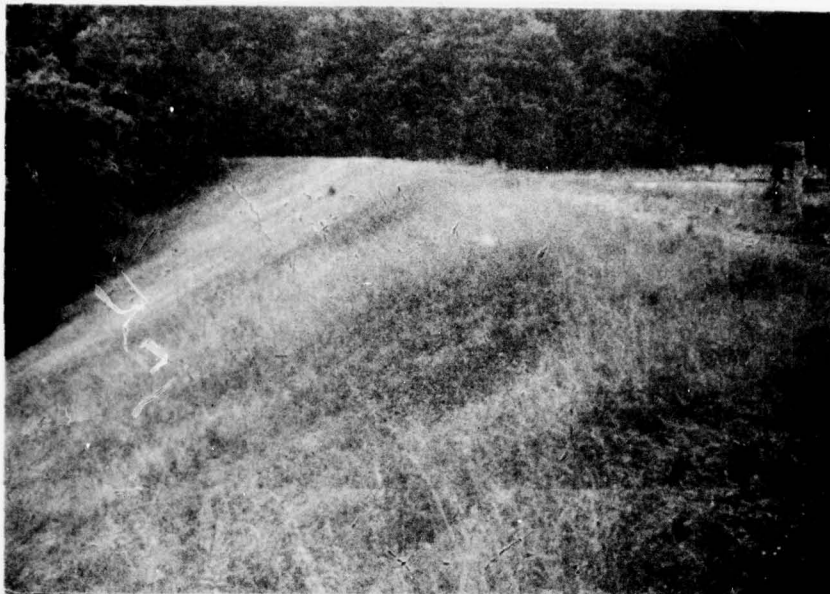
Downstream
Slope
Looking North

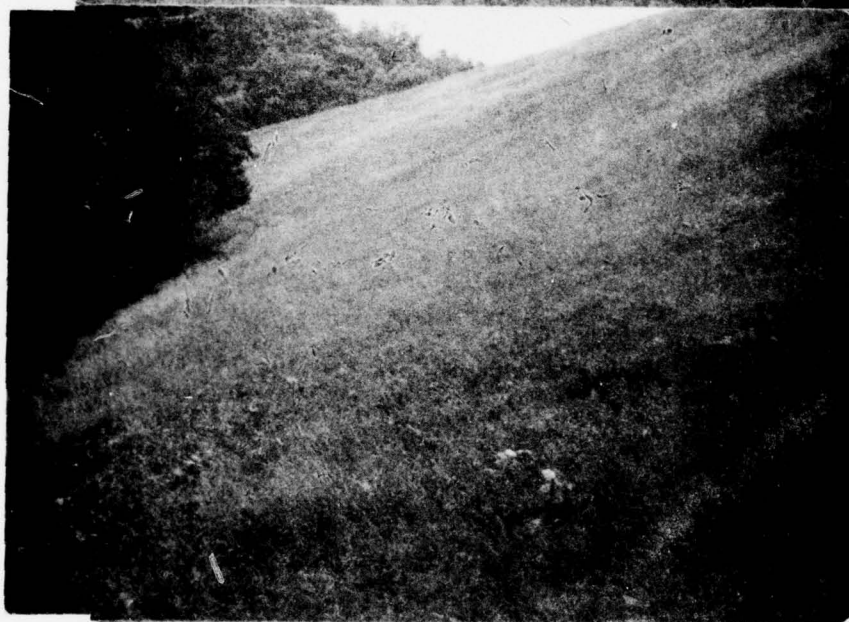
Downstream
Slope

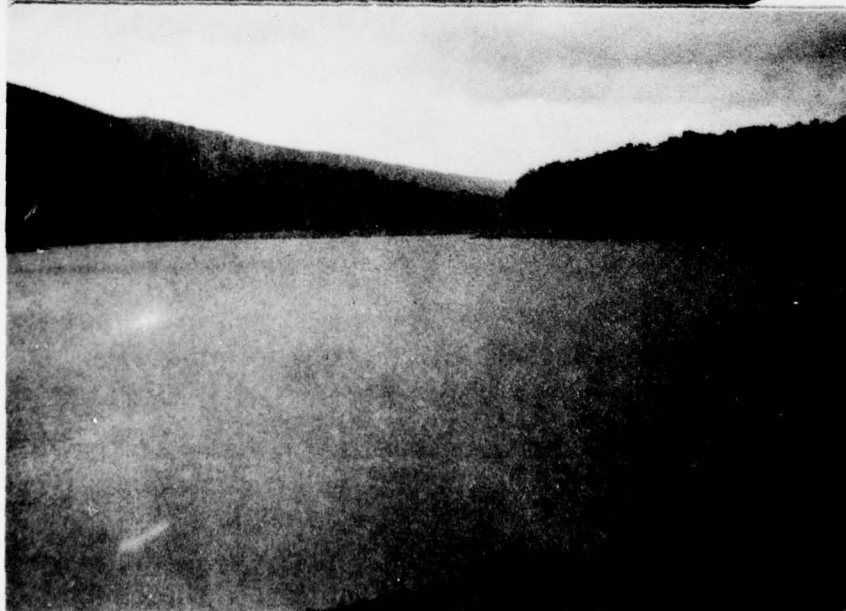
The reservoir area is very well kept. The lake is surrounded by woods and the lake banks did not show any erosion problems. The Bear Gap No.6 Dam (NDS #817) is located approximately 4.4 miles upstream. If Bear Gap No.6 Dam would fail, it can be assumed that the surge of water would overtop Bear Gap No.2 Dam.

Reservoir

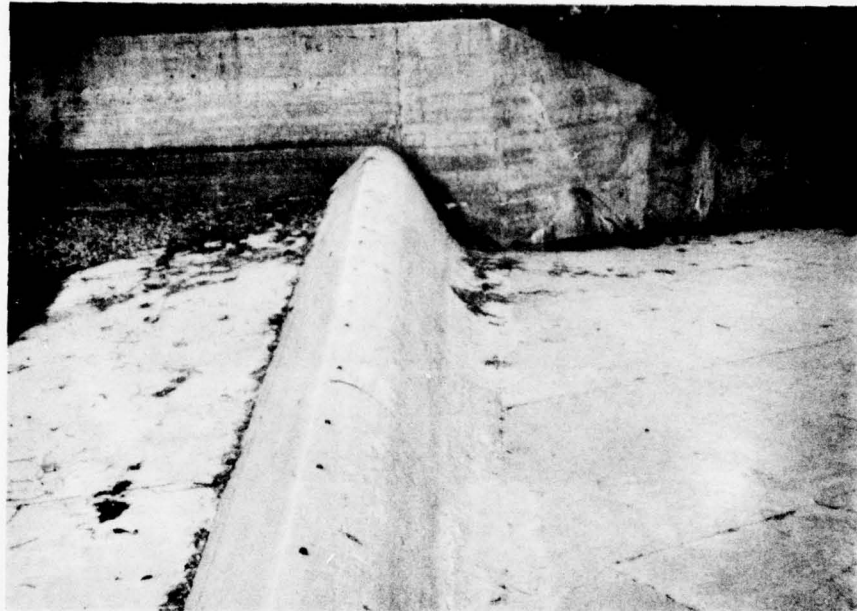
Spillway
Weir

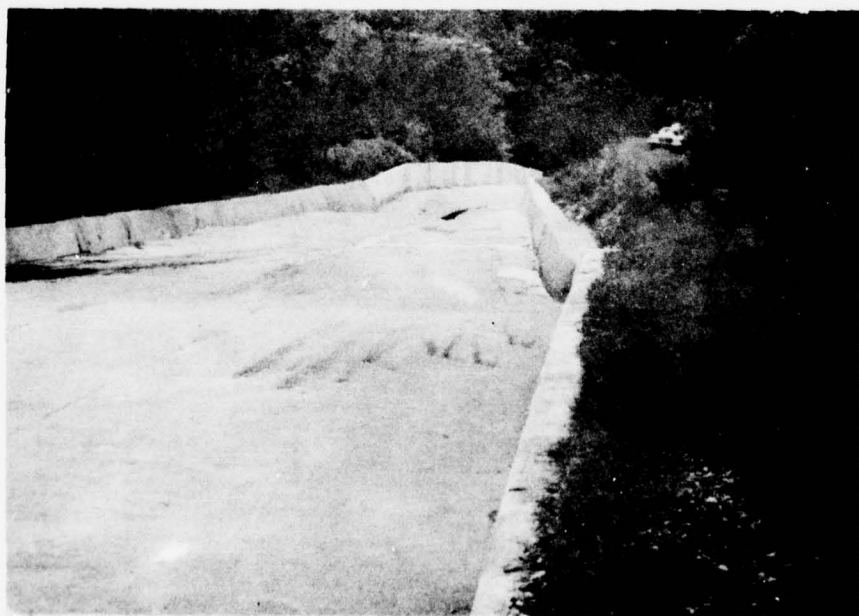
The spillway weir and training walls were in good condition. Tropical storm Agnes (June, 1972) had caused heavy erosion of the spillway chute starting at a point approximately 100 feet downstream from the weir. A total reconstruction of the chute and stilling basin was completed in 1975. Some additional repairs consisting of guniting and the placing of gabions were under way at the time of inspection. The stilling basin had been pumped dry and the effectiveness of the energy dissipation could not be observed. Plates IV and V, Appendix D, contains photographs of the spillway.

Spillway
Channel

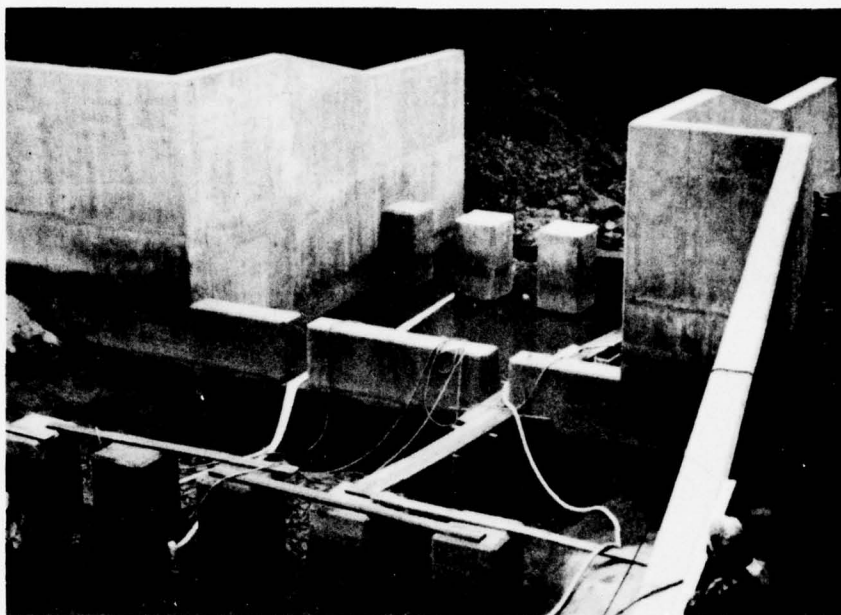
Energy
Dissipator

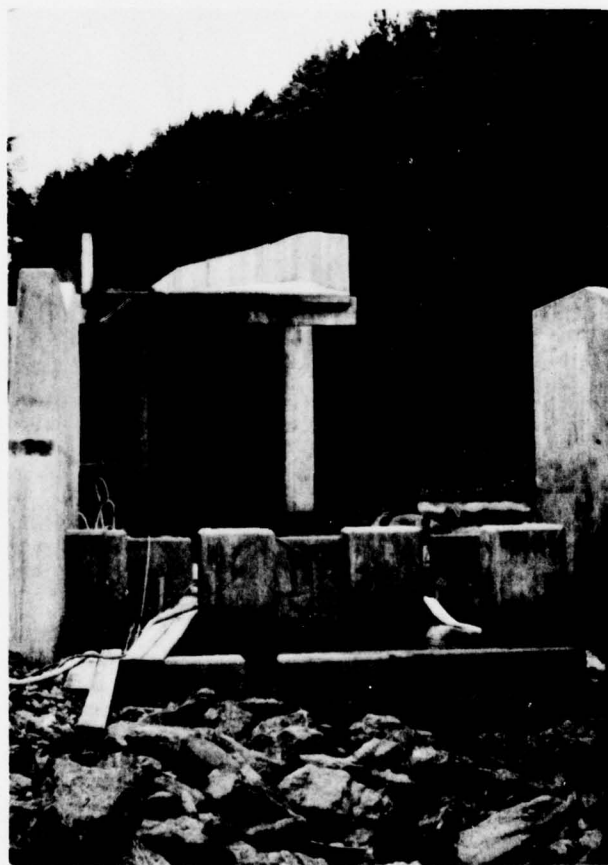
Spillway
Looking Upstream
