NDI No. Pa. - 176
PYMATUNING RESERVOIR

PHASE I INSPECTION REPORT
NATIONAL DAM INSPECTION PROGRAM,

⑪ AUGUST 1978

PHASE I REPORT NATIONAL DAM INSPECTION PROGRAM

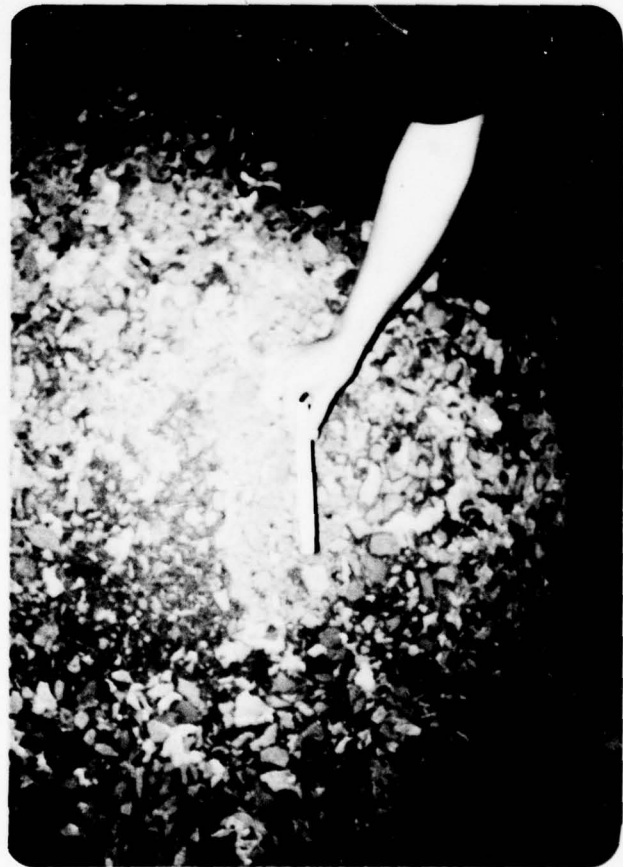
7

The 6- by 8-foot outlet conduit was in good condition aside from some scaling near the inlet (see Photograph 7). The gate control stems and sluice gate were badly corroded and are reported to be inoperative. According to the park superintendent, a contract to replace the stems, stem guides, stem thrust bolt, and to sandblast and paint the sluice gates has been let and this work is scheduled for the near future.

2. Outlet Works. According to available PennDER files, the sluice gate controls which regulate flow through the 6- by 8-foot outlet conduits are in a deteriorated condition. Stop logs had been installed in the right outlet conduit in preparation for repairing the outlet controls. Consequently, we were able to directly observe their corroded condition. Considerable scaling was also observed on the walls of the outlet conduit just downstream of the sluice gates (see Photograph 7).

- a. The outlet works be thoroughly evaluated and repairs made which will ensure the operability of the system. Note: According to State Parks personnel, they are in the process of letting a contract to make the necessary reparations.

- b. The deteriorated concrete within the primary outlet conduits be repaired.
- c. The swampy area at the toe of the dam be drained. A weir or weirs should be installed to monitor flow in the region. This information should be transmitted to the Division of Water Resources Projects, Bureau of Resources Programming within the PennDER for their review. The results of the weir readings and the relationship with pool level, rainfall, and seasonal variations should be evaluated by a registered engineer experienced in the design and construction of earth dams. Further investigations, including the installation of observation wells, may be necessary if the seepage is deemed excessive or if abnormal conditions are indicated.

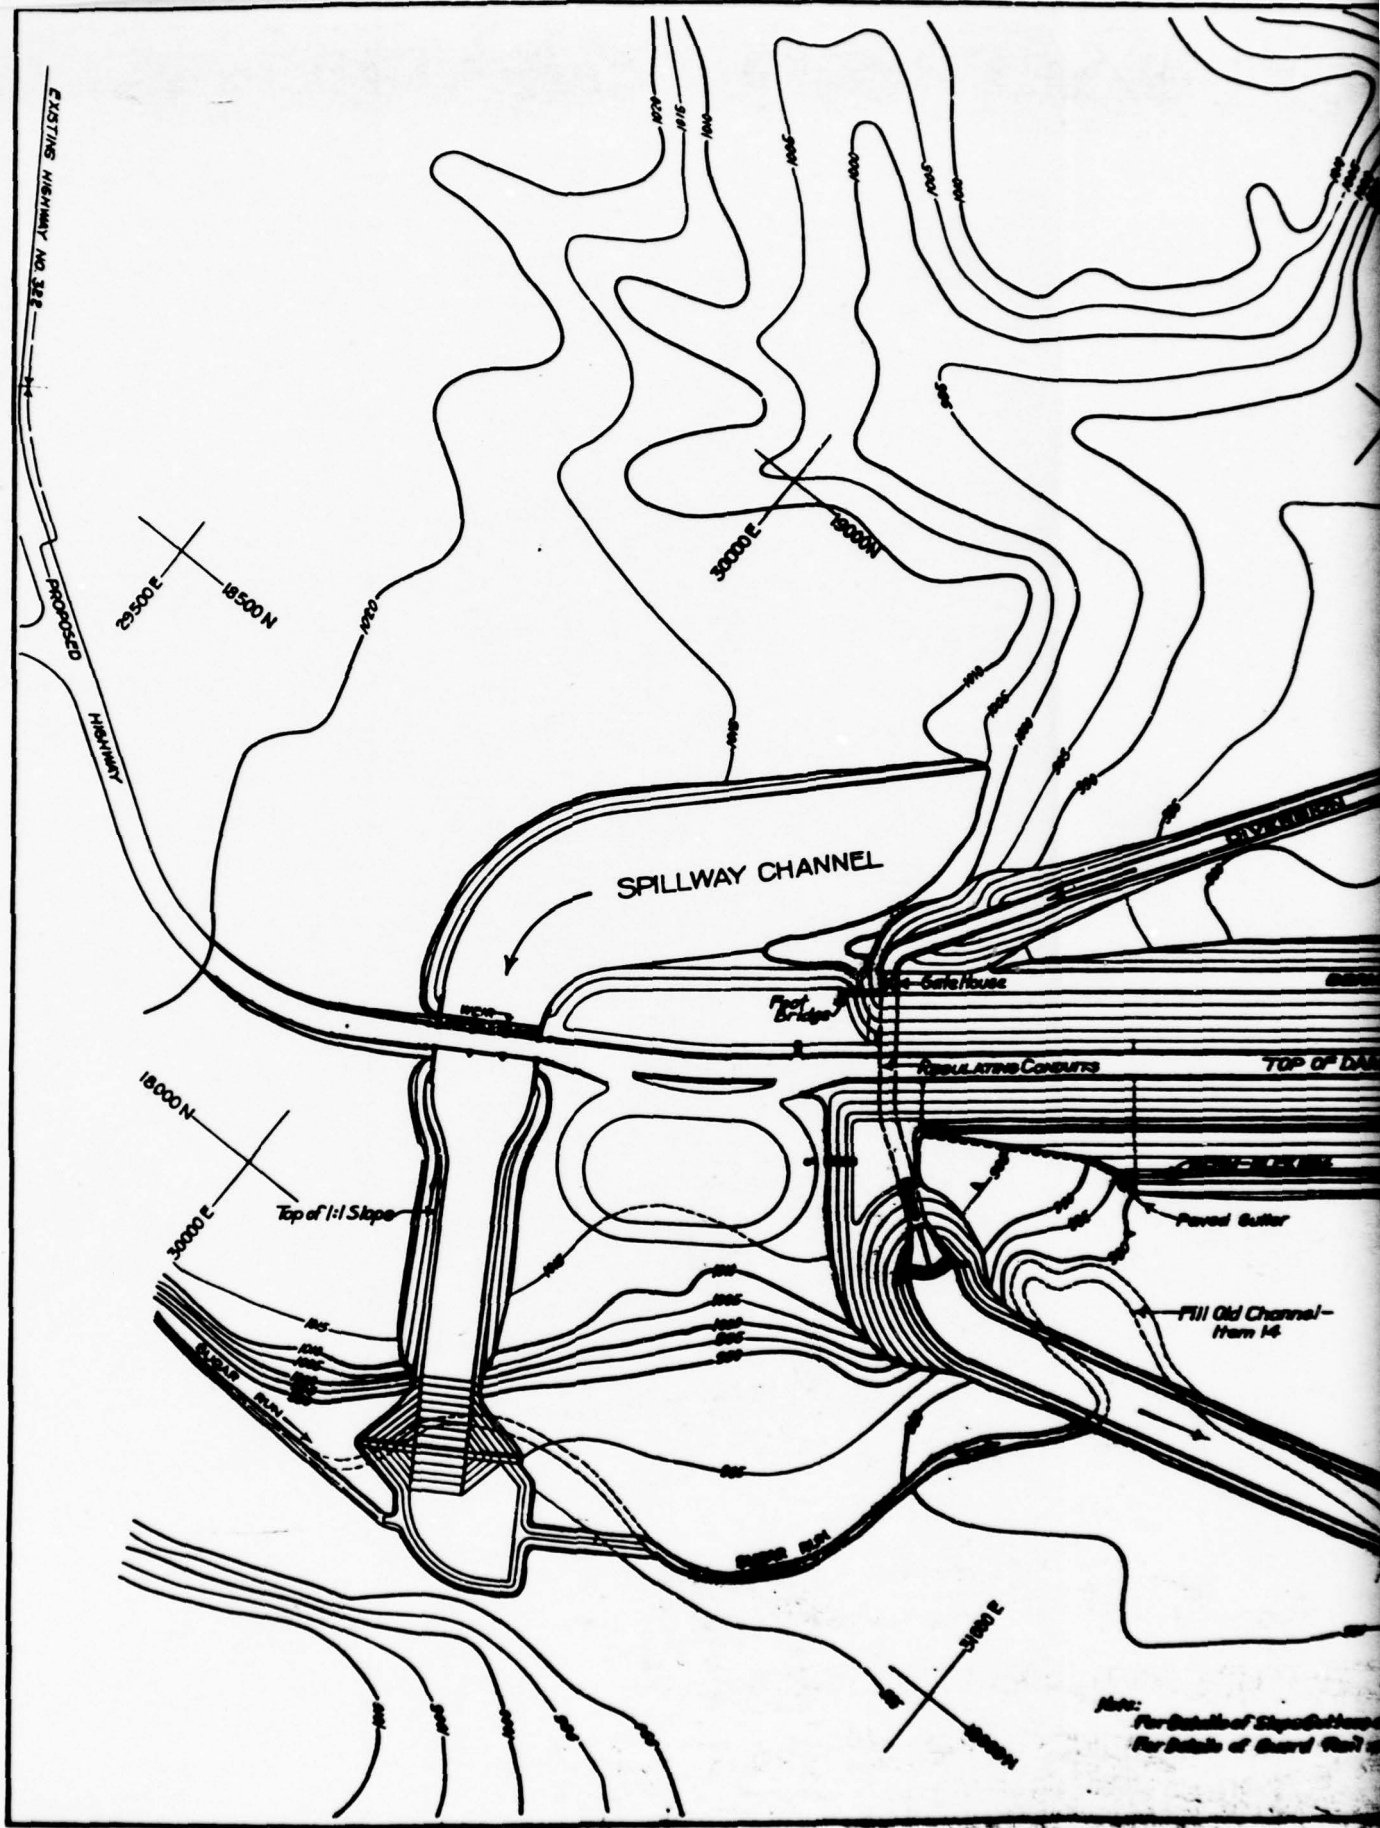
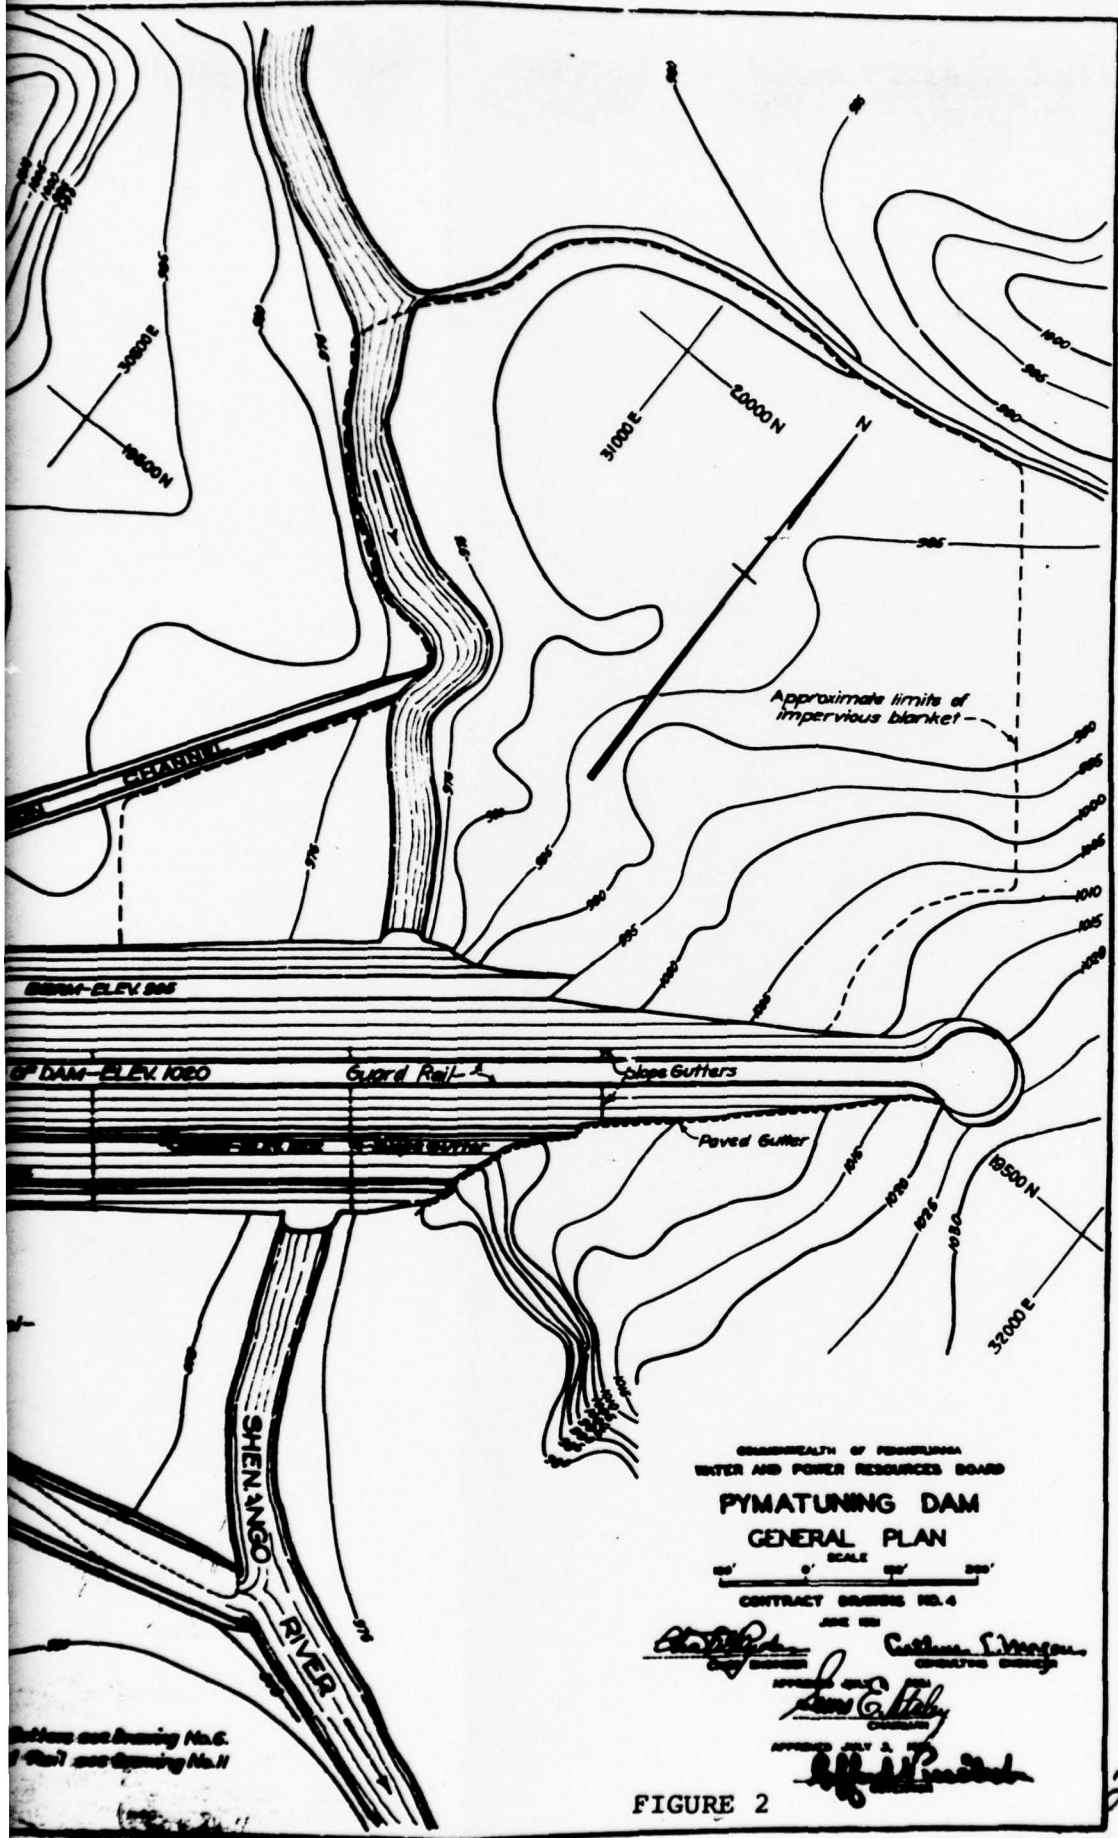
FIGURE 2

a. Embankment. Based on visual observations, the dam appeared to be in fair condition. A small amount of seepage was observed issuing from two seeps located on the natural hillside to the right of the 6-foot by 8-foot outlet conduits. This condition was not considered serious since flow was minimal and it is possible that it is associated with the drains which appear to be draining the parking lot area on the crest of the embankment between the outlet conduits and the emergency spillway (see Figure 2).

Two areas of seepage were found associated with the embankment. The first was noted to the right of the discharge end of the primary outlet structure (see Photographs 5 and 6). Seepage in this area was minimal and may be associated with tile drains which apparently drain the parking area atop the dam (see Figure 2).
