WARREN H. OHL DAM

PHASE I INSPECTION REPORT

NATIONAL DAM INSPECTION PROGRAM

by
BERGER ASSOCIATES, INC
CONSULTING ENGINEERS
HARRISBURG, PA

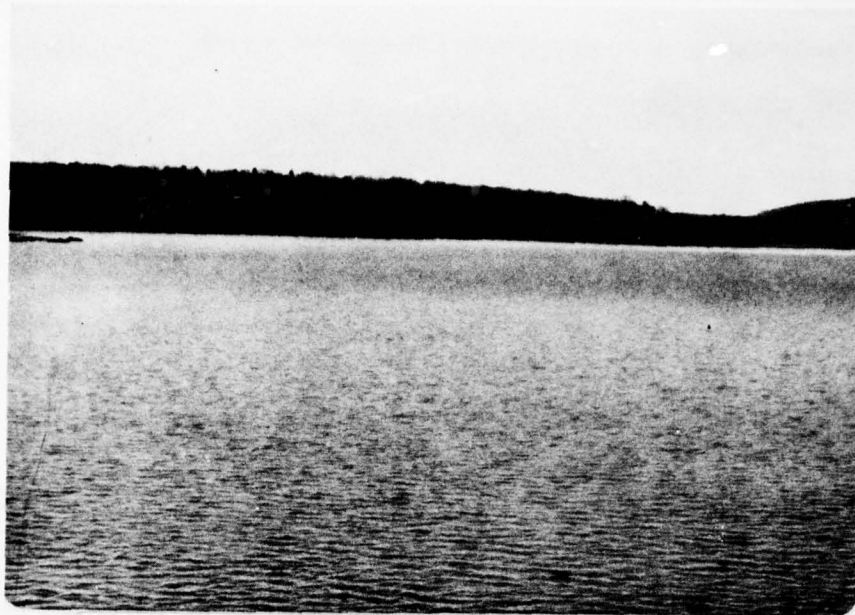
Reservoir

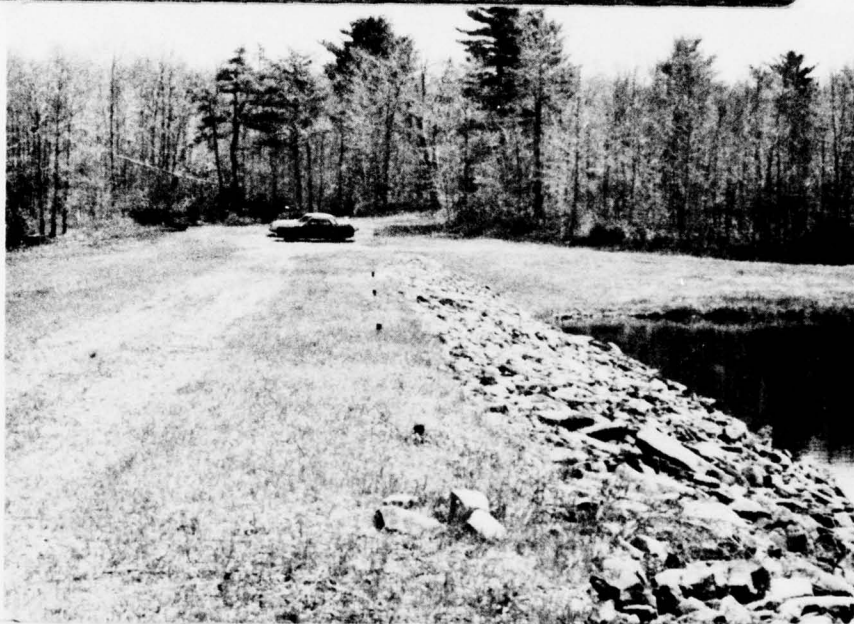
Right
Abutment

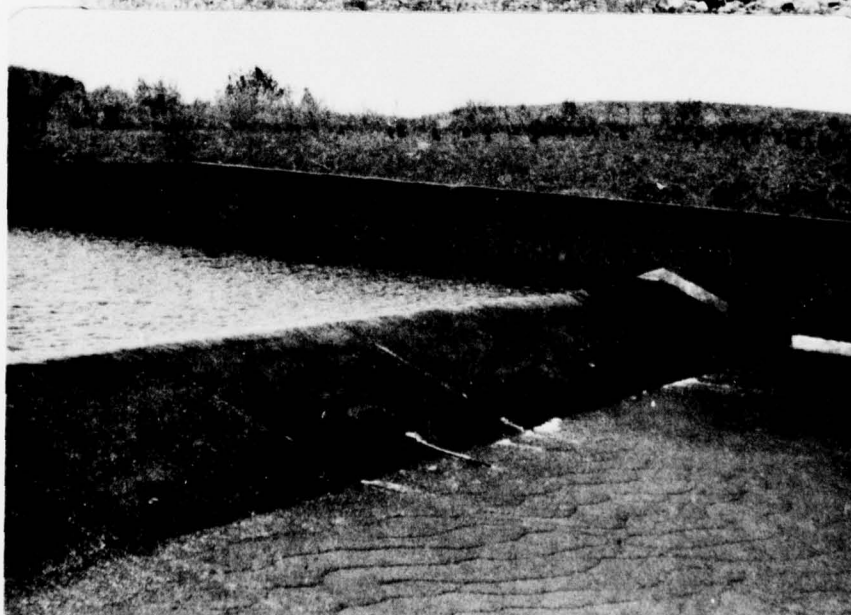
The spillway crest and walls are in good condition, except for a few cracks. The spillway slab shows slight deterioration. Cracking is caused by the excessive length of individual monoliths.

Spillway
Weir

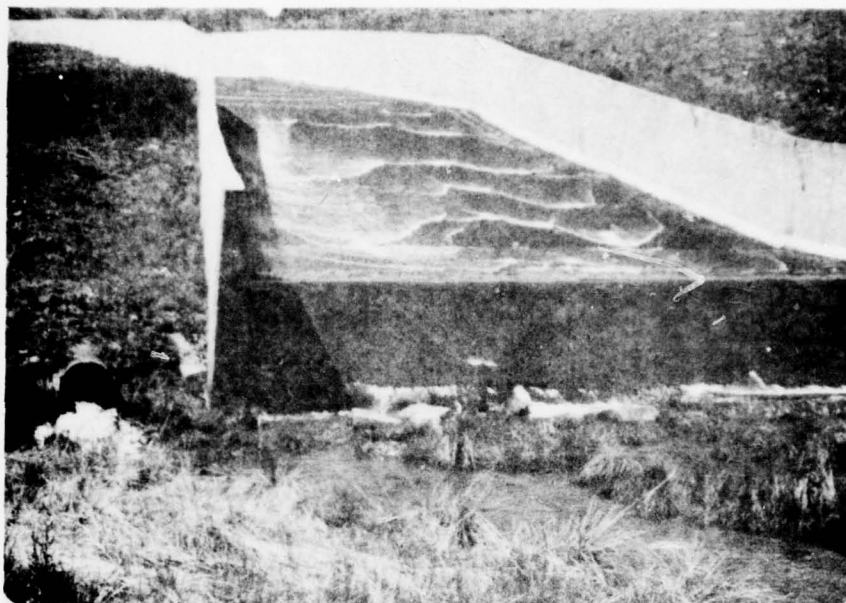
Stilling
Basin

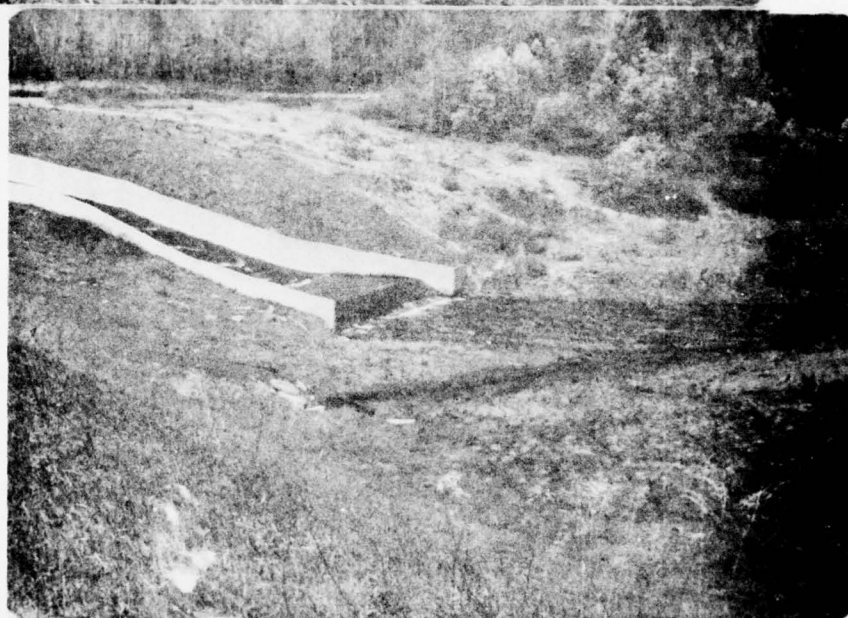
There were no visual observations of undue embankment stresses, which would be indicated by sloughage or cracking. There are, however, large areas of extremely wet soft spots along the downstream toe and immediately downstream from the embankment, indicating seepage through the foundation or embankment. All water is clear, showing no transportation of the fine materials with the present hydraulic head.

Entire toe of embankment slope wet and soggy from leakage.

Downstream
Toe

1. Owner should control the seepage existing on the embankment slope and along the toe.
2. Owner should investigate the cause of and provide for the control of standing surface water between the embankment and the spillway.
3. Backfill all woodchuck holes.
4. Owner should monitor and record seepage quantities. If the flow increases with time, implement remedial measures at once.

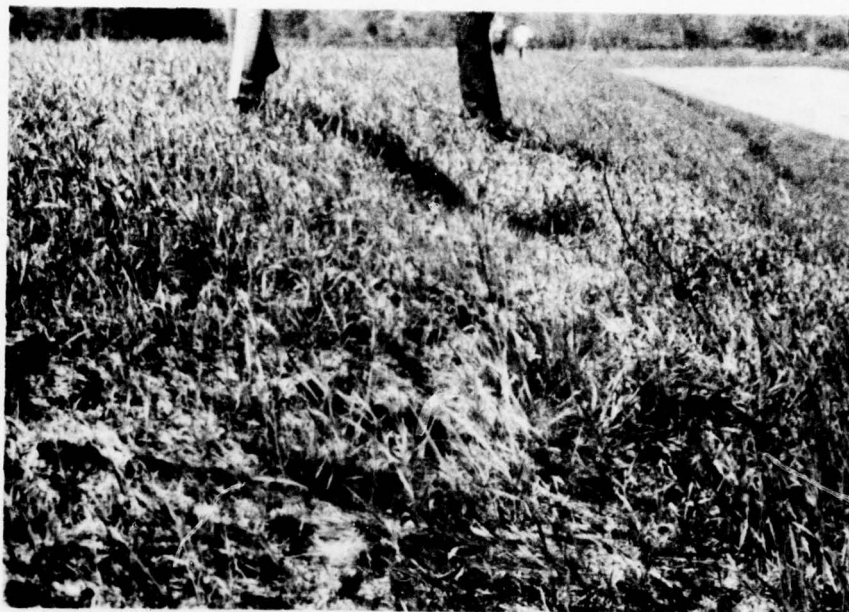
Sloughage

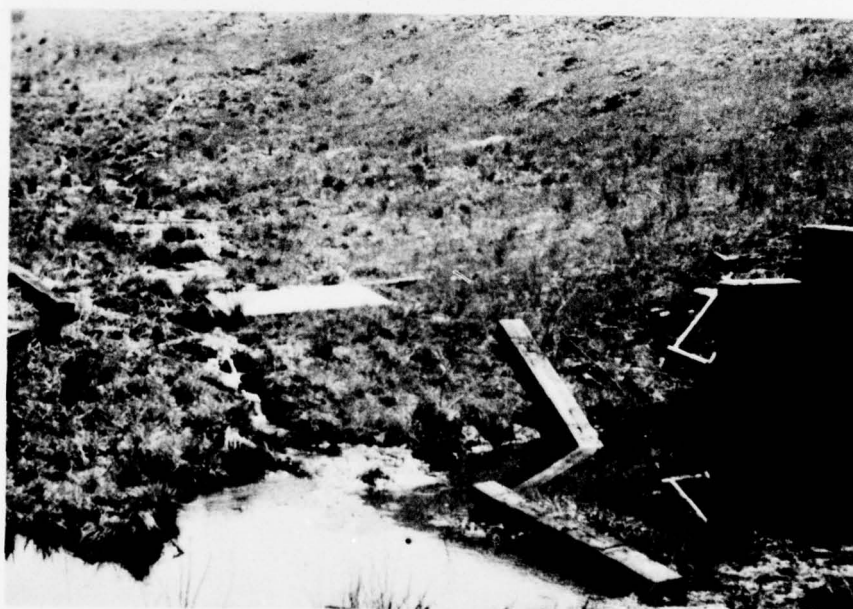
- a. Seepage between the right spillway wall and the dam embankment and in the area of the conduit outlet. Seepage could originate from the fractured rock strata below and adjacent to the dam which was not grouted or from the embankment. Additional studies should investigate and identify the source.
- b. There are no weepholes in the spillway walls. The amount of leakage water could cause instability of the walls if the drain would clog up.

Conduit
Conduit Outlet
and Right
Abutment Seepage
