RILEY RUN DAM  
NDI No. Pa. - 386

PHASE I INSPECTION REPORT  
NATIONAL DAM INSPECTION PROGRAM.

Riley Run Dam (NDI PA-386), Ohio River  
Basin, Riley Run, Elk County,  
Pennsylvania. Phase I Inspection Report.

29 June 1978 (visual inspection)

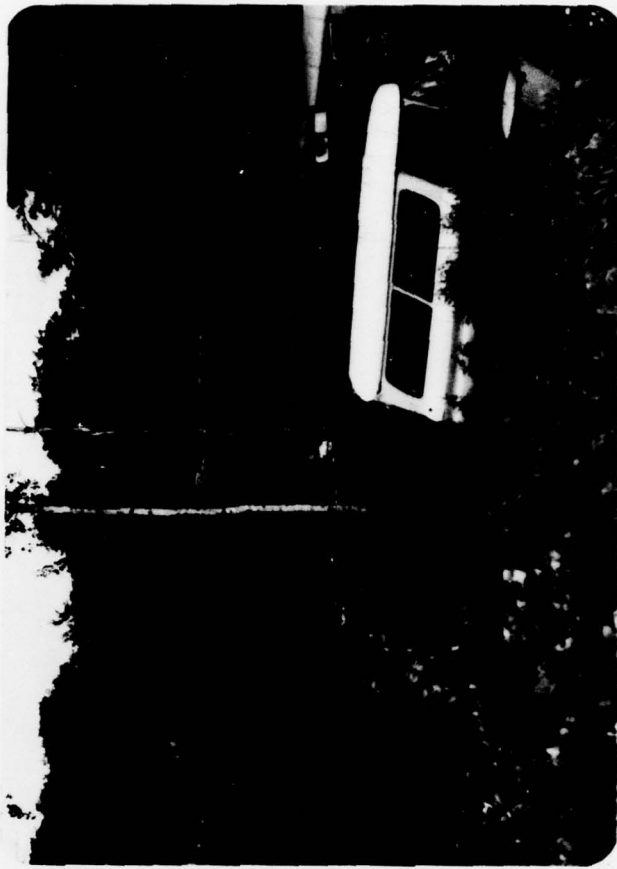
10

**PHOTOGRAPH 10** View of the confluence of Riley Run and the Clarion River located approximately 2 miles downstream of the dam.
