(6) National Dam Inspection Program
LAKE GORDON DAM, (NDS-242), *(1)*
Potomac River Basin.
COMMONWEALTH OF PENNSYLVANIA

PHASE I INSPECTION REPORT

NATIONAL DAM INSPECTION PROGRAM

by
BERGER ASSOCIATES, INC
CONSULTING ENGINEERS
HARRISBURG, PA.

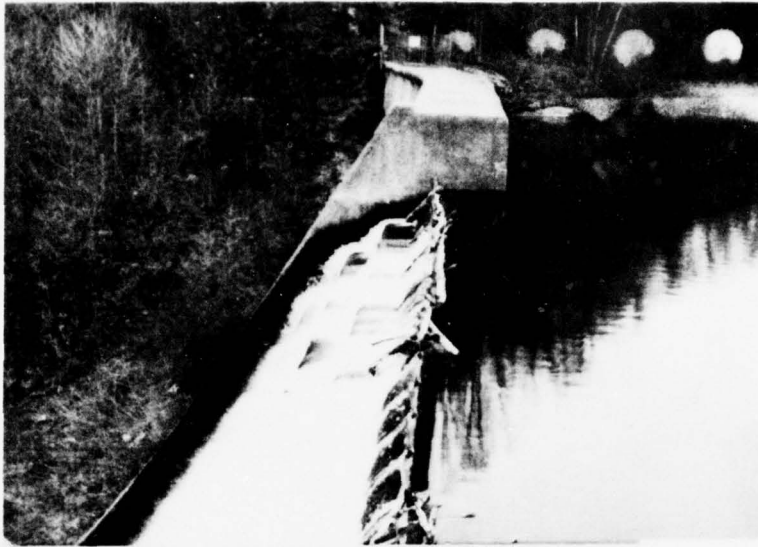
Upstream Face of Dam

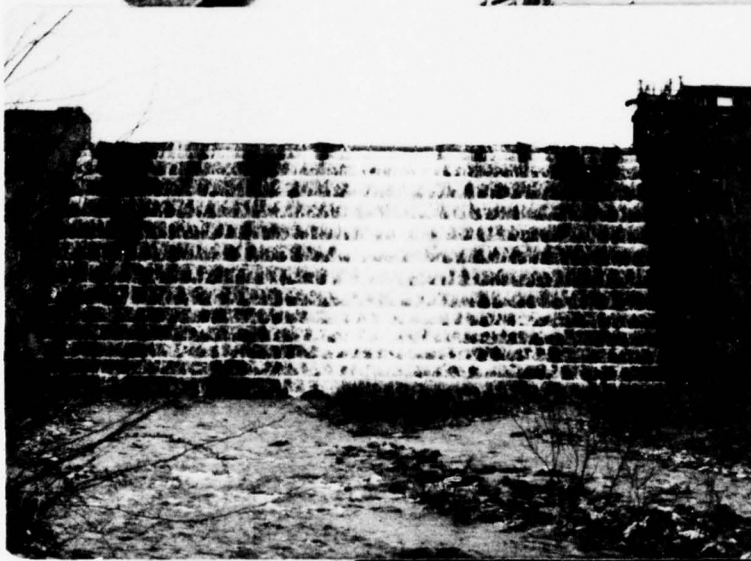
leakage through the dam. Only the boards were removed and, at the present time, the spillway crest is obstructed by horizontal 3 inch high x 8 inch wide planks which are bolted to the crest by the vertical flashboard pins, which are inserted in holes drilled in the spillway crest, and by miscellaneous drift which catches on the pins. The above items reduce the hydraulic efficiency of the spillway opening and it appears that they should be removed.

Spillway
Looking Westward

1. In order to improve the spillway capacity the owner should immediately remove the obstructions on the spillway crest (pins and 3 inch by 8 inch boards). It should be noted that the spillway will still be seriously inadequate after the crest is restored to its original condition.
2. Studies outlined under Paragraph 7.1.d should be initiated immediately and completed within an acceptable time frame.

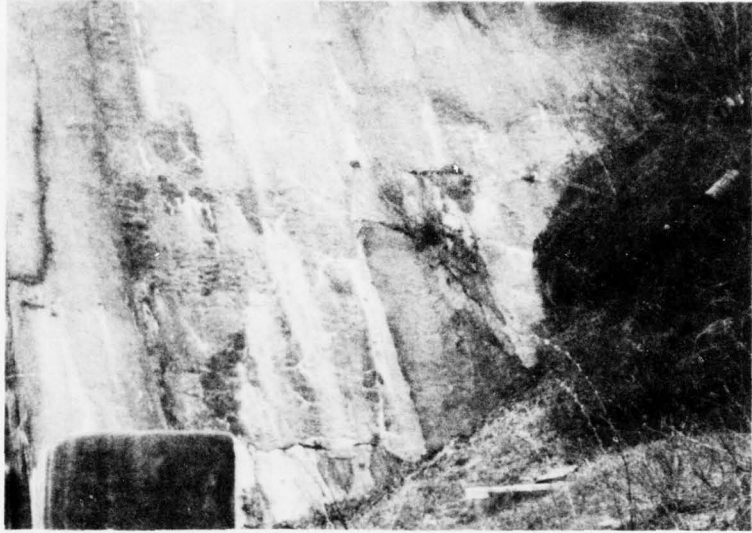
There is considerable cracking of the gunite surface on the downstream face of the dam, but this cracking seemed to be caused by shrinkage rather than resulting from internal dam stresses, or settlements and movements. The gunite prevented observation of the original dam surface and it was not possible to make conclusions on the condition of joints. A bush is growing on the left abutment of the dam surface. The spillway surface could not be inspected due to the amount of water falling over the steps.

Steps in
Spillway
