SUSQUEHANNA RIVER BASIN  
RACKET BROOK, LACKAWANNA COUNTY  
PENNSYLVANIA

BROWNELL DAM  
NDS ID NO. 192  
PENNSYLVANIA GAS AND WATER COMPANY

PHASE I INSPECTION REPORT  
NATIONAL DAM INSPECTION PROGRAM

MAY 1978

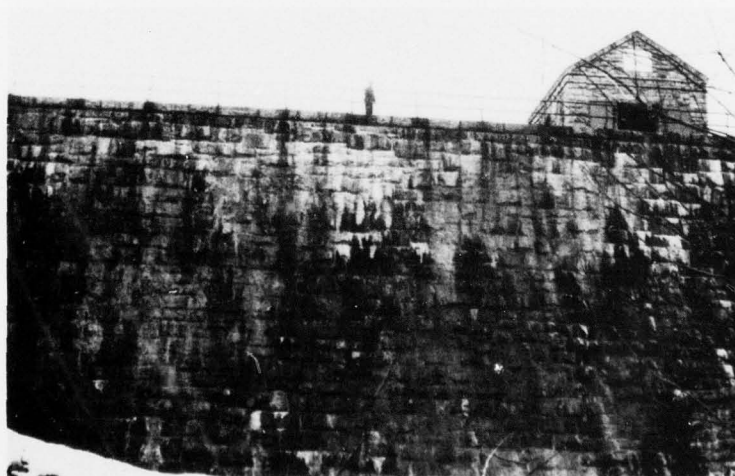
(1) The entire downstream face of the auxiliary spillway (Photograph B) is wet from about 6 feet below the crest. There are white powdery deposits, or efflorescence, over most of the face. The seepage was insufficient to cause flow at the toe

of the structure and was not localized in any particular areas. The mortar was in excellent condition. No cracks were observed. The handrail on the downstream side of the crest is corroded badly.

(1) The slight seepage on the downstream face of the auxiliary spillway is of slight concern at the present time. The cause of the calcium-like deposits on the face is unknown but they did not seem to be associated with any potential problems. The corroded handrail could be a hazard to personnel. It could also collect debris during flow over the auxiliary spillway and reduce the discharge.

B. Downstream Face of Auxiliary Spillway

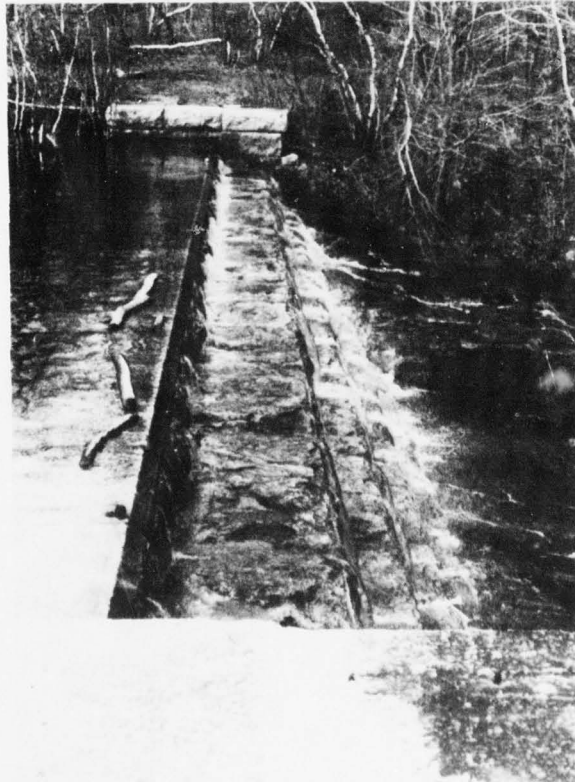
(2) The main spillway (Photograph F) appears to be in excellent condition. Water was flowing over the spillway during the inspection and detailed observations could not be made. However, the stones appeared to be in good condition. Where the spillway discharge turns right and drops over the natural rock ledge, there is evidence of some rock erosion at locations downstream of the right spillway wall. The upstream left and right retaining walls were submerged and therefore only the tops were visible below the water surface. The Owner has not reported any problems with these walls.

F. Main Spillway
