SUSQUEHANNA RIVER BASIN
GARDNER CREEK, LUZERNE COUNTY

GARDNER CREEK DAM
NDS ID NO. PA-00575
DER ID NO. 40-1

PENNSYLVANIA GAS AND WATER COMPANY
PHASE I INSPECTION REPORT
NATIONAL DAM INSPECTION PROGRAM

JUNE 1978

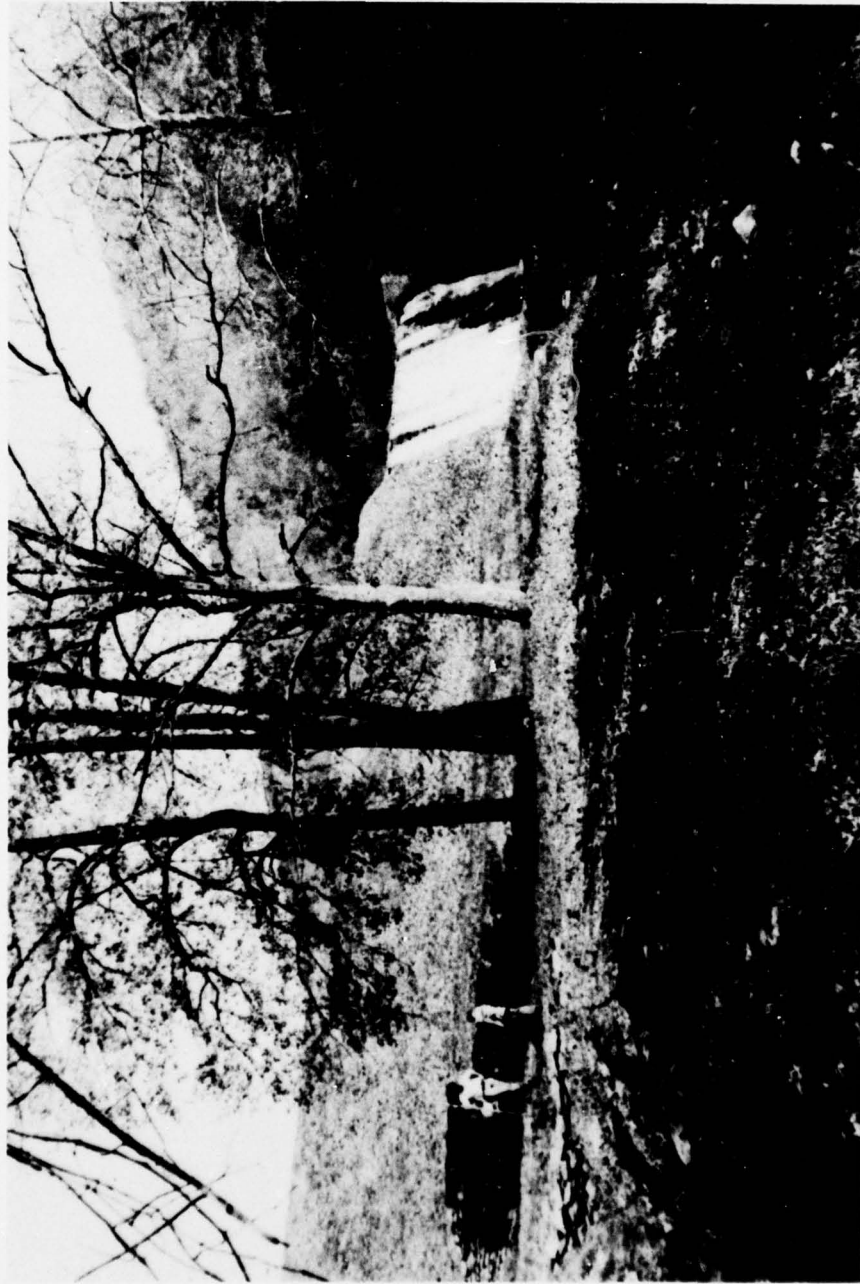
Embankment, Spillway, and Gatehouse
Looking Upstream

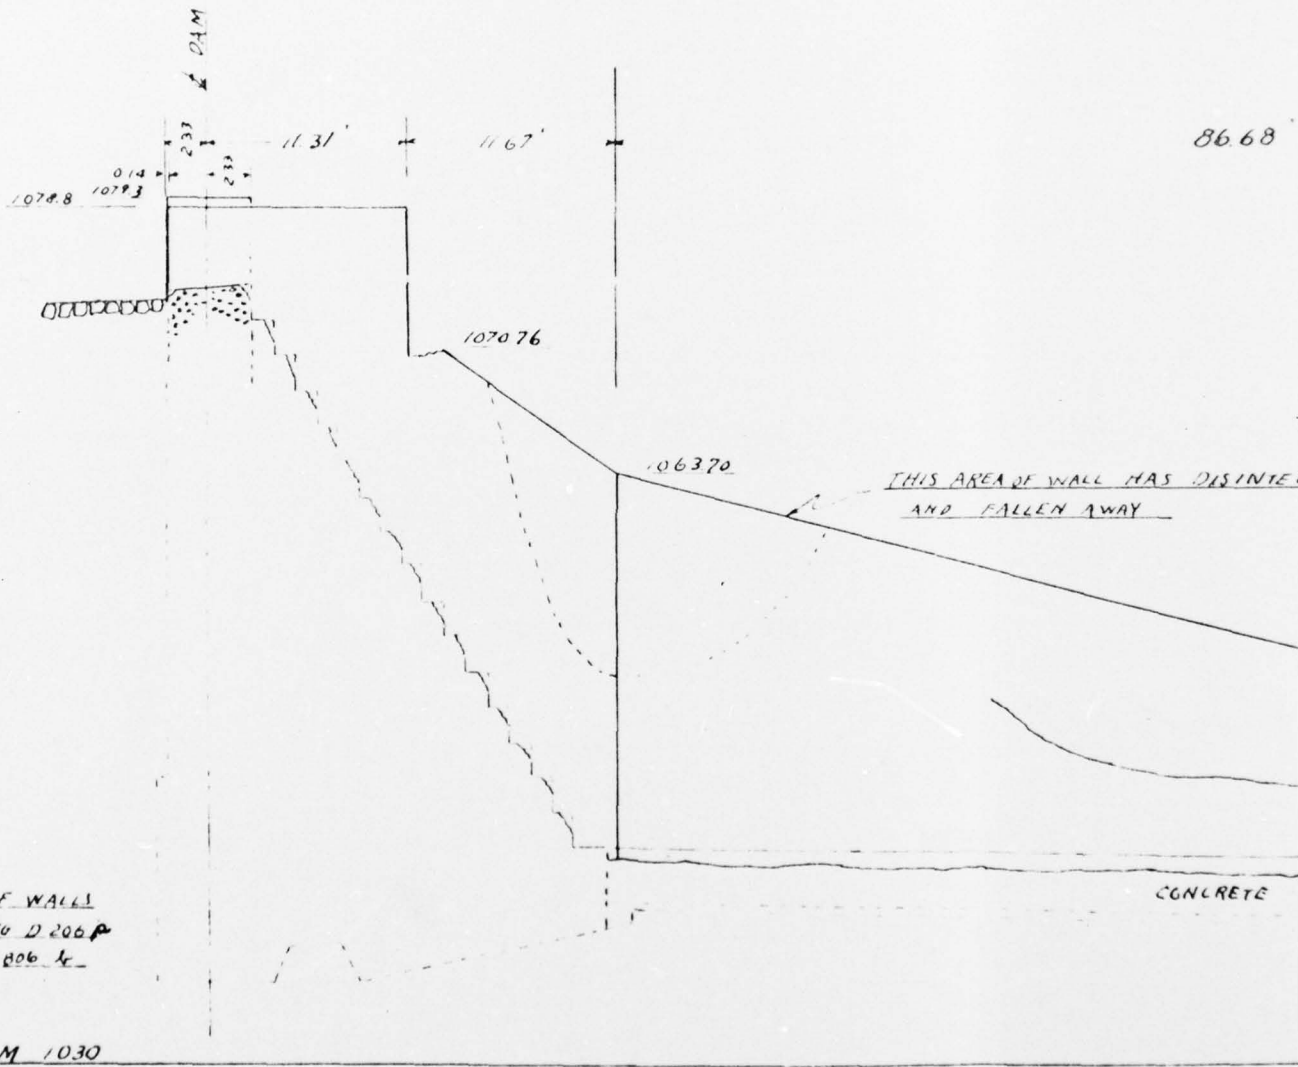
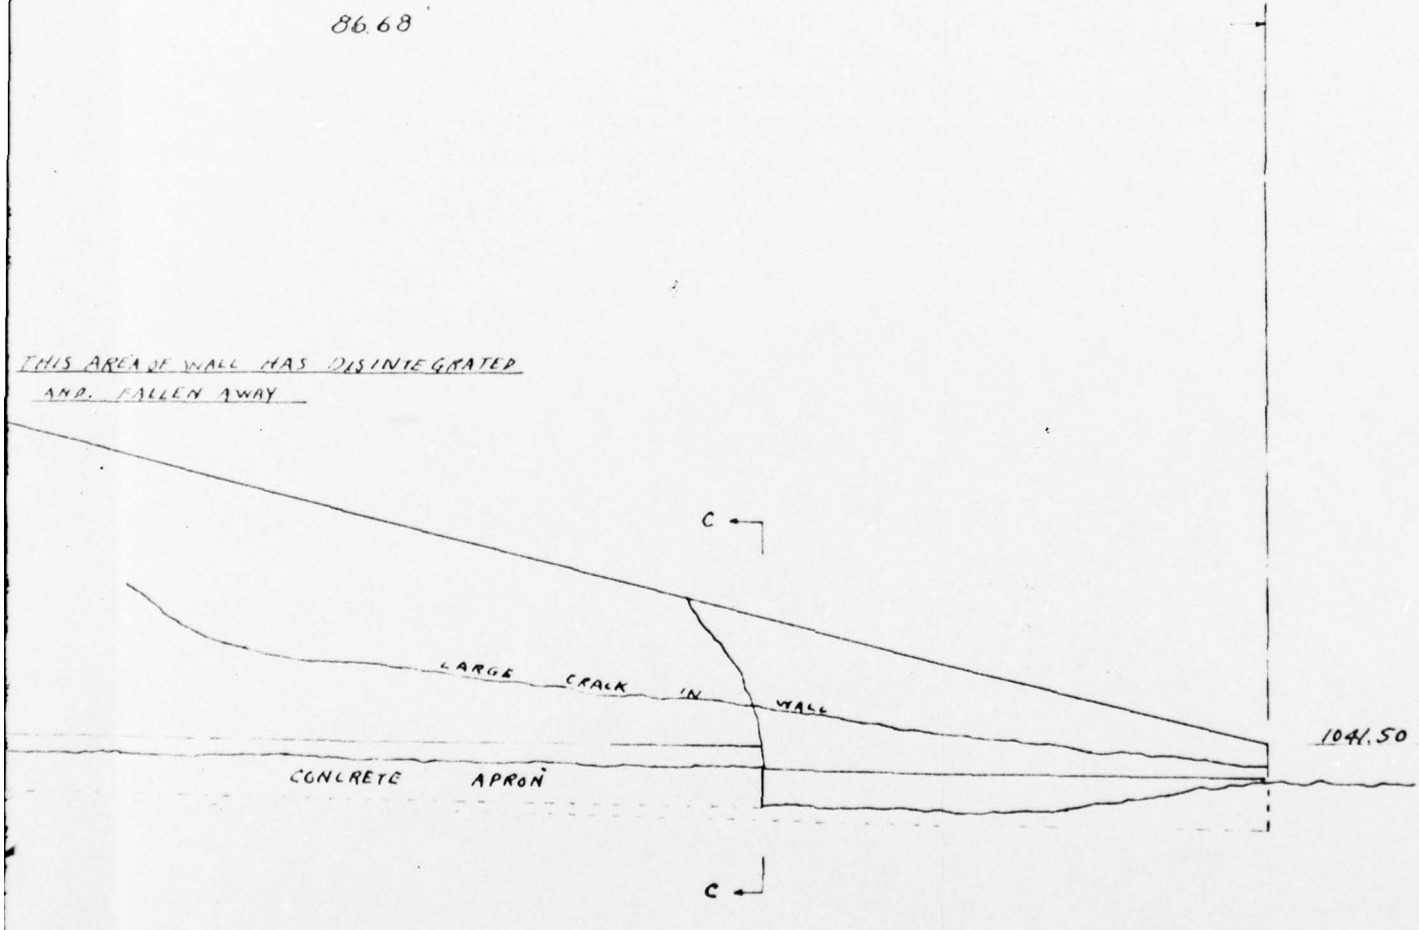
THIS AREA OF WALL HAS DISINTEGRATED
AND FALLEN AWAY

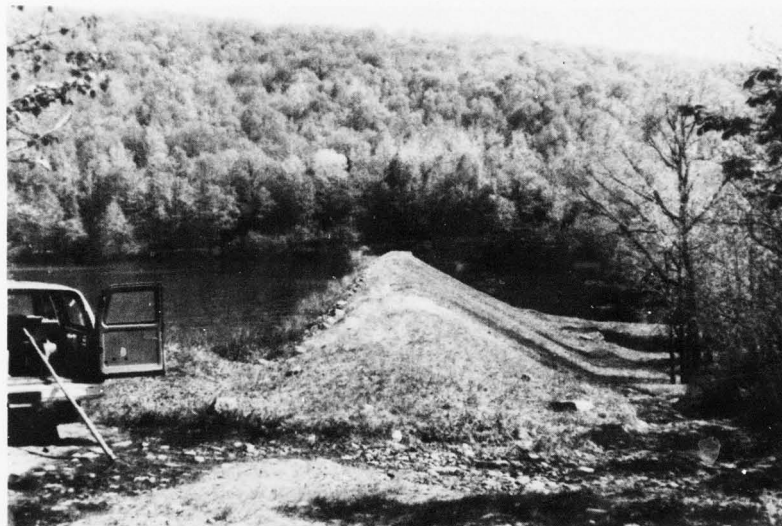
(3) The downstream slope of the embankment had a uniform slope and was adequately maintained. (Photographs A and B). The vegetation consisted of a light growth of weeds and very small shrubs. The type and extent of the vegetation indicated a rather fragile environment. There appeared to be very little topsoil available to support development of sod. Vegetation on the downstream slope had been cut recently. A path was worn or excavated on the downstream slope near the right abutment to a maximum depth of 2 feet. One hole caused by a burrowing animal was located near the center of the dam about 10 feet above the toe. Signs of recent burrowing were observed.

A. Embankment Looking from
Right Abutment

- (3) Repair bare path on downstream slope of embankment.

- (4) Fill hole on downstream slope of embankment caused by burrowing animal.

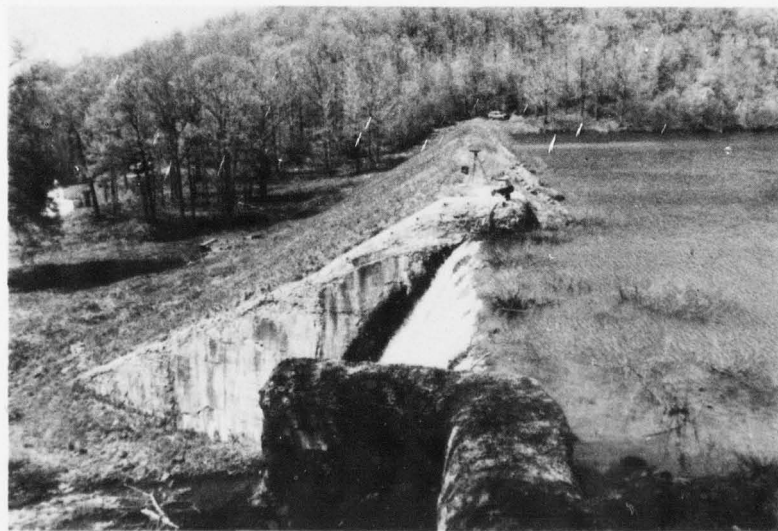
B. Spillway and Embankment Looking from
Left Abutment

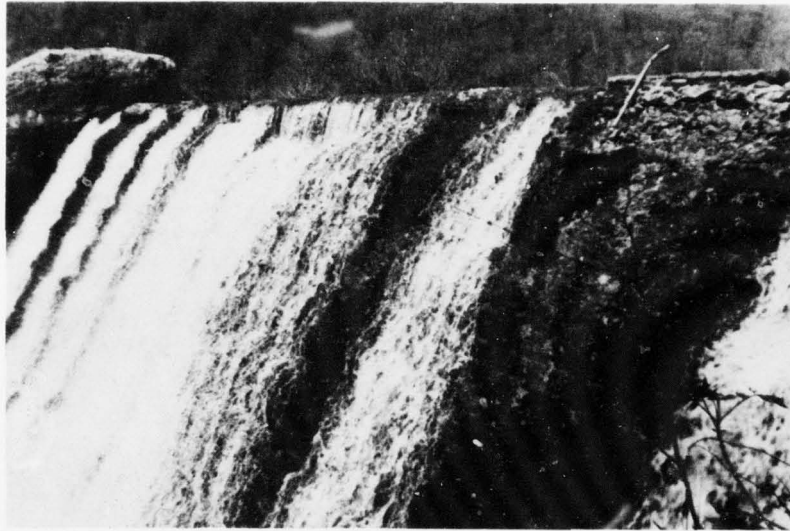
(2) Flow over the spillway crest and over the stepped downstream face of the spillway was not uniform due to disintegration of the concrete (Photographs C and D). Coarse aggregate was exposed over most of the area, and the disintegration had progressed to an estimated depth of 6 inches at some locations. The steps on the downstream face were badly eroded and, in some cases, missing. The downstream face of spillway could not be inspected for leakage or cracking because of the amount of water flowing over it.

C. Crest and Downstream Face of Spillway

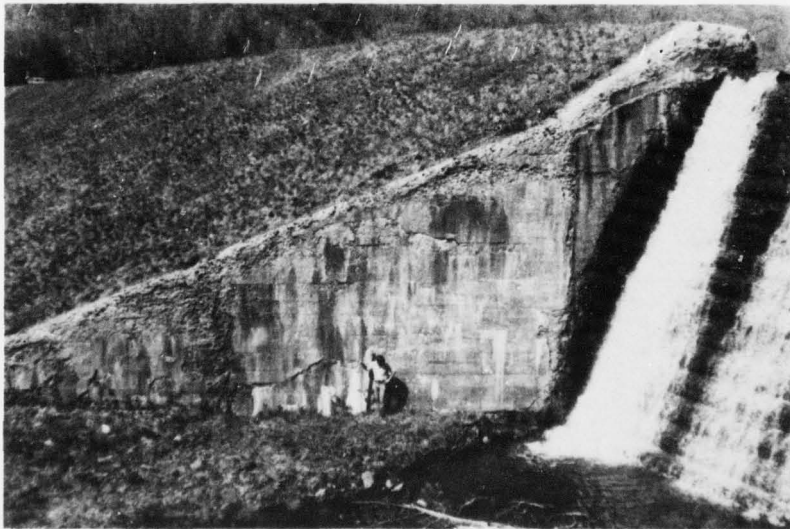
(4) The right spillway wall had very severe scaling over about 30 percent of its exposed face (Photograph D). The average depth of scaling was about 1 inch. A vertical crack was located near the downstream end of the wall. The crack is weathered, but no differential movement was observed.

D. Right Spillway Wall

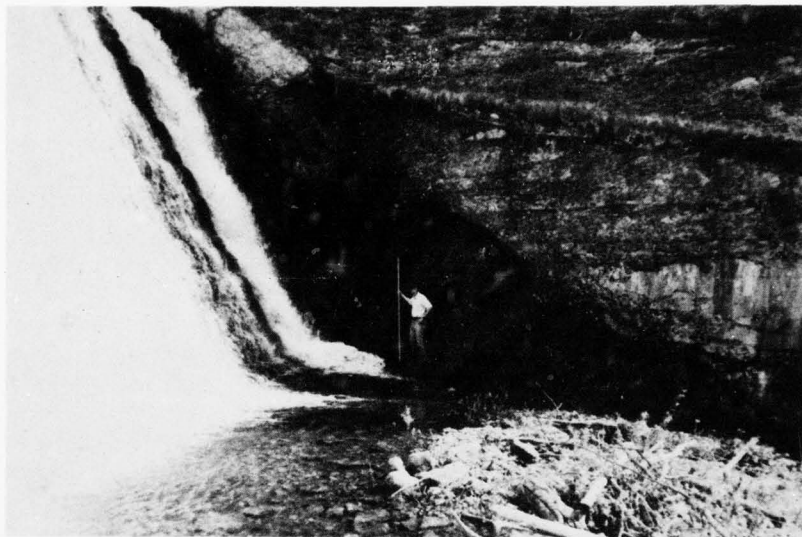
(5) The left spillway wall had severe disintegration over about 80 percent of its exposed face (Photographs E and F). The worst area was a about mid-height near the toe of the spillway (Photograph E). At that location, the estimated depth of disintegration was 2 feet. An average depth of disintegration for the wall could not be determined. A 70-foot long crack, predominantly horizontal and located about 4 feet above the channel bottom, begins near the downstream end of the wall and extends upstream into the area of most severe disintegration (Photographs E and F). The portion of the wall above the crack was overhanging the lower portion by an average of 0.35 foot.

(2) The overall condition of the spillway and the spillway walls are generally unsatisfactory. Review of previous inspection reports indicates that deterioration of the concrete began at least as early as 1919. Repairs were made to the exposed faces of the spillway walls in 1930, but the present condition of the walls is poor. The deterioration of the concrete on the spillway and the right wall does not appear to be so extensive as to seriously endanger the structures at present. However, the left spillway wall has deteriorated to the extent that its structural integrity is questionable. A study of the condition of the spillway was made by the Scranton-Spring Brook Water Service Company in 1950. At that time, the horizontal crack and differential movement had already occurred. Drawings from the files of

the Owner indicate an average movement at that time of 0.16 foot. The present average displacement is 0.35 foot. This increase in displacement, coupled with areas of disintegration to depths of about 2 feet, indicates a potentially serious condition. If this wall failed, a slide of the adjacent hillside would probably also occur. It could not be determined from the visual inspection whether a failure of the wall would seriously endanger the dam and the spillway. The effects of failure would depend on extent of failure, amount of sliding of the hillside, and pool level at time of failure. It is sufficient to say that every effort should be made to avoid a failure of the wall.

E. Disintegration, Large Crack, and Displacement of Spillway Left Wall

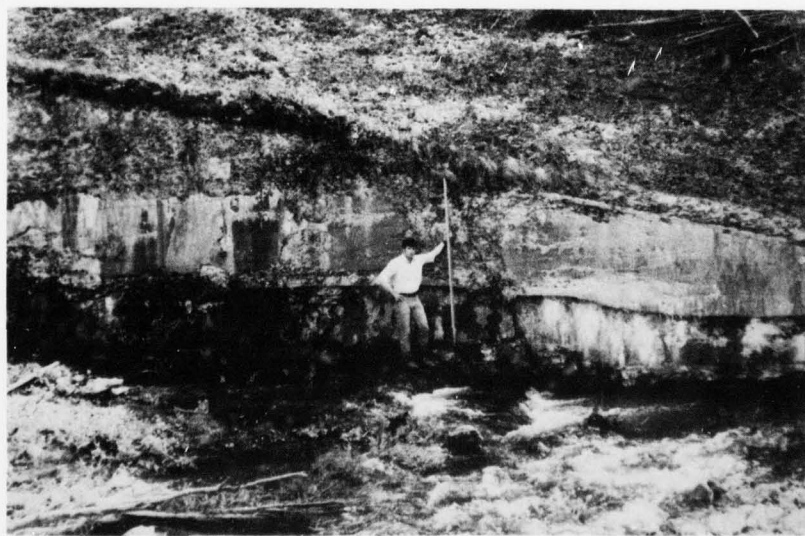
F. Continuation of Above Photo showing Cracking and Displacement of Left Spillway Wall

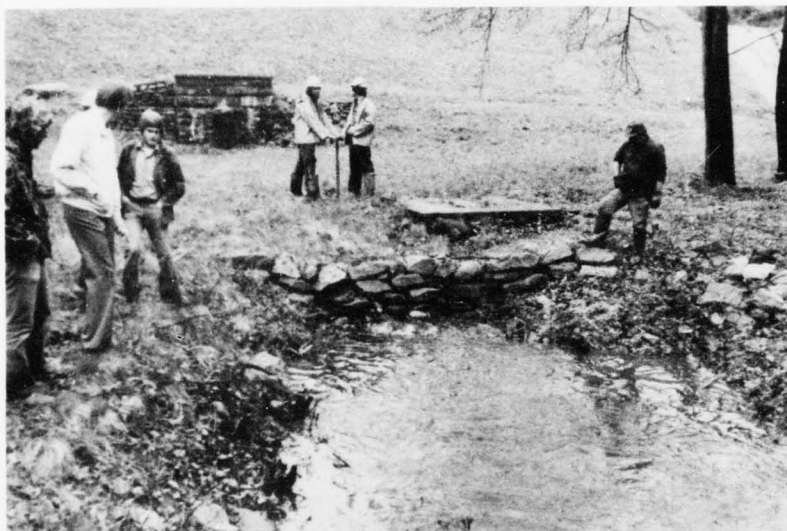
G. Operation of the 16-Inch Diameter Blowoff

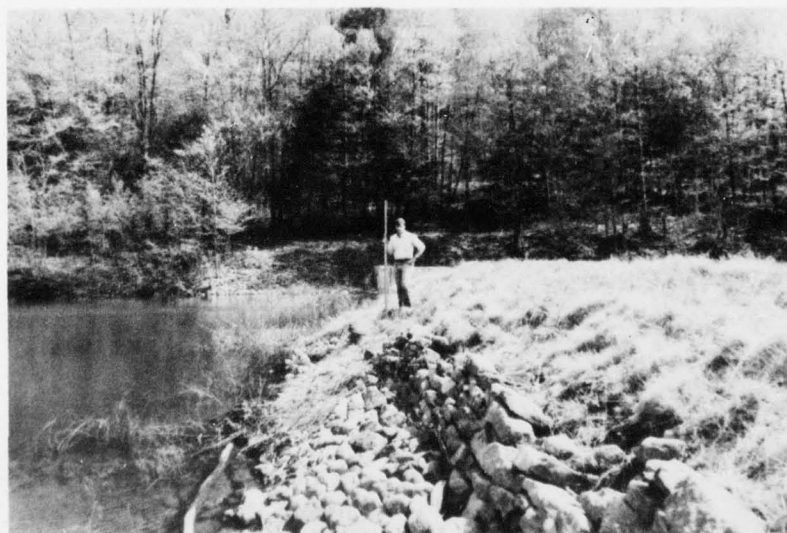
(2) The light brush growing on the upstream slope of the embankment is undesirable. The 30-foot reach adjacent to the spillway where the riprap is missing could easily be eroded during large flood flows or by wave action.

H. Upstream Embankment Surface on Right Side of Spillway showing Missing Riprap Material

- (2) Replace missing riprap near spillway.

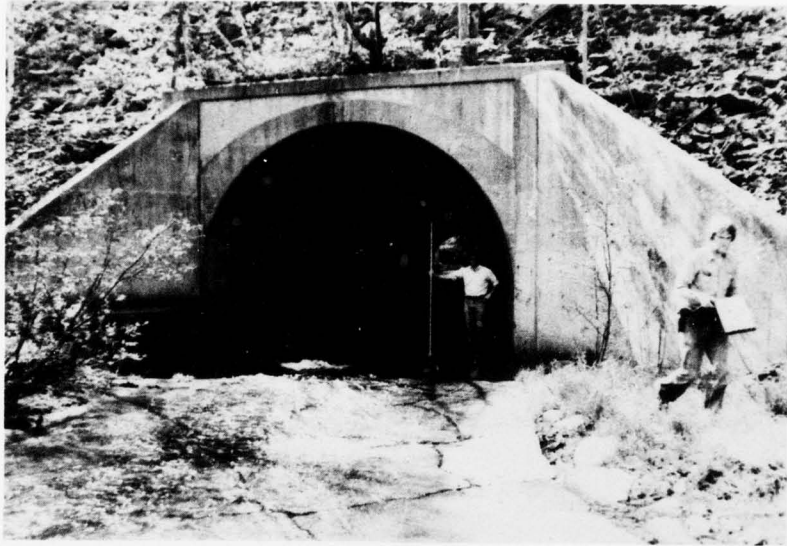
conduit through the embankment is a concrete horseshoe type with a width of 18.6 feet and a height of 13.0 feet (Photograph I). Just downstream from the Turnpike embankment is the railroad embankment. It is about 25 feet high and about 100 feet wide at the base. The material in the railroad embankment fill appeared to be cinders. The conduit through the railroad embankment is a masonry horseshoe type with a width of 9.8 feet and a height of 12 feet (Photograph J). If Gardner Creek Dam failed, the two downstream embankments could decrease or increase the hazard to human life or property. If the embankments did not fail as a result of a failure of Gardner Creek Dam, the hazard to human life and property would decrease. If the embankments did fail as a result of a failure of Gardner Creek Dam, the hazard to human life and property could increase. The mechanics of the interaction between the failure of Gardner Creek Dam and the two downstream embankments are complex and beyond the scope of this study. Therefore, it cannot be assumed that the hazard to human life and property resulting from a failure of Gardner Creek Dam would be reduced by the existence of the two downstream embankments. Consequently, the downstream conditions indicate that a high hazard classification is warranted for Gardner Creek Dam.

I. Outlet Channel Conduit under the Pennsylvania Turnpike, 0.4 Mile Downstream from Dam. Driving through Conduit is Access Route to Dam.

(9) Develop an alternate access route to the dam that would be accessible under all conditions.

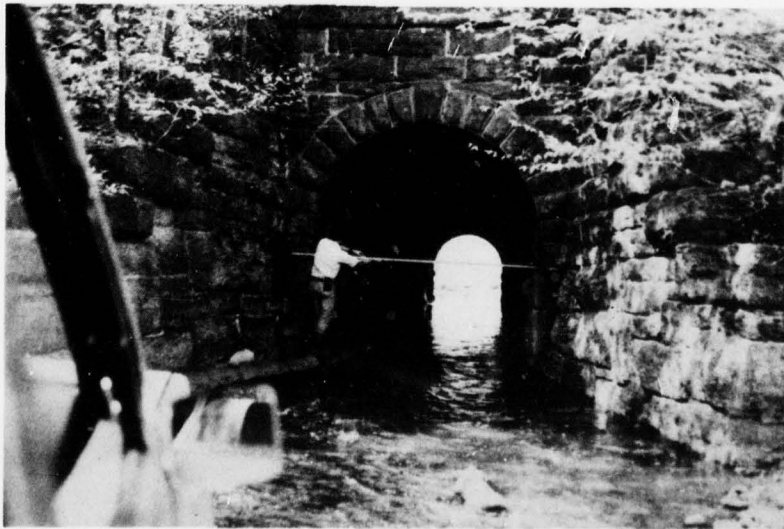
J. Outlet Channel Conduit under Lehigh Valley Railroad located immediately downstream of the Pennsylvania Turnpike Conduit
