National Dam Inspection Program. Indian Creek Dam (NDI-PA-199), Ohio River Basin, Indian Creek, Fayette County, Pennsylvania. Phase I Inspection Report.

INDIAN CREEK DAM
NDI No. Pa. - 199

PHASE I INSPECTION REPORT
NATIONAL DAM INSPECTION PROGRAM

22 June 1978 (visual inspection)

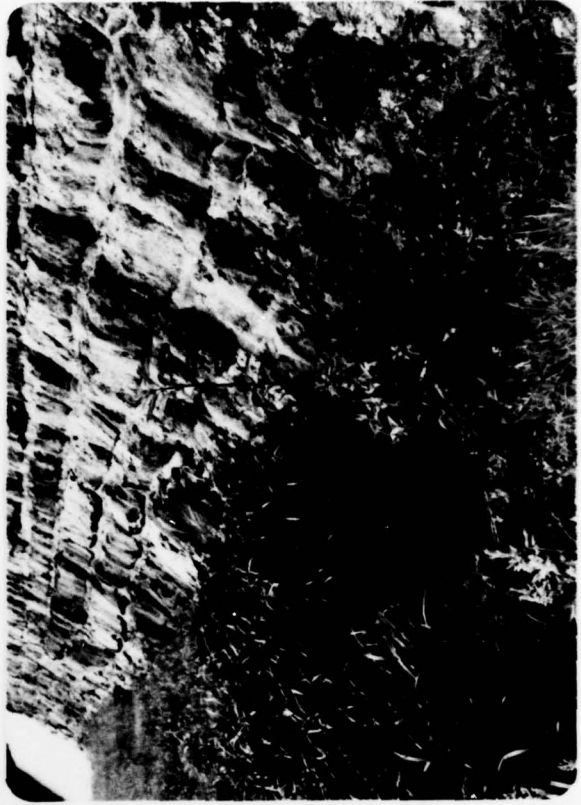
b. Dam. There are many cracks on the downstream masonry face of the structure (see Photographs 4 and 5). Some seepage can be seen issuing from the cracks particularly in the area approximately 130 feet left of the spillway. Deposits of calcium carbonate (efflorescence) cover large areas on the downstream face indicating that dissolution of cement is taking place. A rusty scale can also be seen in this area. The exact nature or source of the scale is not known although it is possible that it is simply staining from iron rich minerals contained within the sandstone masonry. The ground in the area 130 feet left of the spillway is saturated possibly indicating that some seepage is issuing from beneath the structure as well.

A wet area was observed near the toe of the dam approximately 130 feet left of the spillway. It is thought that some of the seepage could be issuing from beneath the structure since the total amount of water noted exceeded that which could readily be attributed to seepage through the dam.

PHOTOGRAPH 4 View of an area of seepage located at the toe of Indian Creek Dam. The rust colored area on the dam represents an area where seepage was passing through the structure. Standing water can be seen near the center of the photograph.

Included in this study should be a more detailed hydrologic and hydraulic analysis to better determine the amount of overtopping under PMF and 1/2 PMF conditions. Consideration should also be given to the cracking and seepage through the downstream face, seepage at the downstream toe and seismic forces. The reservoir should also be drawn down, temporarily, to enable a visual evaluation of the spillway section. The owner should then implement those remedial measures deemed necessary to assure adequate performance under operating conditions.

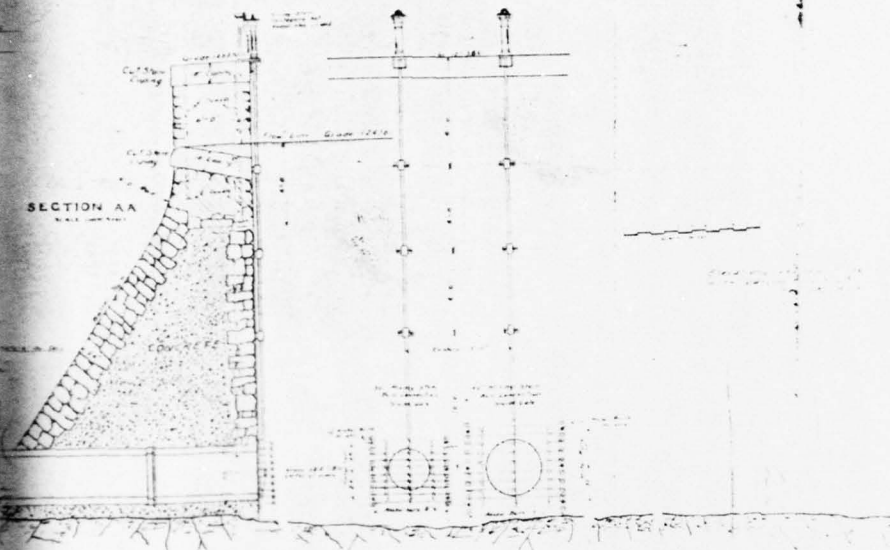
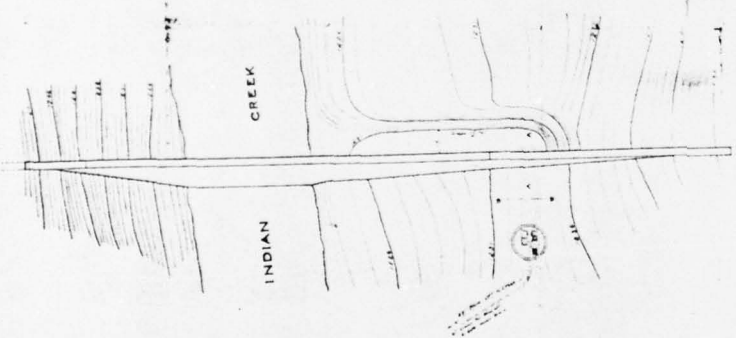
FIGURE 1

Measurements taken in the field generally correspond to those shown on Figure 1. Significant cracking was noted in the stone facing. Seepage along the left section may indicate a poor cutoff condition and should be evaluated in detail.

ELEVATION AND PLAN OF DAM
SCALE 1/4" = 10'
