LAUREL RUN RESERVOIR
NDI No. Pa. - 387

PHASE I INSPECTION REPORT
NATIONAL DAM INSPECTION PROGRAM

AUGUST 1978

PHASE I INSPECTION REPORT
NATIONAL DAM INSPECTION PROGRAM
LAUREL RUN RESERVOIR DAM
NDI# PA-387, PENNDER# 24-54

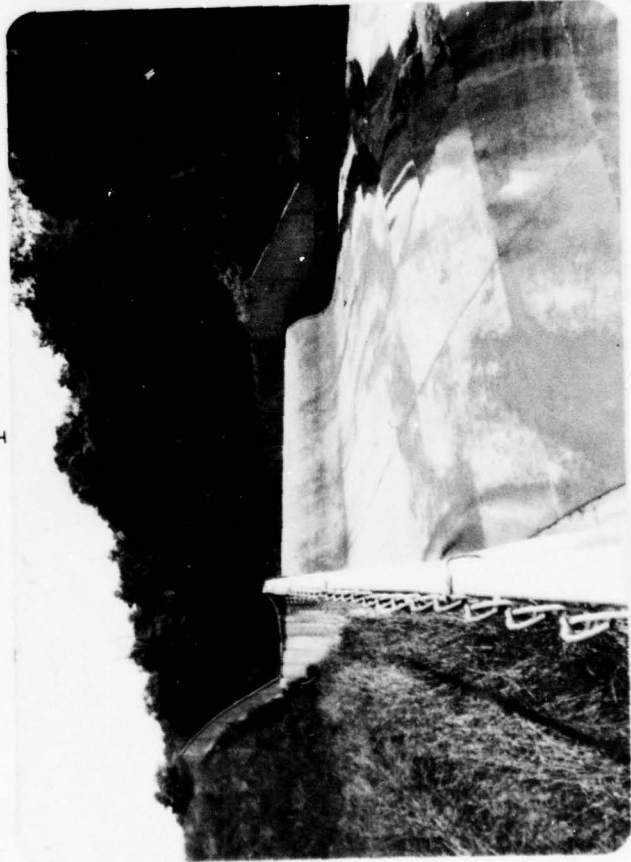
c. Appurtenant Structures. The spillway was found to be in good condition. The ogee weir was not discharging and was entirely visible. Minor flow as shown in Photograph 4 was emanating from several weep holes in the spillway walls. Some cracking and repair was observed at the upstream end of the chute blocks; however, Mr. Wolfel (manager of the water treatment facility) stated that the cracking occurred during the first year of operation and was immediately repaired.

PHOTOGRAPH 3 View of the ogee-crested spillway located at the left abutment. The water in the right portion of the photograph was discharging through weep holes in the spillway wing-walls.

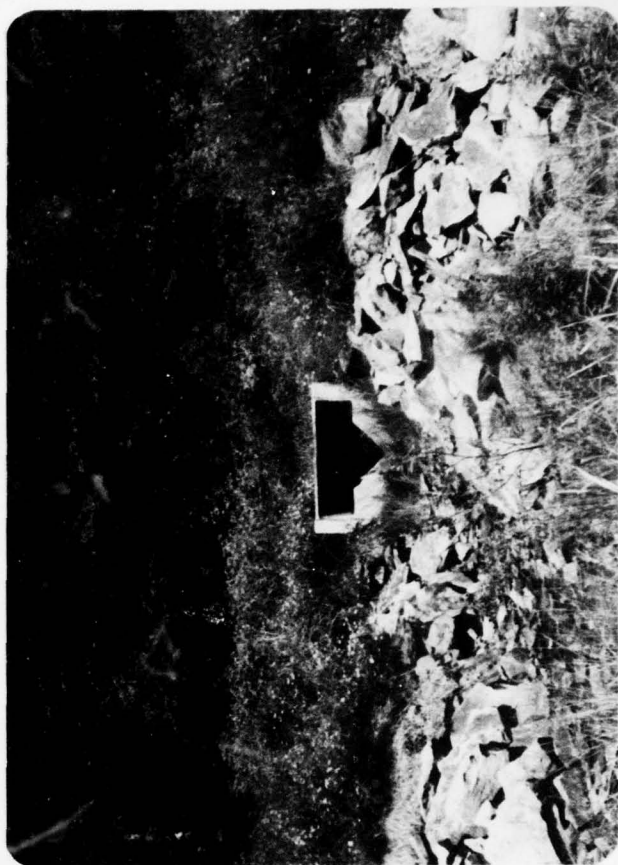
b. Appurtenant Structures. The appurtenant spillway and outlet structures appear to be in good condition. Cracking at the spillway chute blocks has been previously repaired and is of little consequence. The knife-edge of the monitoring weir at the right abutment has been dislodged and needs repair.

PHOTOGRAPH 8 View of a V-notch weir located on the right abutment just downstream of the outlet pipe shown in the previous photograph. The weir was discharging at the time of inspection.

2. Repair the monitoring weir at the right abutment to restore proper functioning. The knife-edge should be properly fastened to the concrete section to ensure that an unobstructed knappe develops as the flow passes the metal edge. The weir should be considered an integral part of the operating works and maintained as such.

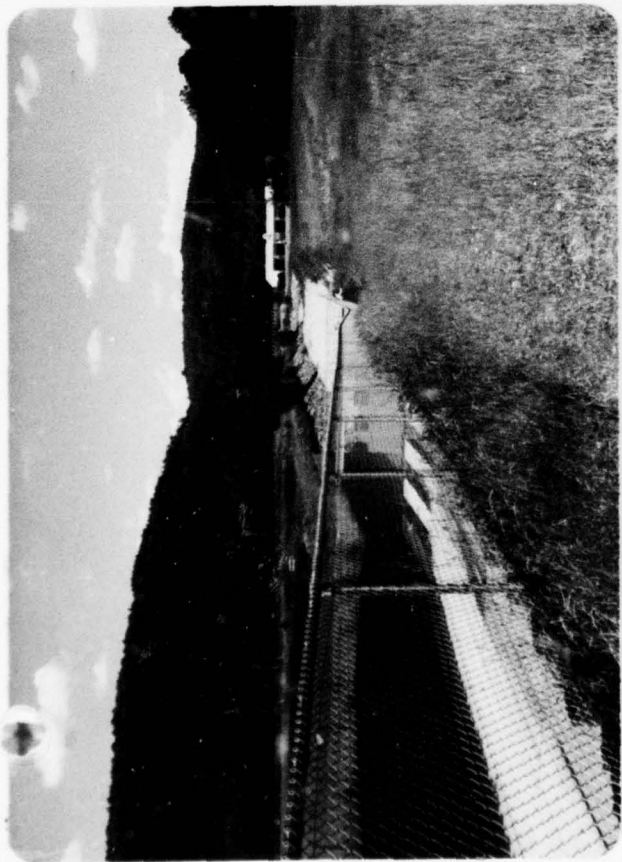
PHOTOGRAPH 5 View of spillway and rock-lined channel just downstream of Photograph 4. Route 120 is visible in the background.

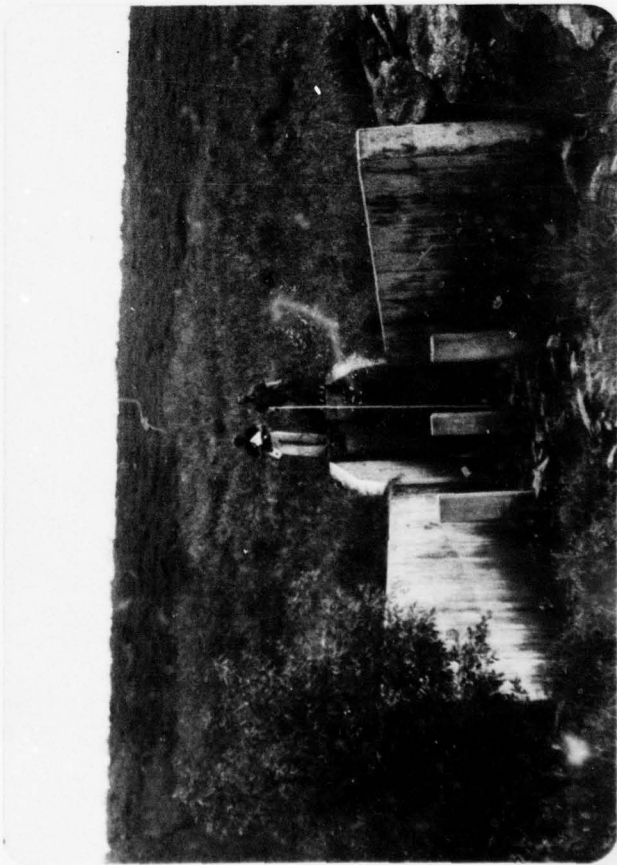
PHOTOGRAPH 7 View of the discharge end of the 48-inch diameter outlet pipe at Laurel Run Reservoir.

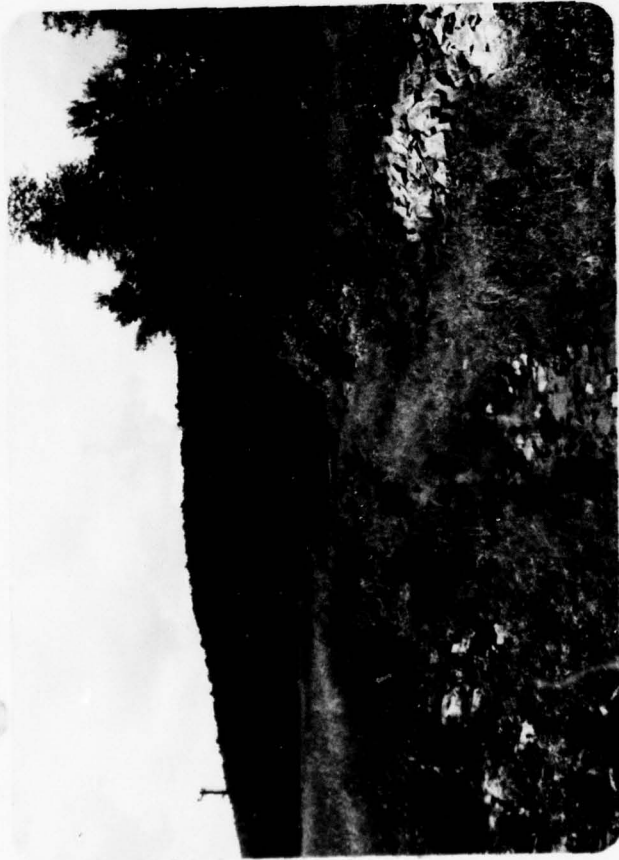
PHOTOGRAPH 9 View of the area just downstream of the 48-inch outlet pipe. Flow from this pipe and from the spillway is directed under Route 120 beneath the bridge visible in the background of the photograph.

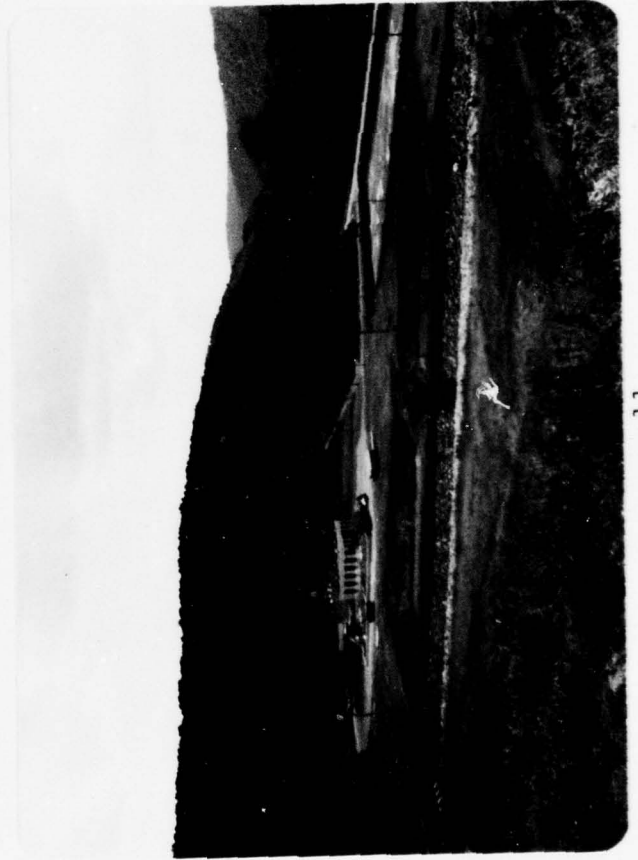
PHOTOGRAPH 11 View of the area downstream of Laurel Run Dam as seen from the dam crest. The steep slopes of Elk Creek Valley can be seen in the background (Laurel Run discharges into Elk Creek just downstream of Route 120) - see Regional Vicinity Map.
