NEIFERT CREEK DAM  
SCHUYLKILL COUNTY, PENNSYLVANIA  
NATIONAL I.D. NO. PA 00654

PHASE I INSPECTION REPORT  
NATIONAL DAM INSPECTION PROGRAM

PHASE I INSPECTION REPORT  
NATIONAL DAM INSPECTION PROGRAM  
NEIFERT CREEK DAM  
NATIONAL ID #PA 00654  
DER ID #54-173

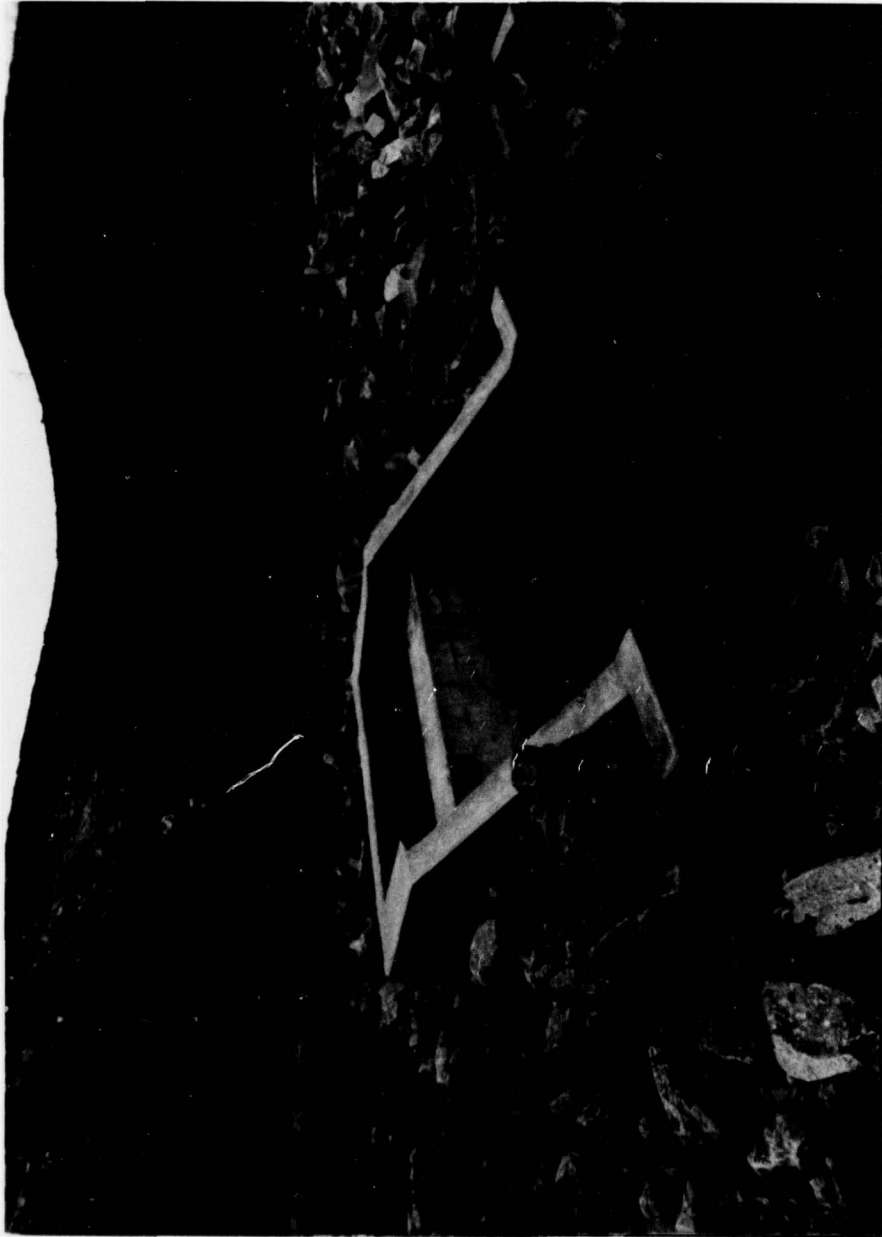
PHOTO NO. 2

VIEW OF OUTFALL STRUCTURE. BAFFLE WALL IS SHOWN ON  
PHOTO IN FRONT OF OUTFALL PIPE.

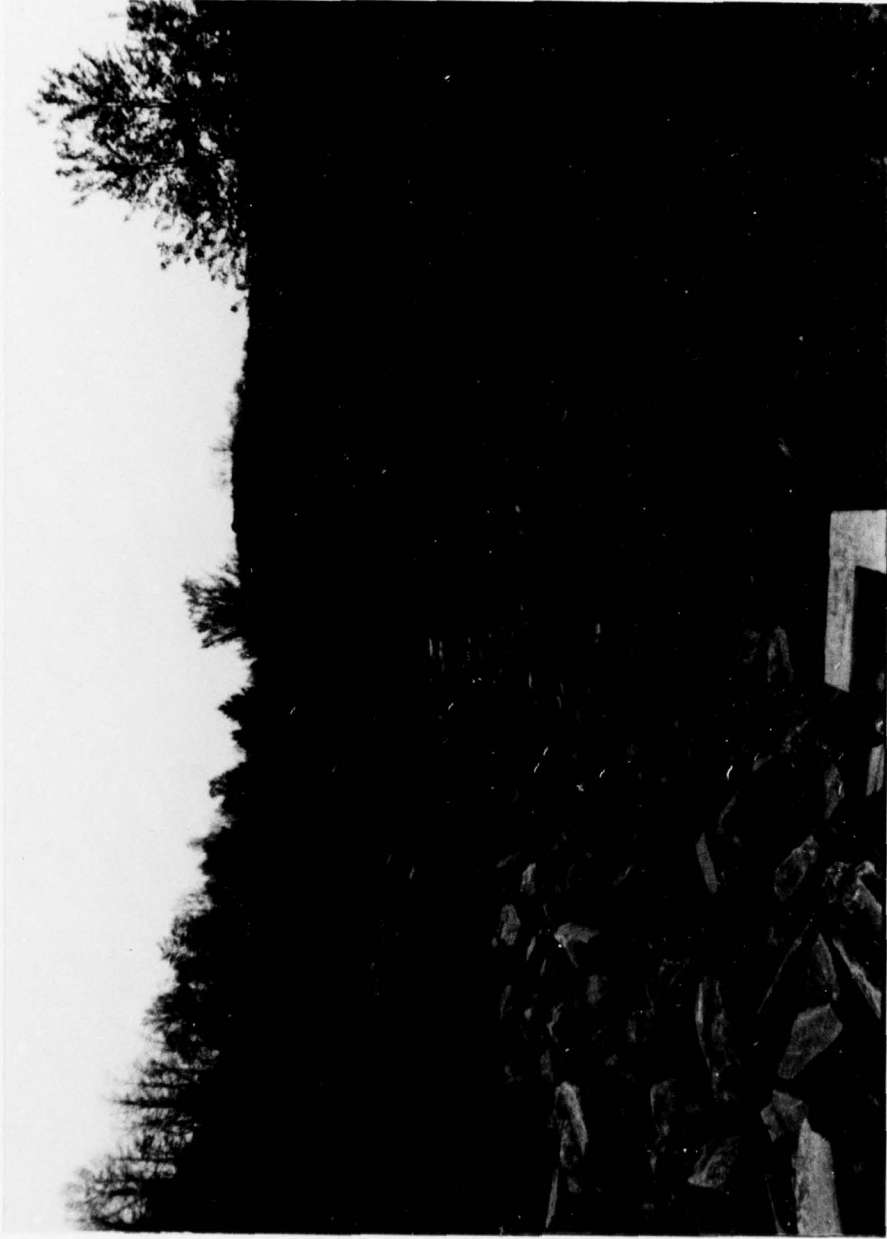
PHOTO NO. 5

e. Downstream Channel. The downstream channel was inspected from the impact basin to the confluence with Little Schuylkill Creek. This channel appears to be stable. Side slopes are moderate and well vegetated. There were no inhabitable structures observed downstream along the flood plain zone until the creek reaches Tamaqua. The town of Tamaqua is approximately 4.8 miles downstream and the flood wave produced by dam failure would have dissipated by the time it reached the town. State Highway Route 54 is the only road along the stream channel between the dam and Tamaqua and damage would be expected to be minimal.

VIEW OF CHANNEL DOWNSTREAM OF OUTFALL STRUCTURE.  
EMERGENCY SPILLWAY IS LOCATED ON LEFT SIDE OF PHOTO.

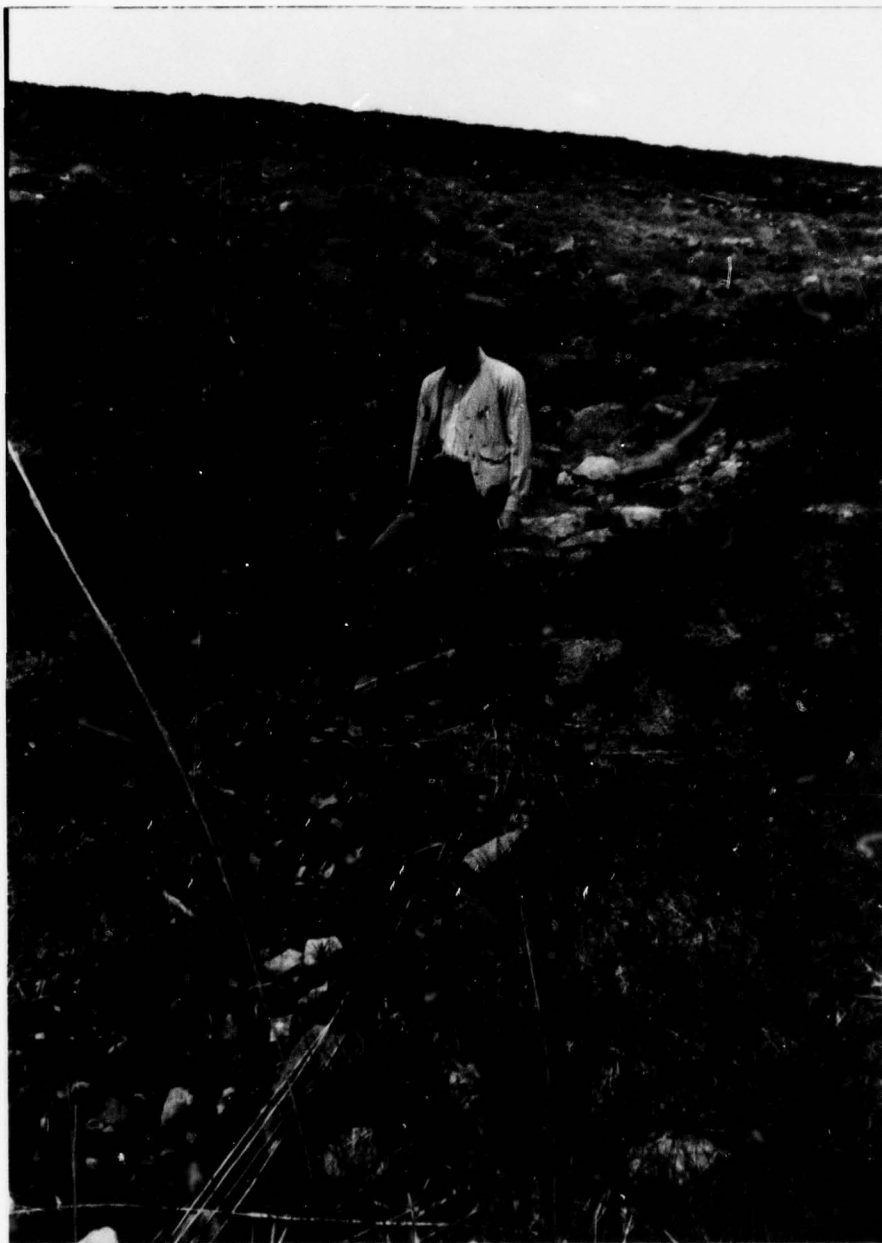
b. Dam. During the visual inspection, there were no indications or evidences observed of distortions in alignment or grade that would be indicative of movement of the embankment or the foundation. All slopes appeared to be in good condition and the crest, although unprotected, was also evaluated to be in good condition. Some erosion was noted along the crest and along the upstream slope which can be attributed to motor bike traffic. One small seep, located as shown on Plate 2 of Appendix E, was noted during this inspection. A photograph of this seep is enclosed herein as Photo No. 6.

a. Visual Observations. The visual observations did not indicate any existing embankment stability problems. Only one small spring with practically imperceptible flow was observed near the downstream toe of the dam, approximately 20 feet upstream of the impact basin. However, with the low pool at the time of inspection, observations for structural integrity were of limited value.

a. Assessment. The visual inspection and design use of Neifert Creek Dam indicates that the dam embankment and foundation is performing satisfactorily. Overall the appearance and condition of both the dam and appurtenant facilities is good. Only one clear, almost imperceptible seepage zone was located near the downstream toe of the dam. At present, this seep is not a hazard to the integrity of the dam.

SEEPAGE OBSERVED AT THE JUNCTION OF THE  
DAM (LEFT) WITH THE NATURAL ABUTMENT (RIGHT).  
THE SEEP IS LOCATED APPROXIMATELY 20 FEET  
UPSLOPE OF THE OUTFALL STRUCTURE.
