NATIONAL DAM SAFETY PROGRAM. ASHOKAN DAM (NY 41), HUDSON RIVER --ETC(U)

REPORT DOCUMENTATION PAGE		READ INSTRUCTIONS BEFORE COMPLETING FORM
1. REPORT NUMBER	2. GOVT ACCESSION NO.	3. RECIPIENT'S CATALOG NUMBER
4. TITLE (and Subtitle) Phase I Inspection Report Ashokan Dam Hudson River Basin Ulster Co. New York Inventory No. N.Y. 41		5. TYPE OF REPORT & PERIOD COVERED Phase I Inspection Report National Dam Safety Program

PHASE I INSPECTION REPORT  
NATIONAL DAM SAFETY PROGRAM  
ASHOKAN RESERVOIR, INVENTORY NO. 41  
HUDSON RIVER BASIN  
ULSTER COUNTY, NEW YORK

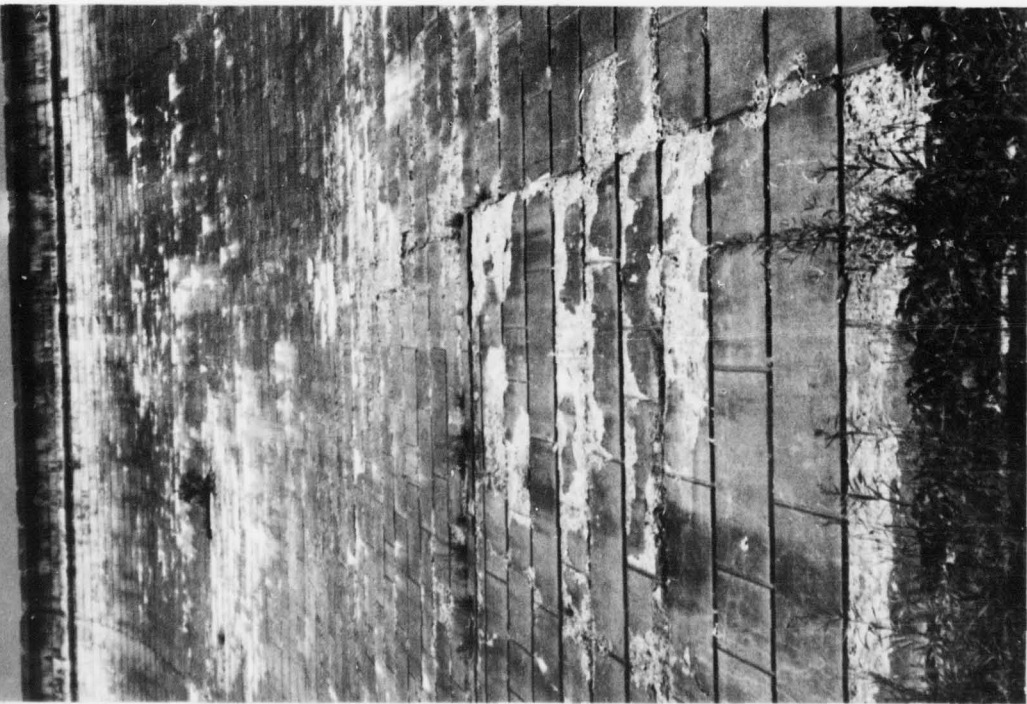
The masonry portion of the Olive Bridge Dam appears to be in generally good condition. There were no visible signs of distress or movement. There was some growth, including a sapling, on the downstream face. There were some spalling and minor cracks on the concrete surfaces of the downstream face.

Salt used in snow removal appears to be the probable cause of some deterioration and spalling of the concrete surfaces of the parapets and upper ledges on the downstream face.

The spalling of the concrete on the downstream face of the dam, including the upper ledges and parapets, is probably the result of the action of chloride ion

There were no visible leaks on the downstream face of the dam but the growth of vegetation and the presence of a sapling are possible indications of moisture at the downstream face.

DOWNSTREAM FACE OF MASONRY DAM.  
NOTE VEGETATION AND SPALLING ON FACE

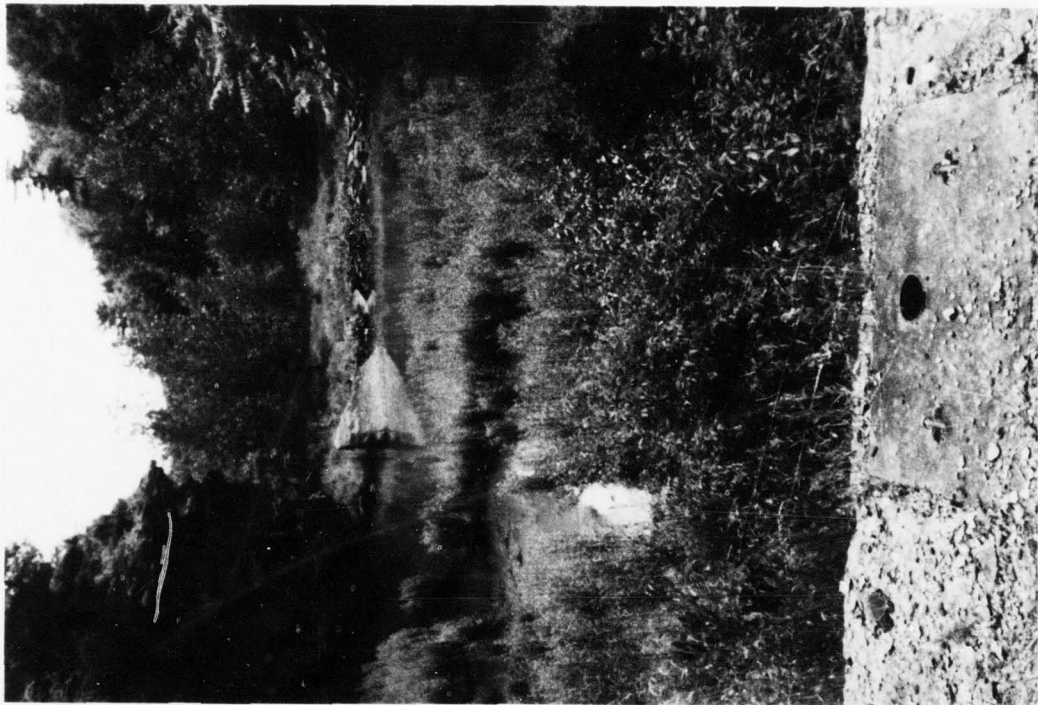
The channel downstream of the masonry dam is the Esopus Creek. Although the channel contained trees and dense bushes, its present condition would not impede discharges from the reservoir. The findings at waste weir channel are described in Paragraph 3.1 f.

DOWNSTREAM CHANNEL (ESOPUS CREEK) OF  
MASONRY DAM SHOWING VEGETATION  
AND EXPOSED ROCK

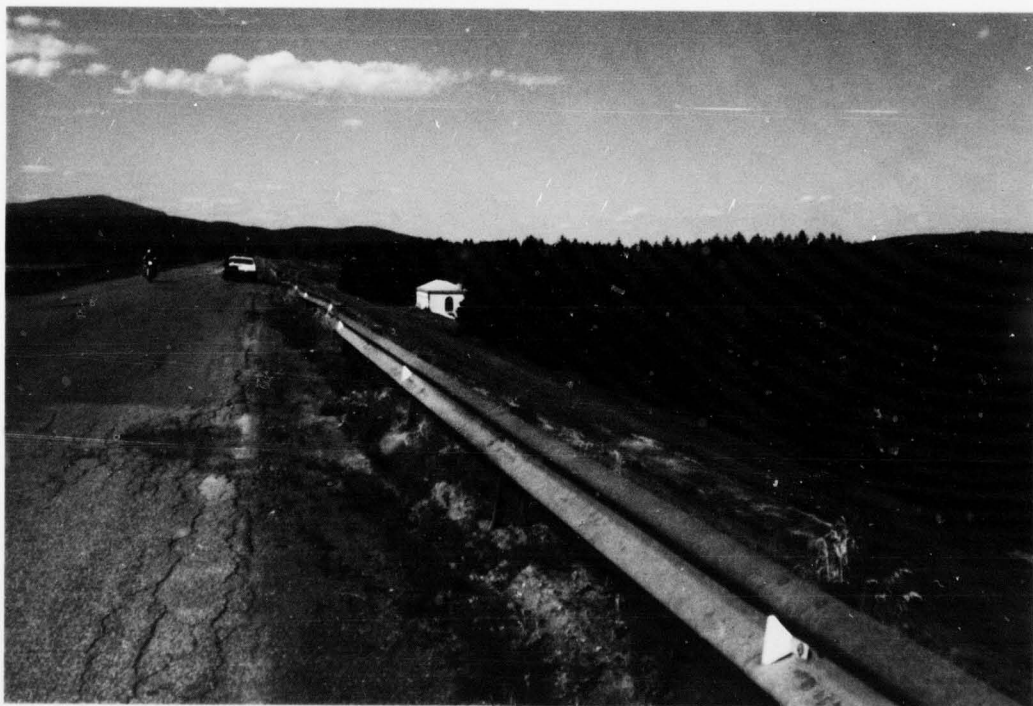
It is reported that during the winter or early spring of 1978 the downstream slope near the south end of the Dike was affected by sloughing which was caused by heavy surface runoff. It appears that the sloughing occurred downslope of an area where the roadway pavement has undergone cracking and differential settlement. The maximum settlement in the area is as much as 2 inches. From the observed signs it appears that pavement deterioration in this area may have been occurring gradually or periodically after each rainy season causing the cracks to open wider and the roadway to tilt toward the downstream slope, thereby collecting more and more surface runoff during major storms. The sloughing may have been triggered by the buildup of water pressure in the layer of crushed rock which, according to the contract drawings, underlies the topsoil and clayey earth layer on the downstream slope. Uplift pressure on the underside of the impervious soil cover would then result in sloughing. The area affected by sloughing is 100 ft wide at the top of slope and 50 ft at its downslope limit. The slope was repaired by placing fill and turf on the slope. The pavement distress has not been corrected.

VIEW OF DOWNSTREAM SLOPE OF WEST DIKE LOOKING NORTH.  
NOTE PAVEMENT FAILURE AT CREST AND REPAIR OF SLOPE

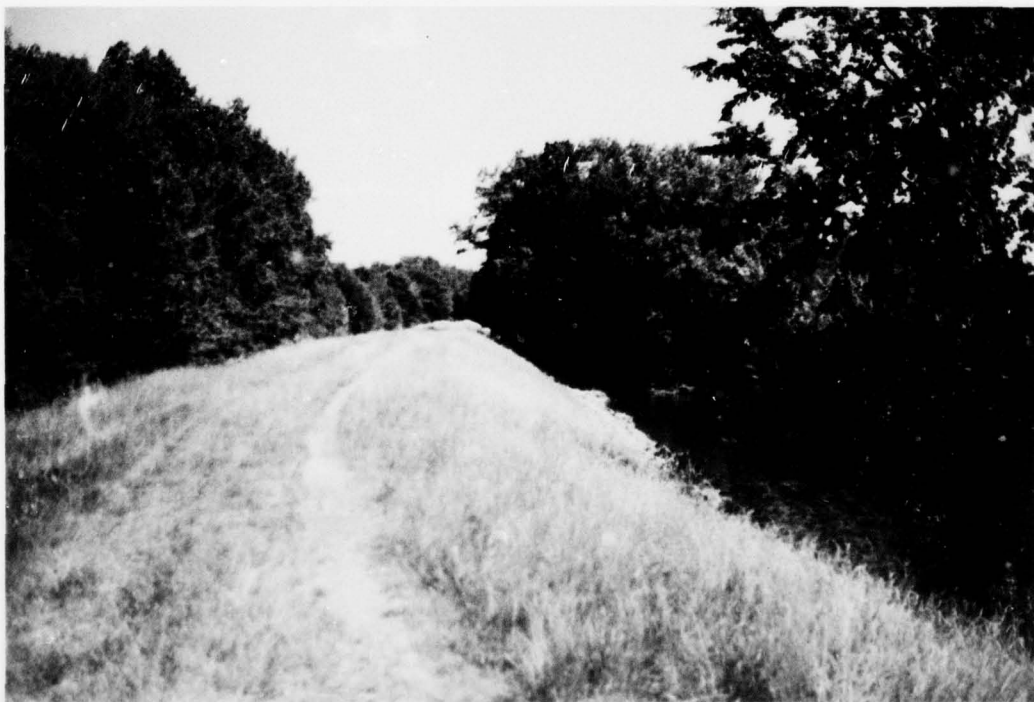
OVERVIEW OF CREST AND UPSTREAM SLOPE OF WOODSTOCK DIKE .  
(LOOKING EAST) NOTE PATHWAYS AND OVERGROWN GRASS.

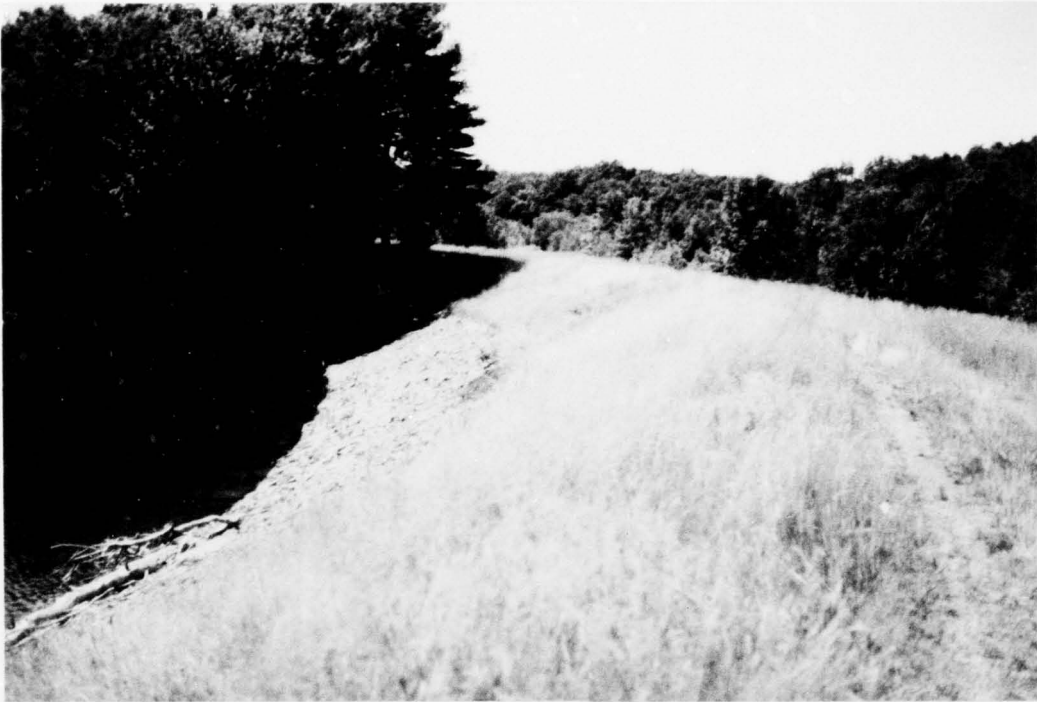
OVERVIEW OF CREST AND UPSTREAM SLOPE OF WOODSTOCK DIKE.  
(LOOKING WEST) NOTE PATHWAYS AND OVERGROWN GRASS.

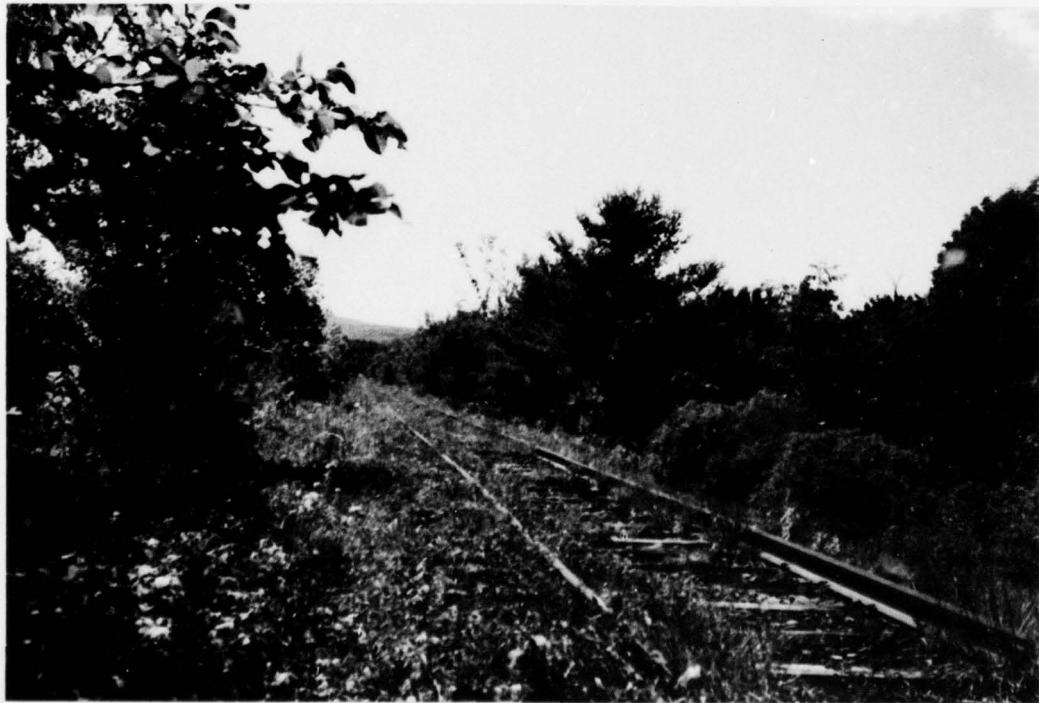
VIEW OF CREST OF GLENFORD DIKE. (LOOKING WEST)  
NOTE ABANDONED RAILROAD TRACK AND HEAVY VEGETATION

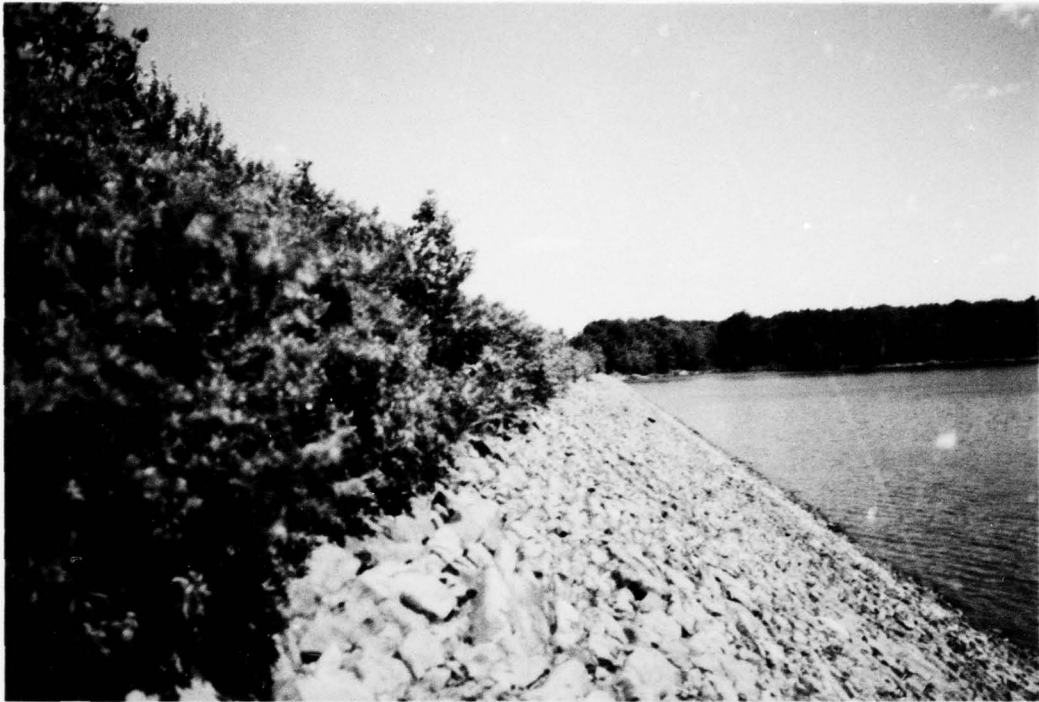
The Glenford Dike appears to be in generally good condition; the horizontal and vertical alignments are also good. There were no visible signs of sloughing, erosion, cracking or other distress on the crest or on either slope. The riprap slope protection is in good condition. The upstream slope above the riprap is overgrown with trees, bushes and saplings. There is a 4-foot high

UPSTREAM SLOPE OF GLENFORD DIKE. (LOOKING EAST)  
NOTE RIPRAP AND HEAVY VEGETATION.

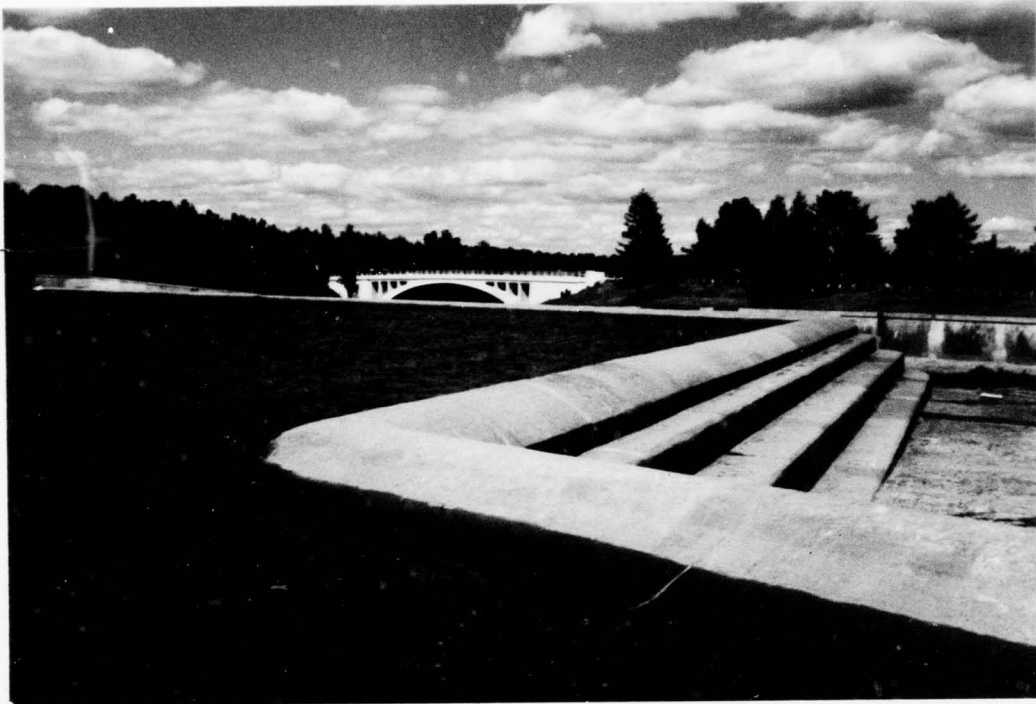
OVERVIEW OF SPILLWAY CREST AND RESERVOIR. (LOOKING NORTH)  
NOTE MINOR VEGETATION.
