CANEADEA DAM

ALLEGANY COUNTY, NEW YORK  
INVENTORY NO. 484

PHASE I INSPECTION REPORT  
NATIONAL DAM SAFETY PROGRAM

**JULY 26, 1978**

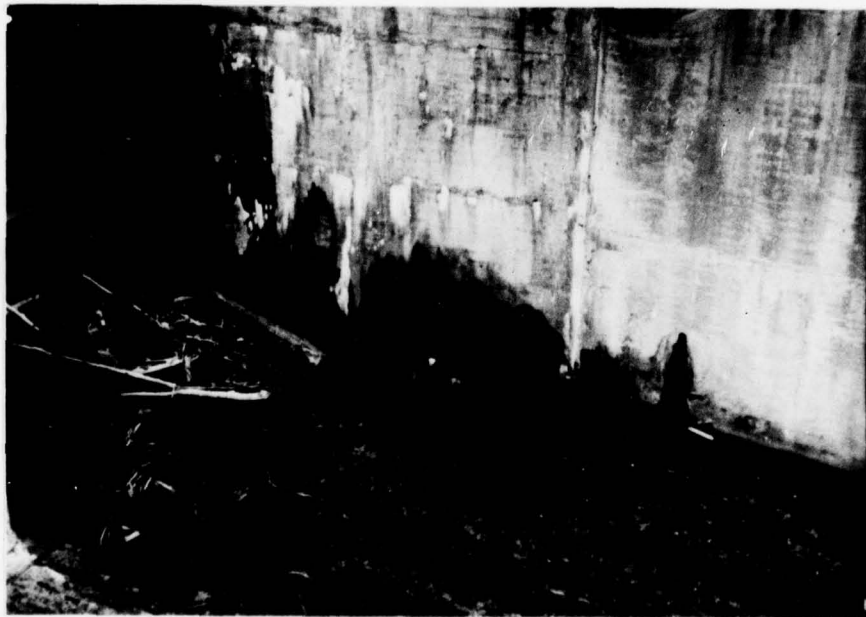
Both spillway gates were closed and the lake surface was about 0.4 ft below the top of gate (El 1440.0). Side seals were tight. At the north gate there was a slight leak at the bottom of the north end and moderate leakage squirting just above the bottom corner of the south end. At the south gate there was light leakage at both bottom corners. It was reported that the north gate bottom timber had been replaced in the spring of 1978 and was thought to be warped. Upstream side J-seals as shown on the drawings were not installed, but were stored in the gatehouse. The visible gate surfaces had patches of rust.

DOWNSTREAM VIEW AT BOTTOM OF LEFT SPILLWAY GATE INCLUDING  
WEEP HOLE DISCHARGE

- 2) Determine source of bottom leakage at south side of north spillway gate, and correct the problem.
  - 3) Revise drawing 31430-73 to show as-built side seal details. It is understood that the J-seal, presently shown, was not installed.

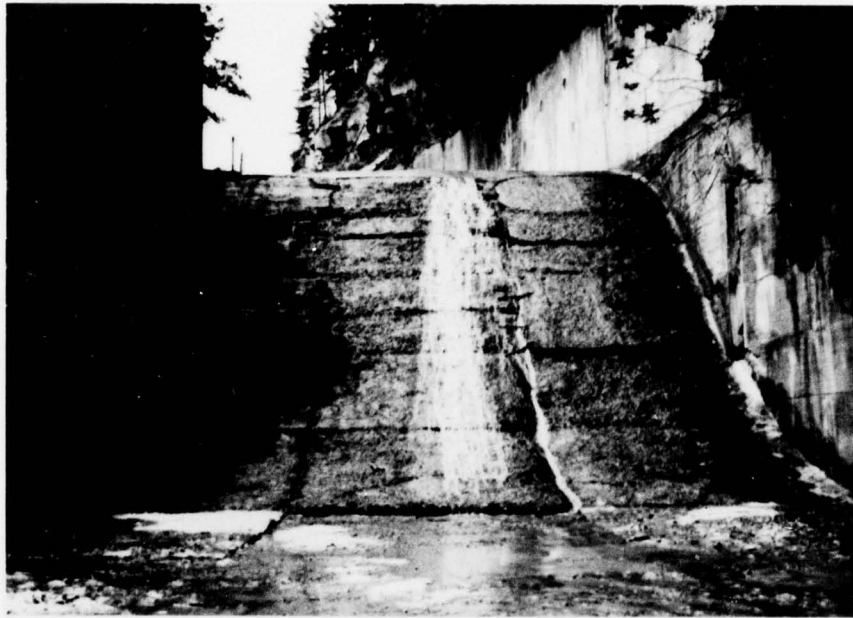
There is substantial erosion on the downstream portion of the sloping chute floor. The flatter floor slab near the abrupt end is also badly eroded. At the downstream end of the high right wall where the chute slab drops sharply there is some local undermining - a chunk of concrete several cubic feet in volume is missing.

CHUTE AT DOWNSTREAM END OF SPILLWAY CHANNEL

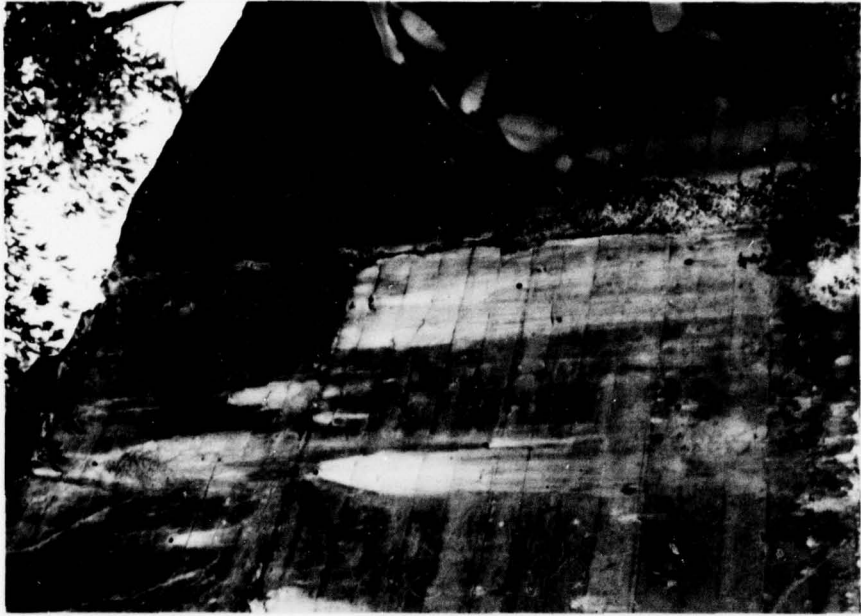
There are exposed rebars and several sizable spalled areas on the exterior face of the right spillway chute wall and carbonate deposits near the vent holes in the spillway chute wall. There is also deterioration of the concrete on both sides of several vertical monolith joints.

RIGHT SPILLWAY CHANNEL WALL EXTERIOR  
FACE, MONOLITH JOINT

- 3) An attempt should be made to clean inoperative weep holes in the spillway channel.
  - 4) Initiate a program of rehabilitation of concrete structures with exposed rebars and spalled or eroded surface areas of walls and slabs. Priorities for repair would depend upon the severity of damaged concrete.

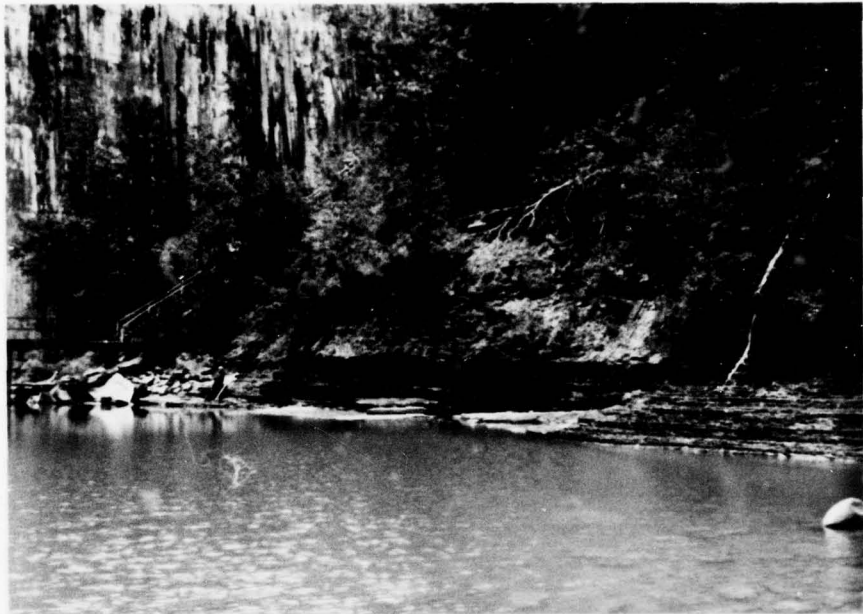
Seepage was also observed coming from the downstream face of the north (left) concrete abutment.

AREA OF SEEPAGE ON LEFT SIDE DOWNSTREAM OF DAM

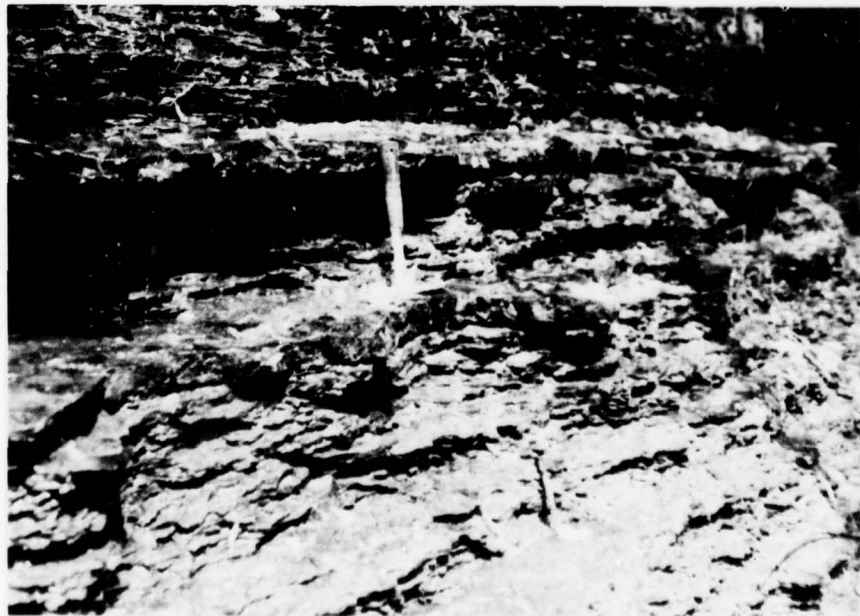
SEEPAGE FROM ROCK LEDGE SHOWN IN ABOVE PHOTO

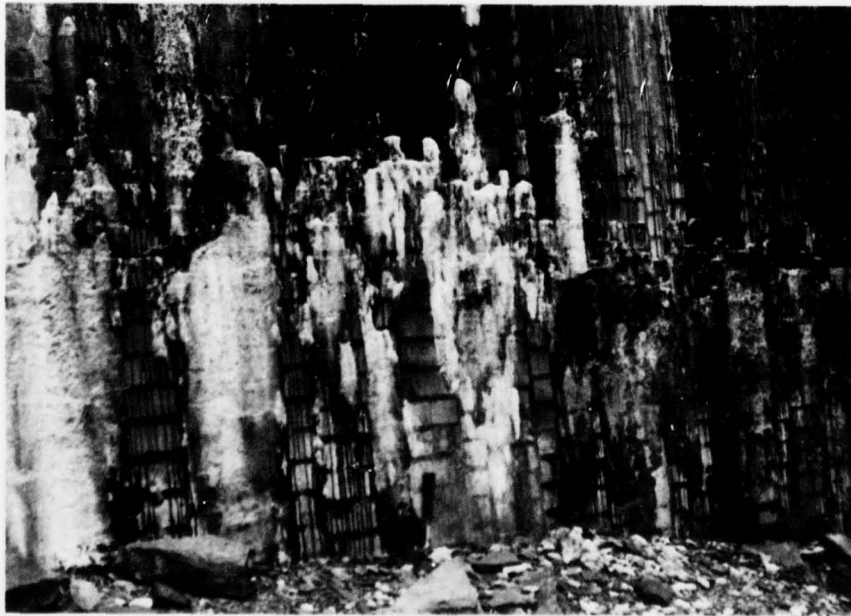
There are numerous areas with white deposits on the downstream face of the dam; deposition of as much as 2 inches thick has been observed. Minor leakage on downstream face of dam appears to be along horizontal and vertical joints of brickwork.

CLOSEUP OF BASE OF DOWNSTREAM FACE SHOWING BRICK FACING  
AND MINERAL DEPOSITION DUE TO SEEPAGE

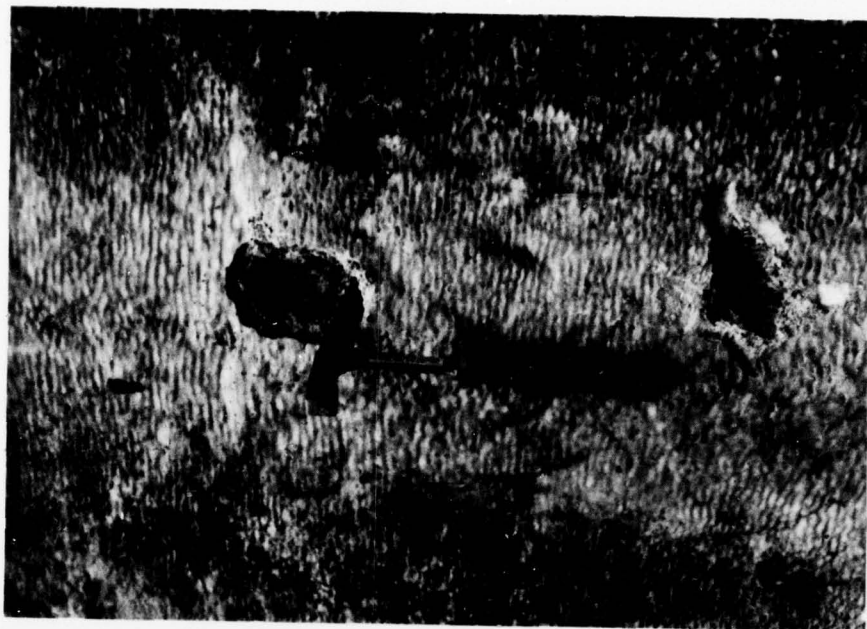
DETAIL, SHOWING THICKNESS OF DEPOSITION  
ON DOWNSTREAM FACE OF DAM

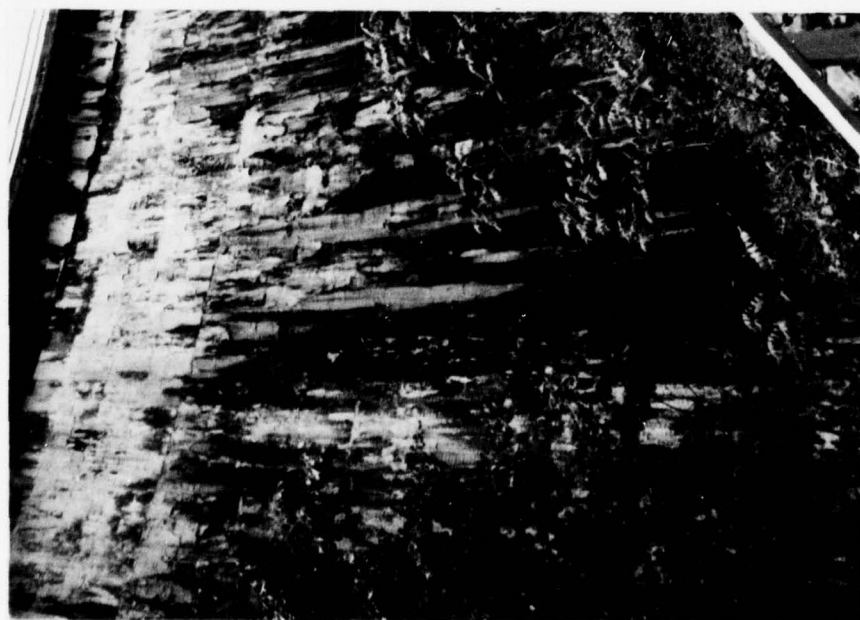
OVERALL VIEW OF DOWNSTREAM FACE OF DAM SHOWING  
MINERAL DEPOSITION DUE TO SEEPAGE

1. Concrete Surfaces UPSTREAM AND DOWNSTREAM FACES OF ARCH DAM ARE BRICK FACED. THERE ARE NUMEROUS AREAS WITH WHITE (EFFLORESCENCE) DEPOSITS ON THE DOWNSTREAM FACE OF DAM. SOME CRACKS AND SPALLING OF BRICK ARE VISIBLE.
