**RIDGEWOOD RESERVOIR  
KINGS COUNTY NEW YORK  
INVENTORY NO 160**

**PHASE I INSPECTION REPORT  
NATIONAL DAM SAFETY PROGRAM**

**NEW YORK DISTRICT CORPS OF ENGINEERS**

**JULY 1978**

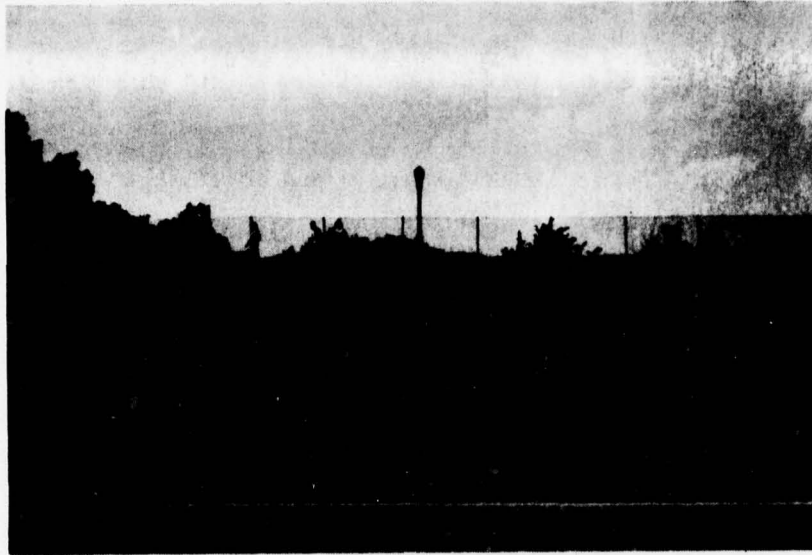
7. East side embankment.

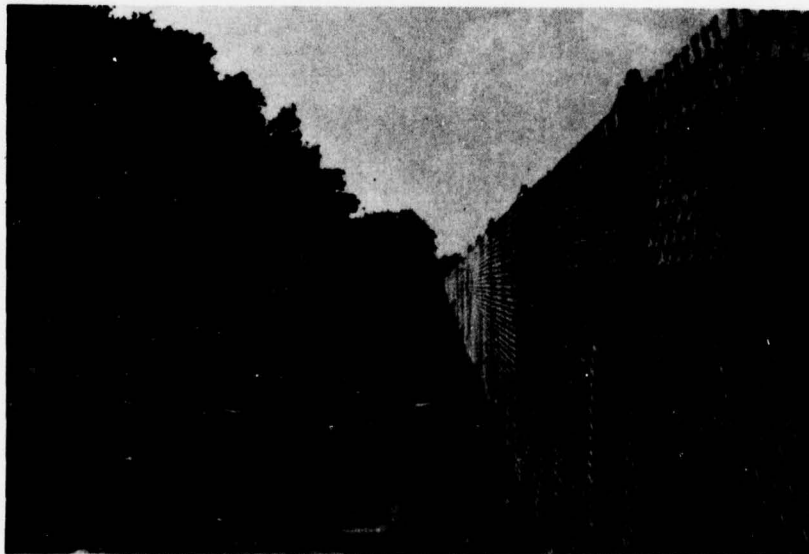
8. View along fence at top of embankment on south side of basin #3. Notice large trees on side of embankment.

This reservoir complex consists of three basins, side by side. The easterly basin, empty and out of service for a number of years, is overgrown with reeds. The central and westerly basins are in use. All perimeter and basin dividing embankments, and slopes in areas of (originally) basin excavation, are generally in good condition with no evidence of structural movement or cracking. Reservoir side slopes have been provided with riprap, observed to be in serviceable condition with the exception of limited areas where the riprap has been displaced by vandals. Minor erosion is occurring at such locations. Heavy growth of small to medium size foliage has developed through the riprap across much of the two inservice basin perimeters. Examination of downstream slopes indicate no seepage is occurring through embankments. Large, mature trees exist on downstream slopes at several areas.

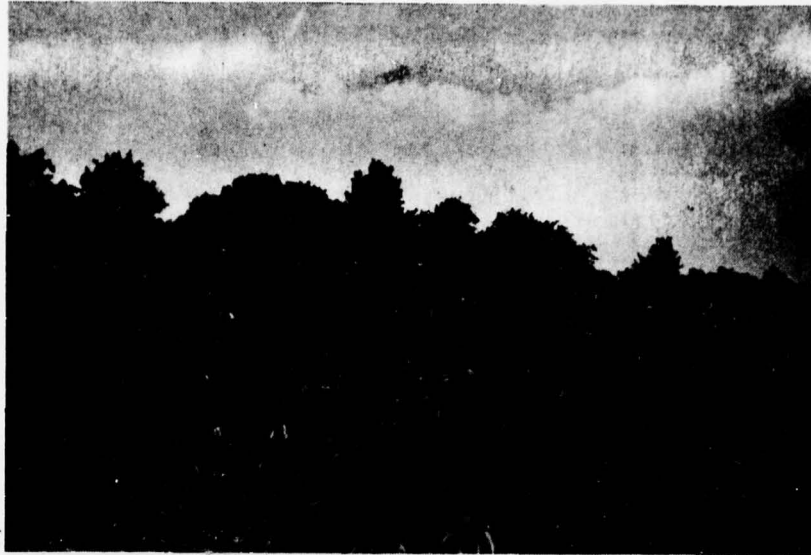
9. View of riprap in basin #1. In generally good condition.
