**NEVERSINK RESERVOIR DAM
SULLIVAN COUNTY NEW YORK
INVENTORY NO 348**

**PHASE I INSPECTION REPORT
NATIONAL DAM SAFETY PROGRAM**

AUGUST 1978

PHASE I REPORT
NATIONAL DAM SAFETY PROGRAM

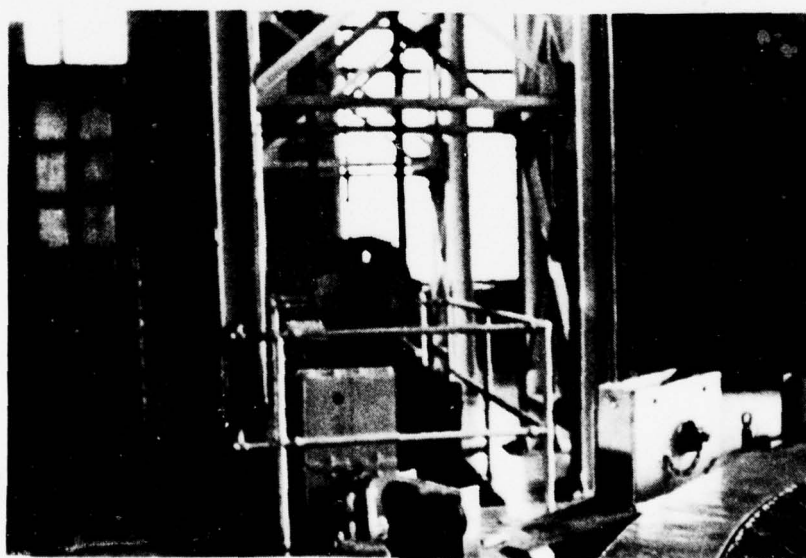
8. Gate house area showing control gate mechanism. Full time staff keeps facility well maintained.

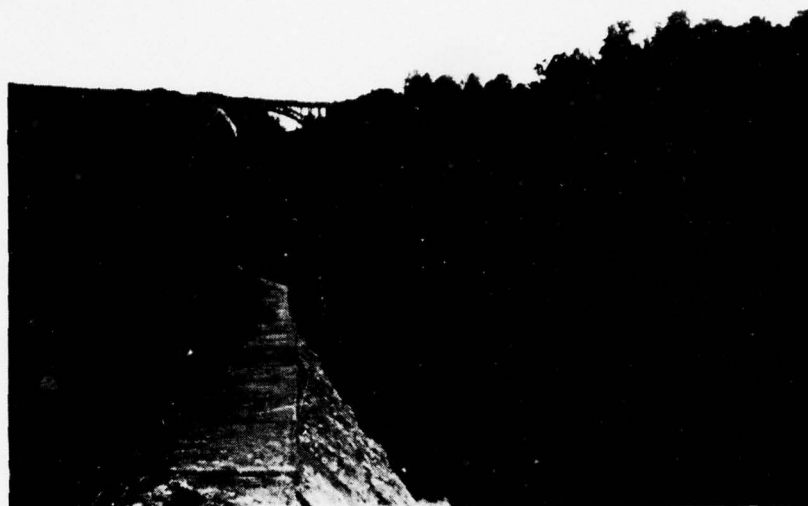
9. View of emergency spillway from stilling basin area. Notice significant vegetative growth in spillway. Left is fence. Discharge tunnel is submerged in basin.

VISUAL EXAMINATION OF	OBSERVATIONS	REMARKS OR RECOMMENDATIONS
CONCRETE WEIR	Some surface spalling. Very minor leaking through joints in the masonry.	
APPROACH CHANNEL	Reservoir face.	
DISCHARGE CHANNEL	Some vegetative growth which should be removed from emergency spillway channel	
BRIDGE AND PIERS	Good.

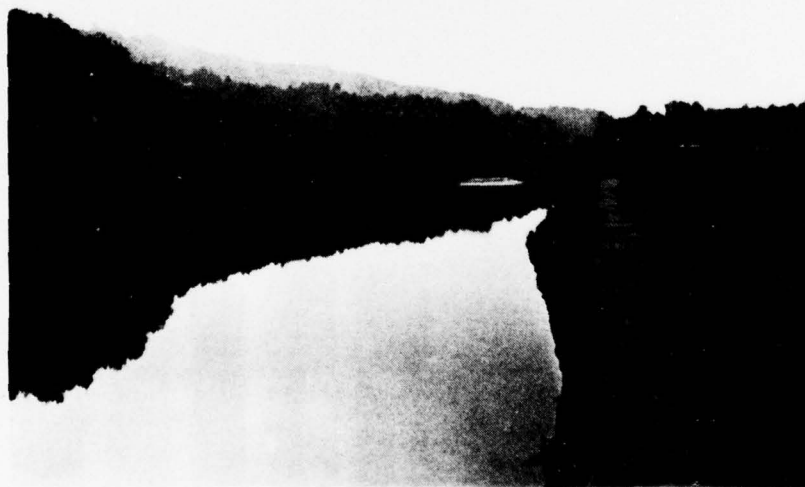
10. View of downstream area below stilling basin.
