MOHAWK RIVER WATERSHED  
KECKS CENTER CREEK BASIN

## CORK CENTER STORAGE RESERVOIR DAM FULTON COUNTY, NEW YORK

### PHASE I INSPECTION REPORT NATIONAL DAM SAFETY PROGRAM /

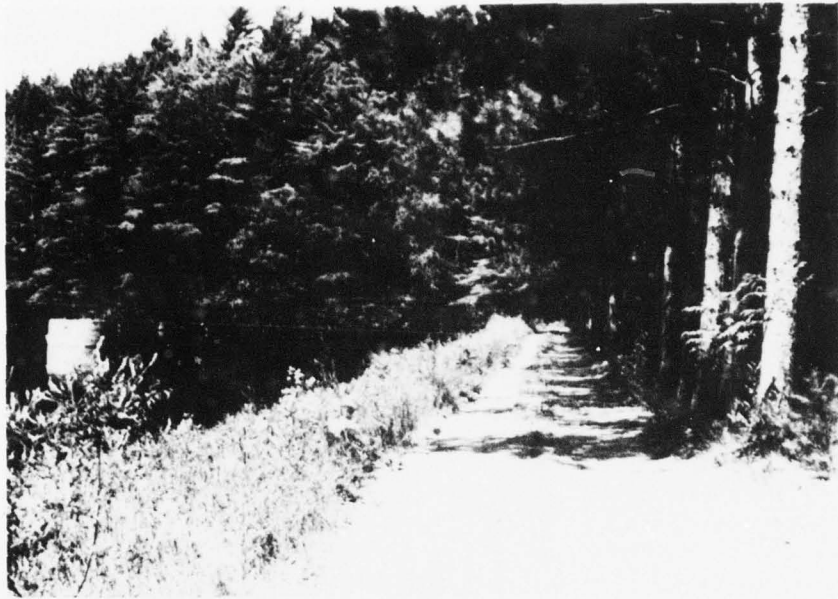
FIGURE 1      CREST OF DAM LOOKING LEFT

The approach road leads to the left abutment of the earthen embankment from whence a 10-foot wide road (Fig. 1, Appendix D) in fairly good condition continues over the crest to the junction of the right abutment with the spillway. Just before the spillway, the embankment takes a 90° turn such that the direction of the spillway is perpendicular to that of the embankment. Over the spillway, there is a 3-foot wide concrete footbridge (Figs. 2 and 3, Appendix D) leading to a small length of embankment, which is heavily wooded and appears to be natural ground.

Near the center of the main embankment, there is an angle-iron access bridge leading to a concrete intake structure (Fig. 1, Appendix D). The access bridge was constructed in 1963, and is generally in good condition but rusted. It needs scraping and painting, but one should be careful to avoid contamination of water with lead compounds or other potentially detrimental material.

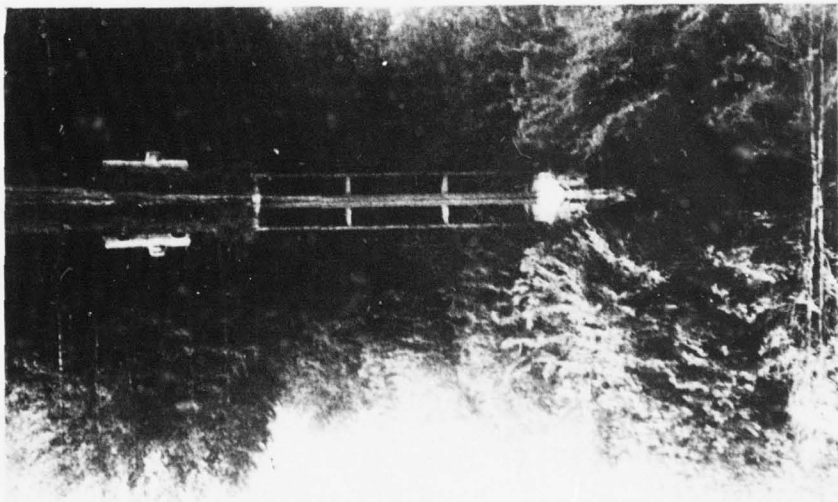
FIGURE 2      SPILLWAY OVERVIEW

i. The overflow section itself (Fig. 2, Appendix D) appears to be in generally good condition with a moderate amount of spalling and erosion of its downstream slope and piers (Fig. 7, Appendix D).

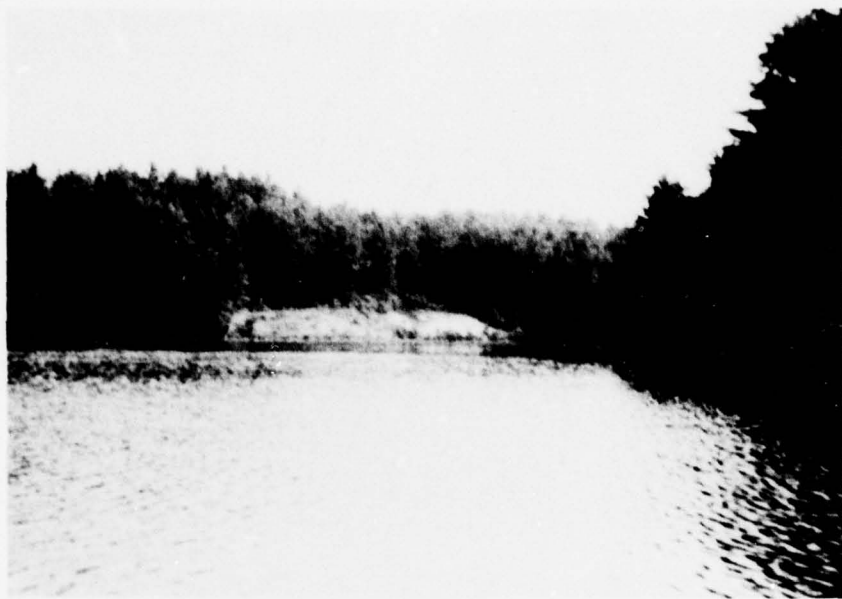
FIGURE 15      RESERVOIR SIDE SLOPES

The reservoir area is heavily wooded except for one naturally sandy area that is covered with moss and scrub only (Fig. 15, Appendix D). Side slopes of the reservoir are steep; about 1½ horizontal to 1 vertical. However, there is no evidence of slope failure. There is a moderate amount of sedimentation at the upstream entrance and an indication of sedimentation at the dam, suggested by the turbidity of water released from the mud pipe.
